TECHNOLOGY@ROCKY FLATS

Demonstration & Deployment Summary

Harmonic Delamination: "Sonic Shakedown" makes Smart Work out of Risky Work

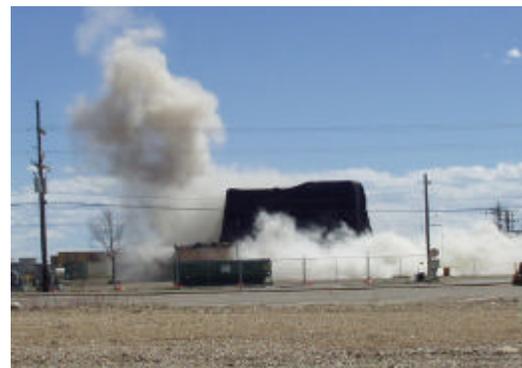
B886 shown draped in engineering fabric at the moment of detonation

The two-story building was draped in black engineering fabric. When the charges went off under the fabric, all that could be seen was some smoke, but little else. The design of these charges set up pressure waves that forced the concrete and rebar to separate, thus allowing demolition equipment to more easily tear down the building.

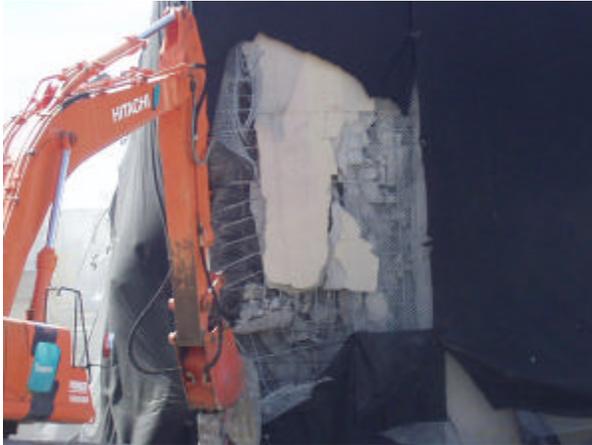
View of concrete fractured from the rebar

Kaiser-Hill Construction hired Controlled Demolition Inc. (CDI) as the D&D subcontractor for Building 886. CDI proposed to use 'harmonic delamination', a technique to fracture concrete away from rebar, to support Kaiser-Hill Construction in the demolition of B886. CDI took two weeks to prepare the building by drilling down from the roof to make 32-ft. holes in the 4-ft. to 5-ft. thick walls. Small amounts of explosives were placed in the holes and set off sequentially in three shots. When the charges were set off, high velocity detonation waves moved through the walls,

separating the concrete from the rebar reinforcement. These pressure, or sonic, waves were tuned to the rebar/concrete laminate so as to literally shakeup the building and make conventional demolition feasible.

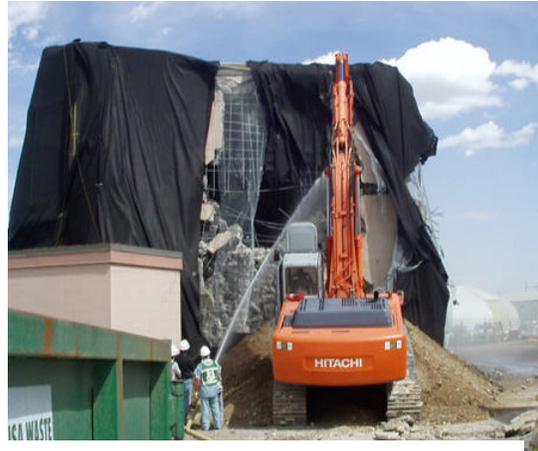
Conventional demolition work gets underway

Following the detonation of the Harmonic Delamination charges, the structure remained standing but was substantially weakened. Kaiser-Hill Construction moved in and demolition then proceeded manually with the Tracked-Excavator, also called T-Rex. The T-Rex operator, with instructions from the CDI Project Manager, had a much easier time removing chunks of the building during the mechanical demolition stage that began soon after delamination was complete.
