FIGURES

U.S. Department of Energy
 Rocky Flats Environmental Technology Site

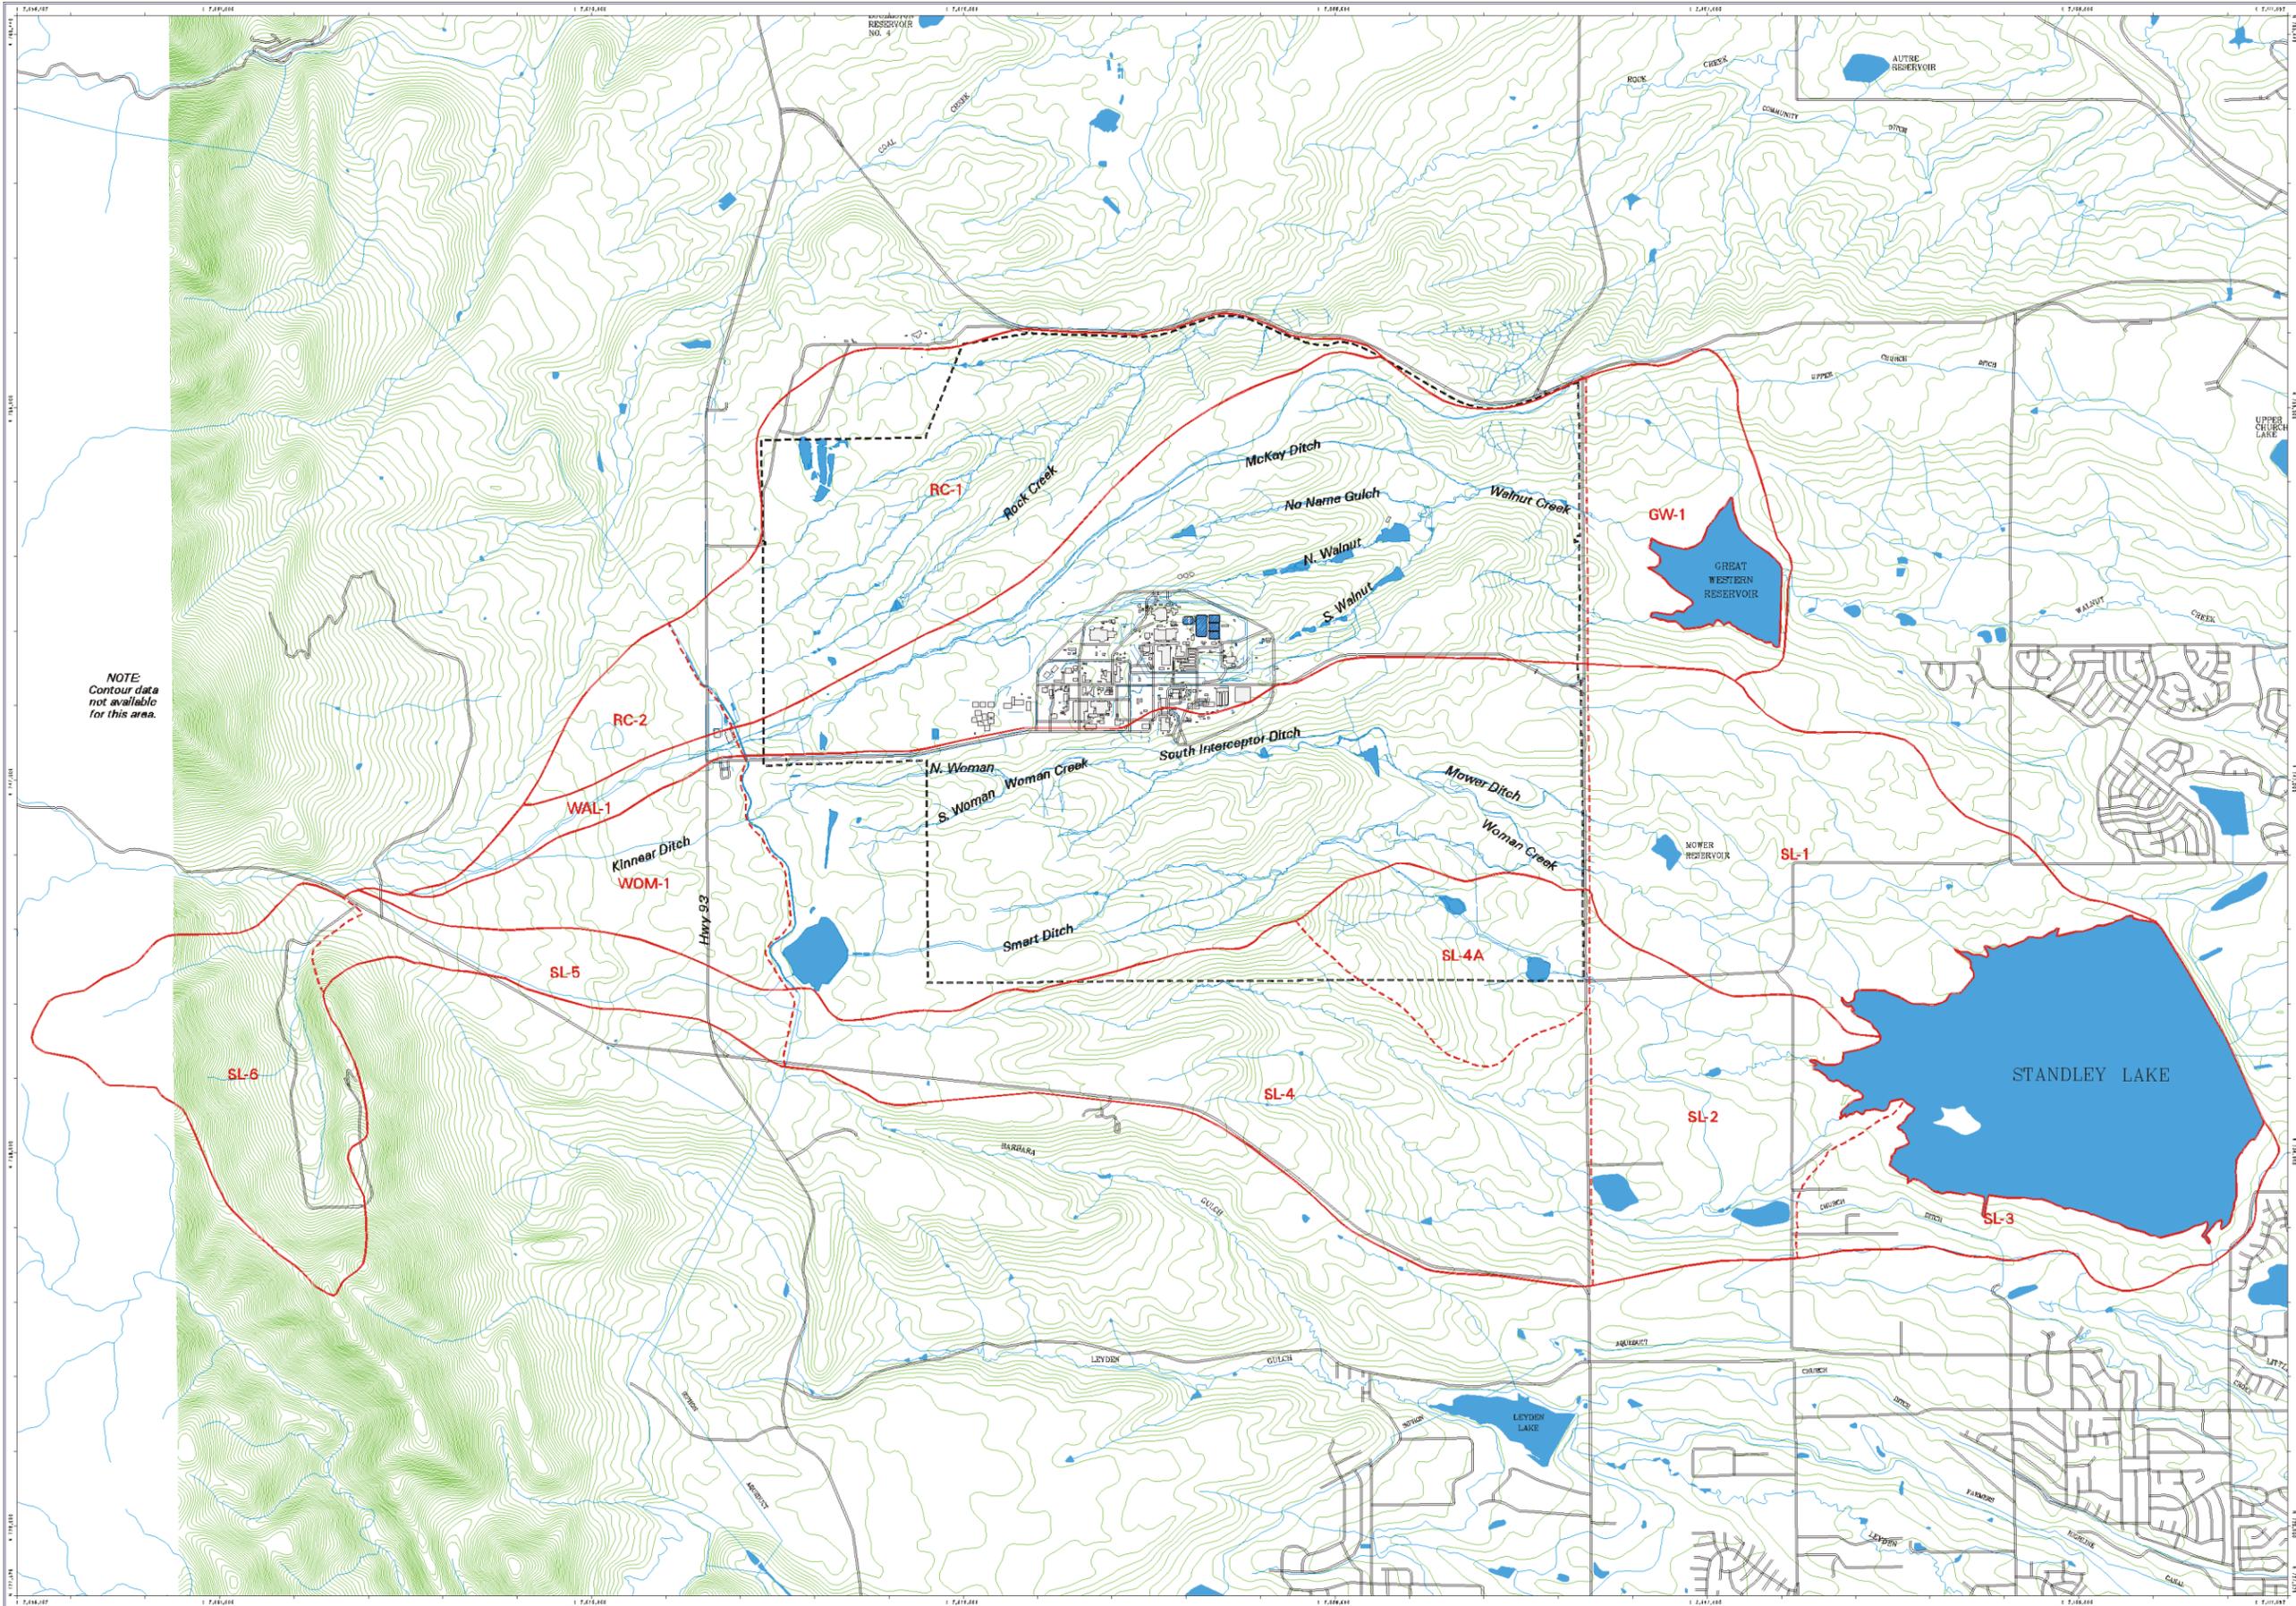
Figure 1
Major Drainage Basins at Rocky Flats

Sub-Basin Boundary
- Areas of Sub-basins**
- Rock Creek 1 - 1662.9 Acres
- Rock Creek 2 - 219.5 Acres
- Walnut Creek 1 - 143.2 Acres
- Woman Creek 1 - 563.7 Acres
- Great Western 1 - 594.0 Acres
- Standley Lake 1 - 1537.2 Acres
- Standley Lake 2 - 939.4 Acres
- Standley Lake 3 - 428.8 Acres
- Standley Lake 4 - 1806.3 Acres
- Standley Lake 4A - 528.4 Acres
- Standley Lake 5 - 380.7 Acres
- Standley Lake 6 - 912.2 Acres
- Standard Map Features**
-

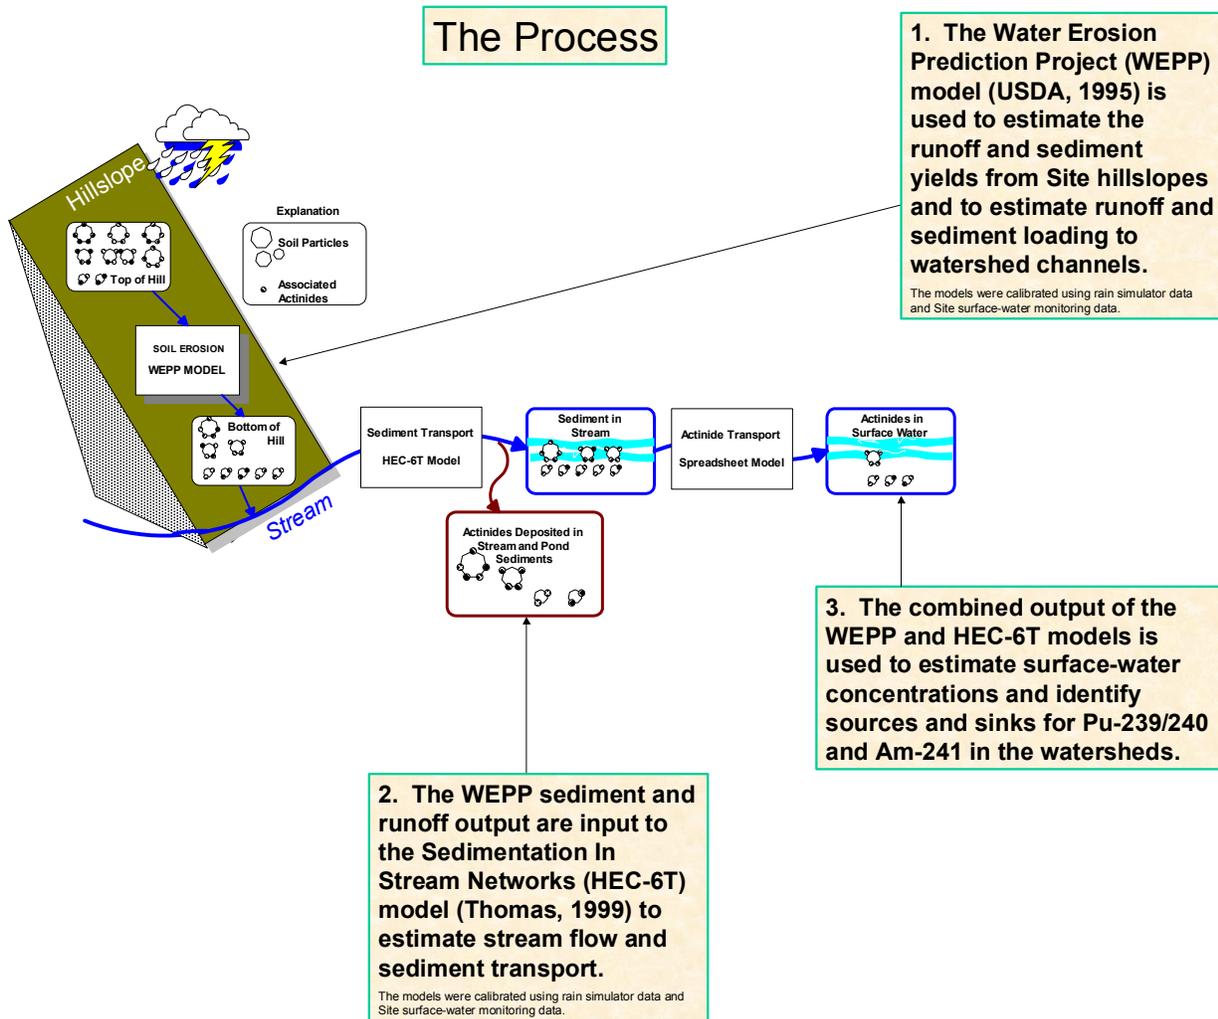
Figure 2. Schematic Diagram of the AME Erosion, Sediment and Actinide Transport Modeling Process

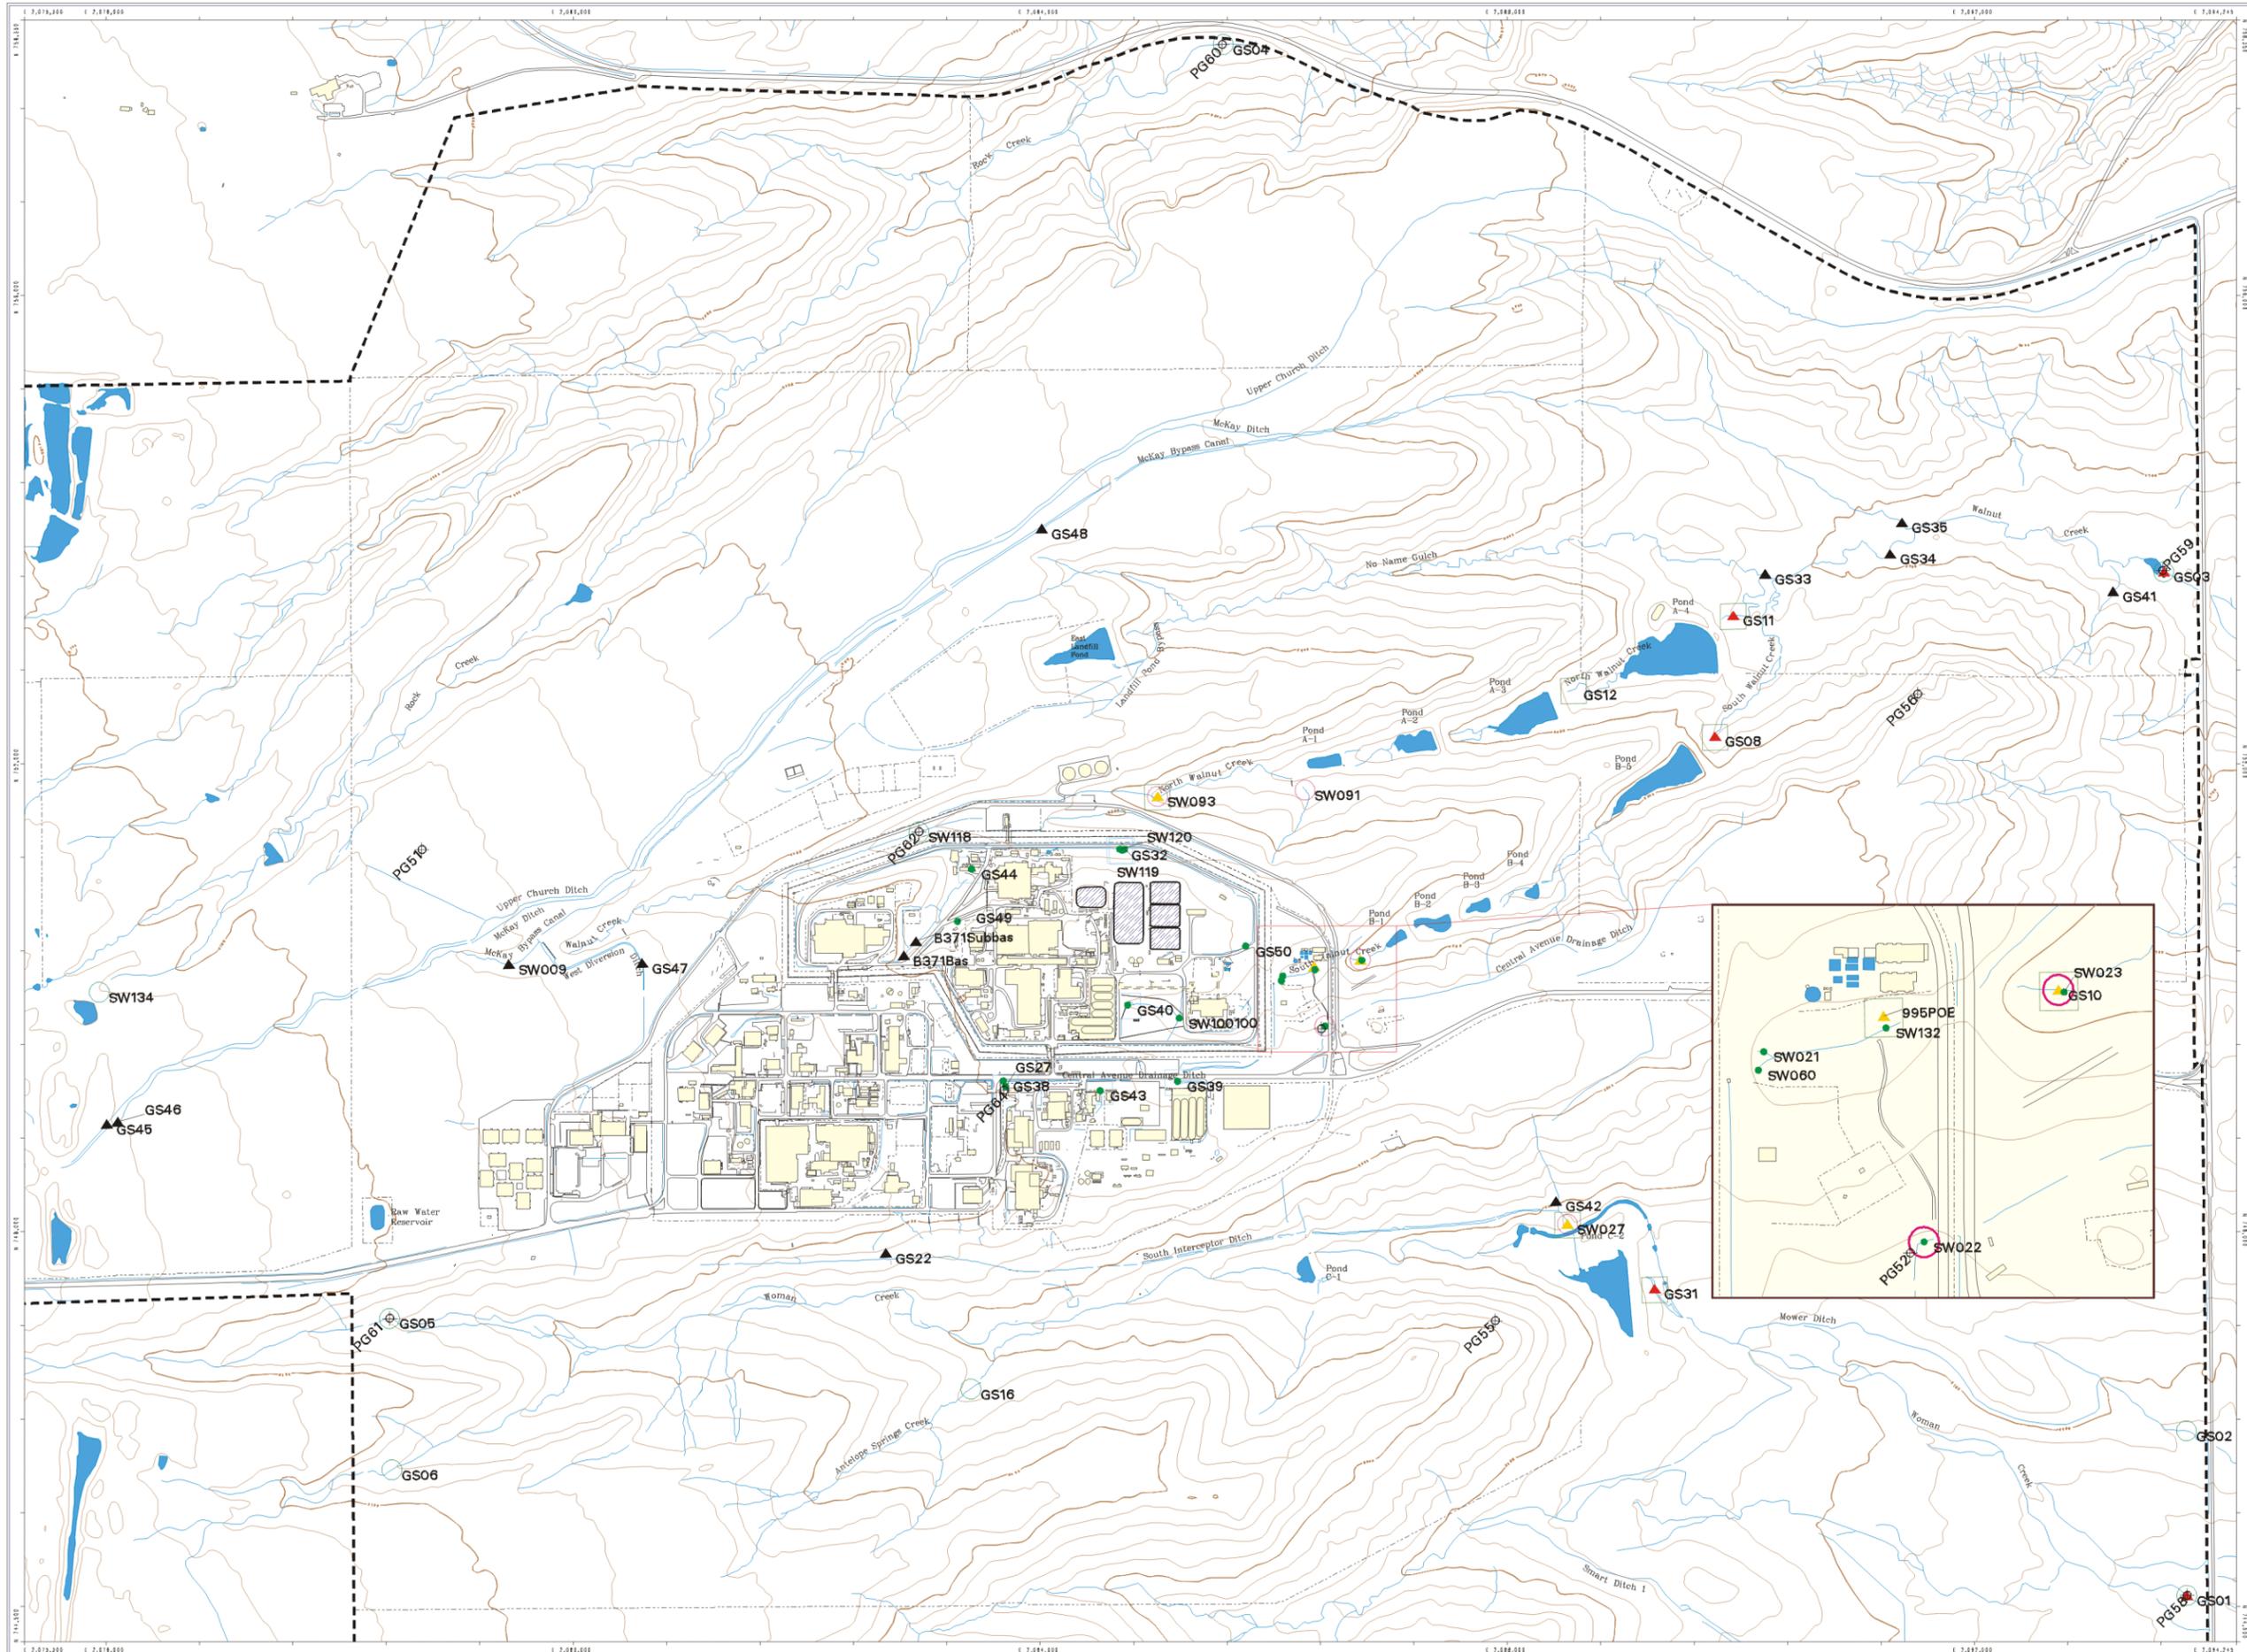
Figure 3
Automated Surface
Water Monitoring
Locations and
Precipitation Gages for
FY 2001
EXPLANATION

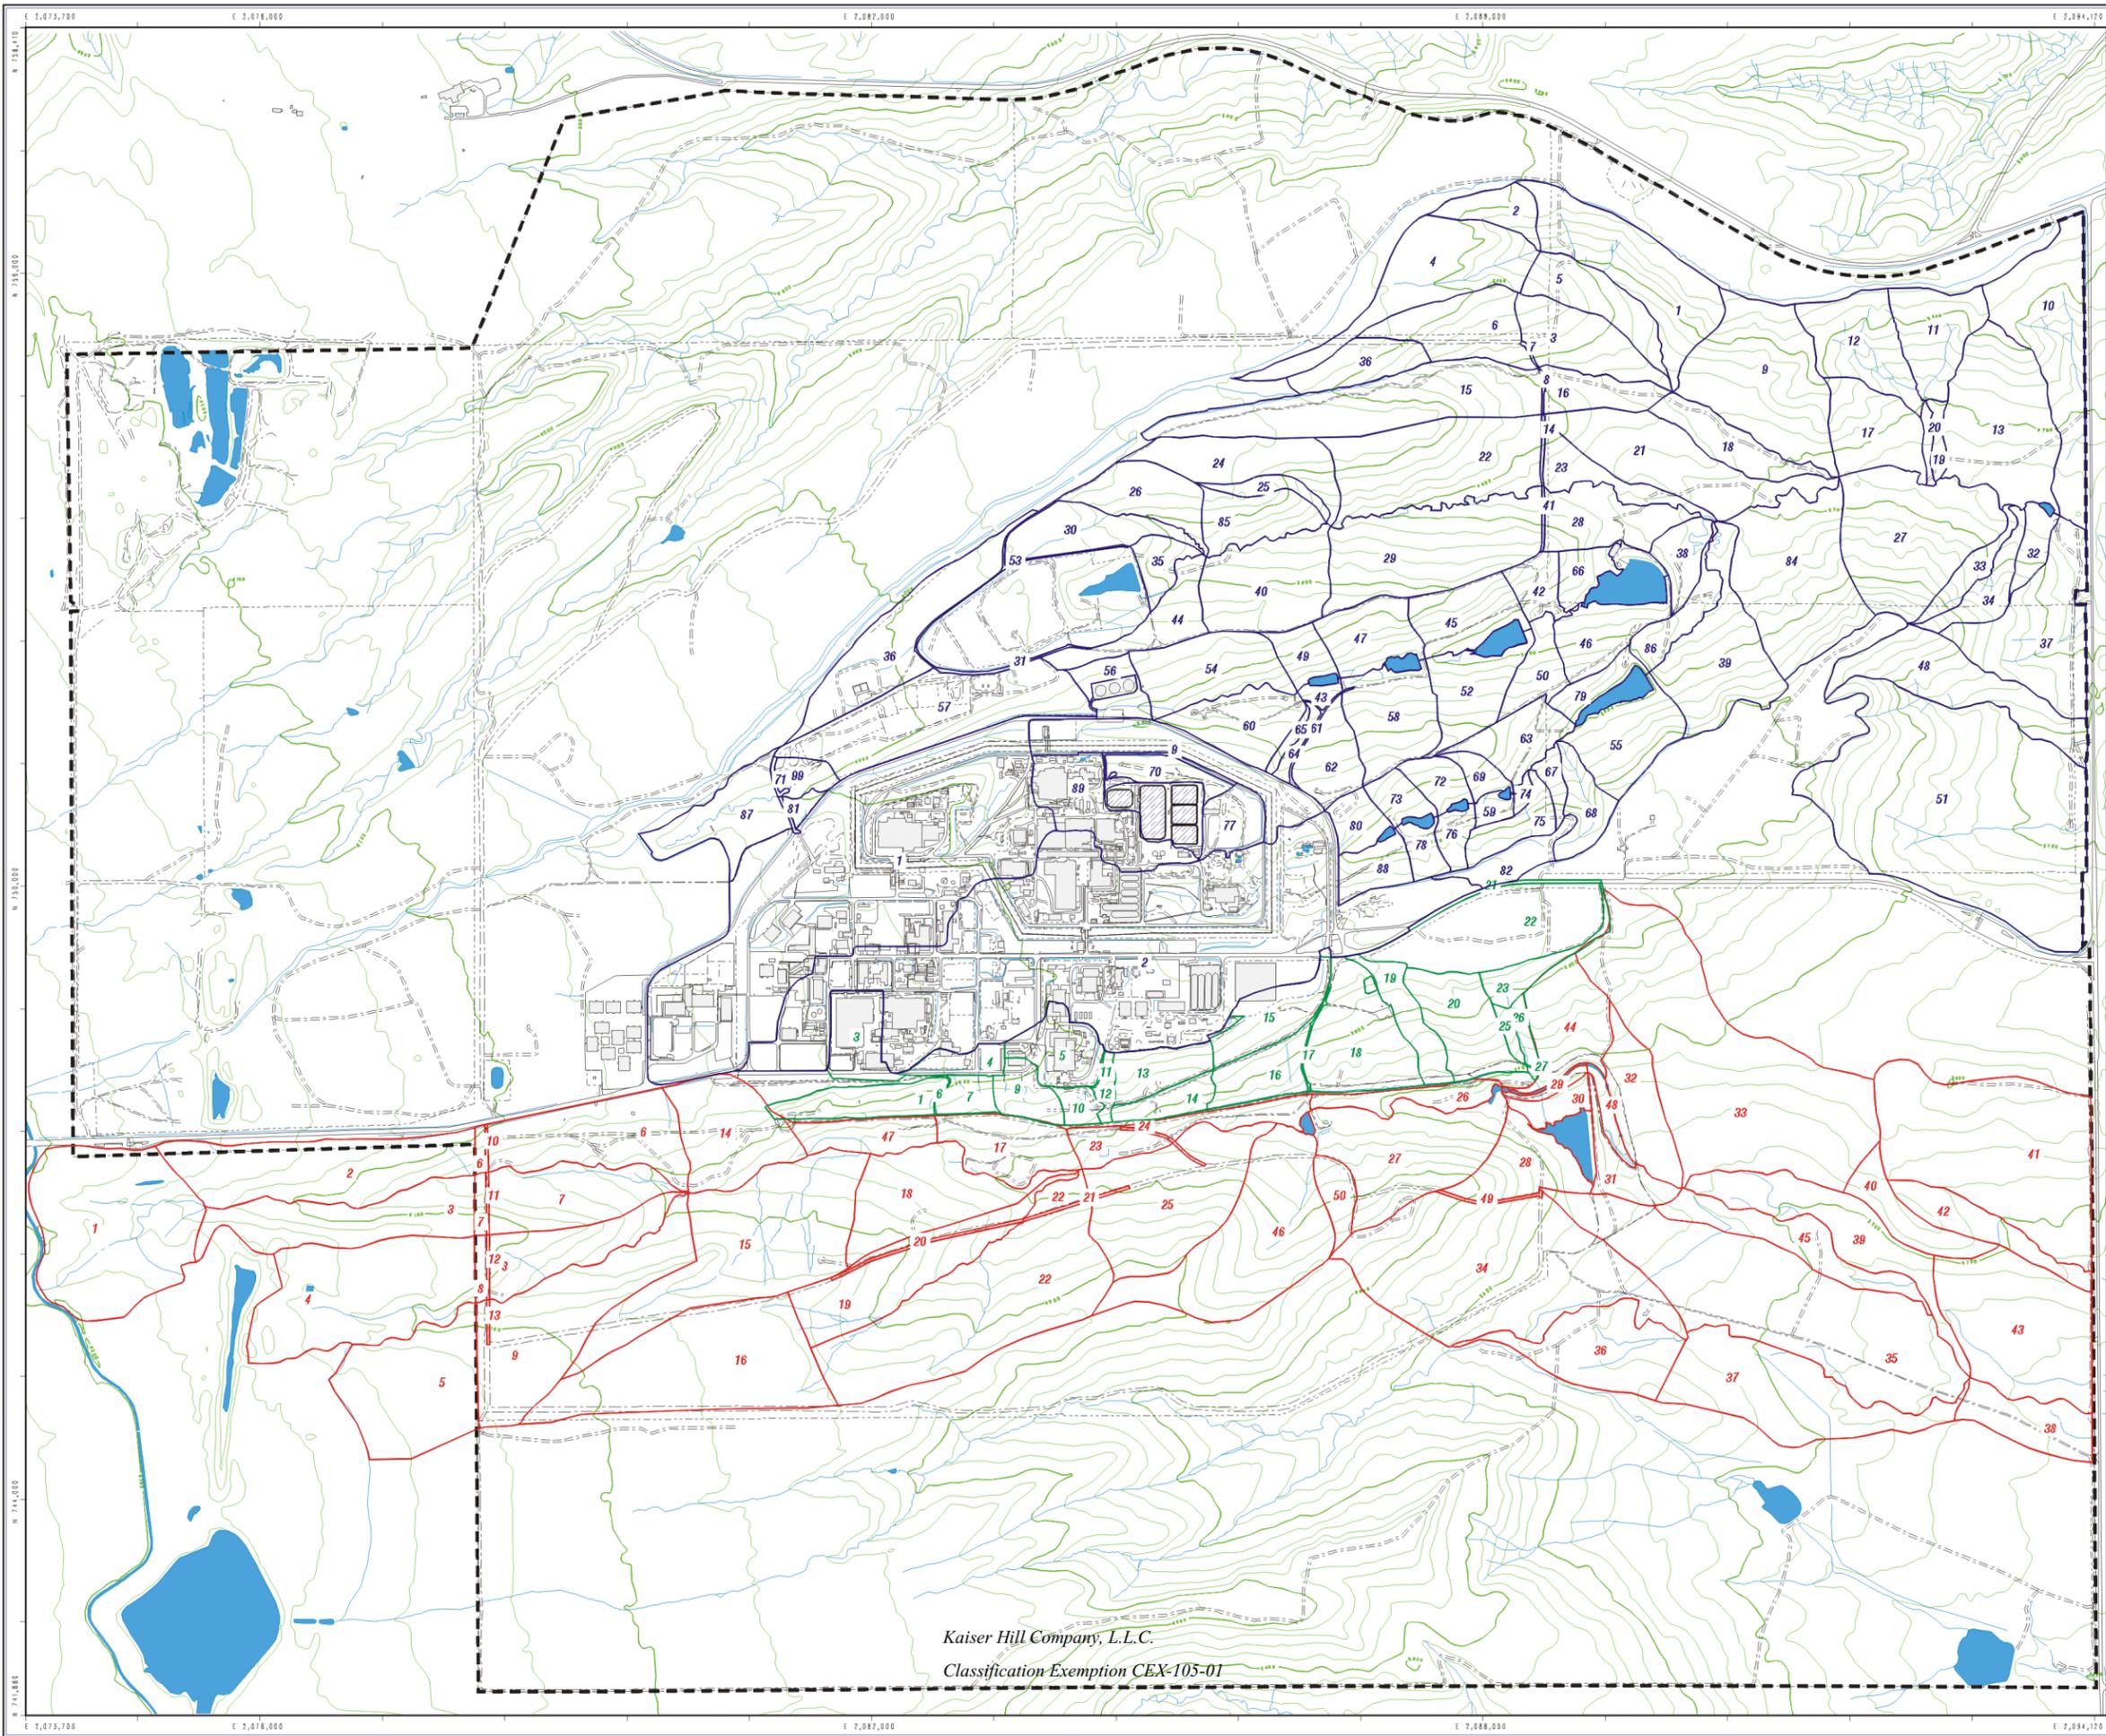
Figure 4

All Watershed Hillslopes

- Hillslope Boundaries**
- Woman Creek Watershed Hillslopes
 - South Interceptor Ditch Hillslopes
 - Walnut Creek Watershed Hillslopes

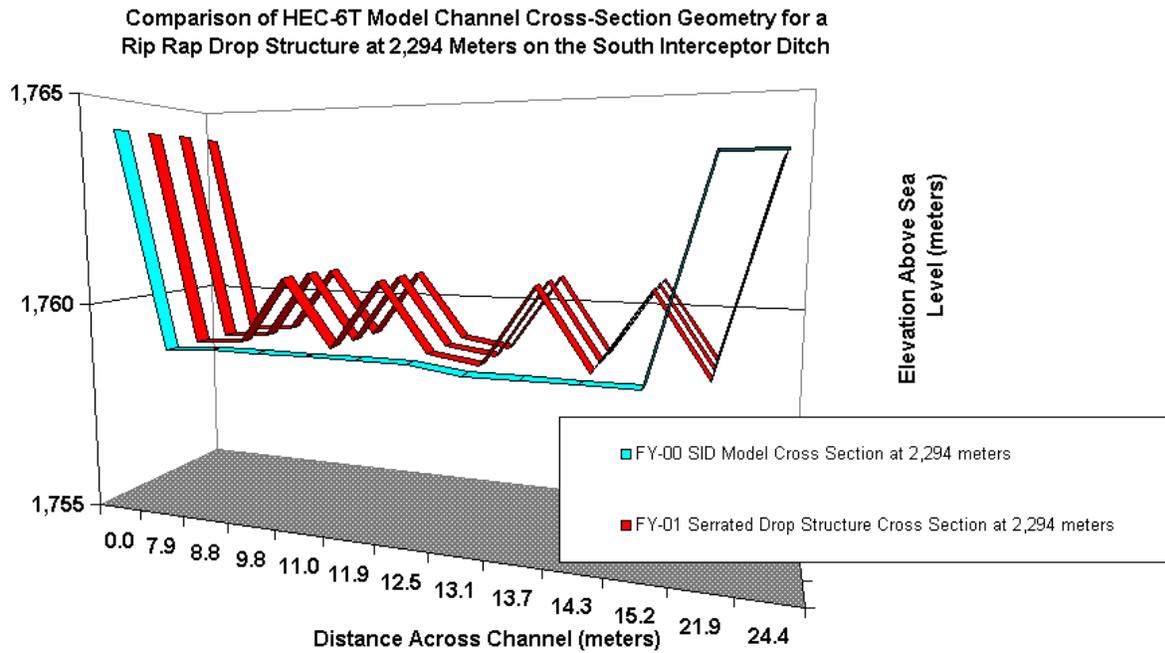
Figure 5. Comparison of HEC-6T Cross Section Geometry for a Typical Rip Rap Drop Structure On the SID

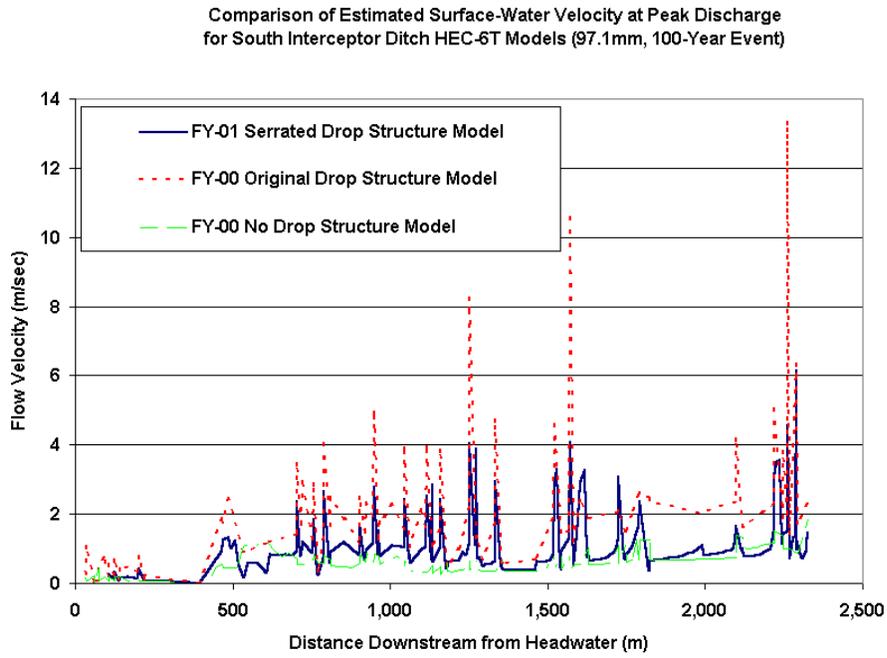
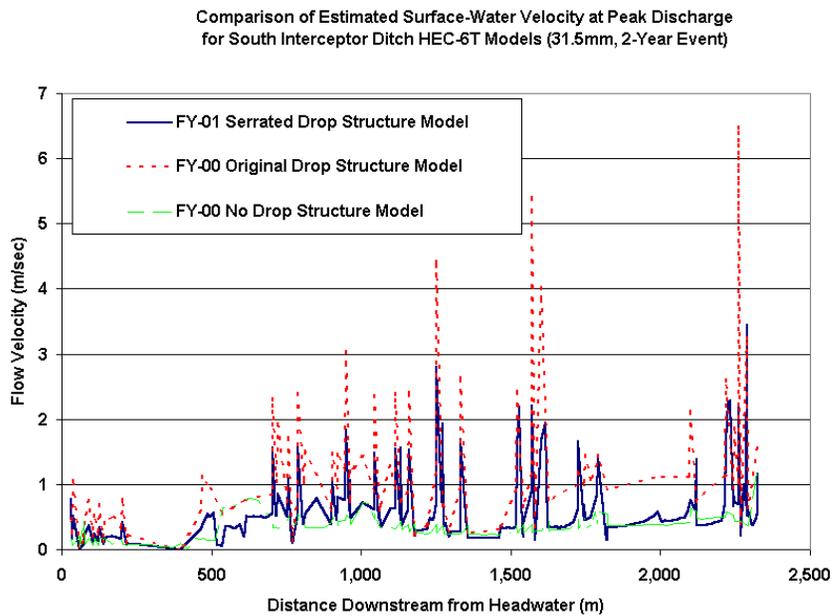
Figure 6. Comparison of Estimated Flow Velocities at Peak Discharge for the SID HEC-6T Models—31.5-mm and 97.1-mm Events

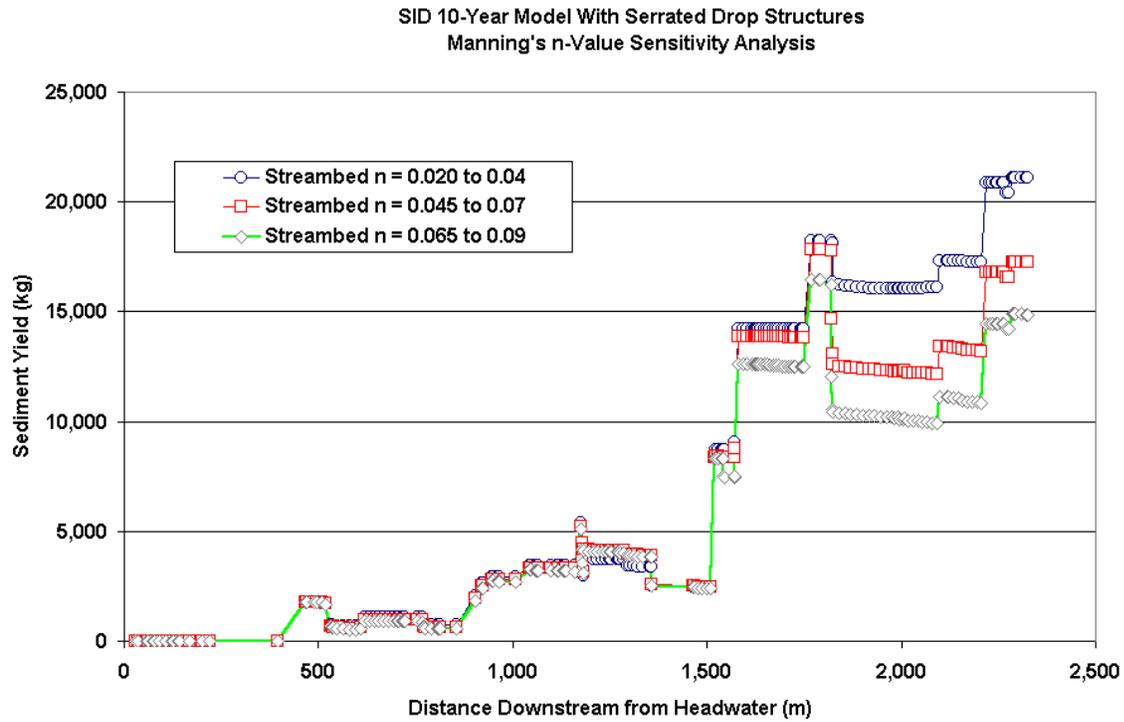
Figure 7. Results of Manning's n-Value Sensitivity Analysis for the FY01 Serrated Drop Structure HEC-6T Model for the SID-62.3-mm, 10-Year Event

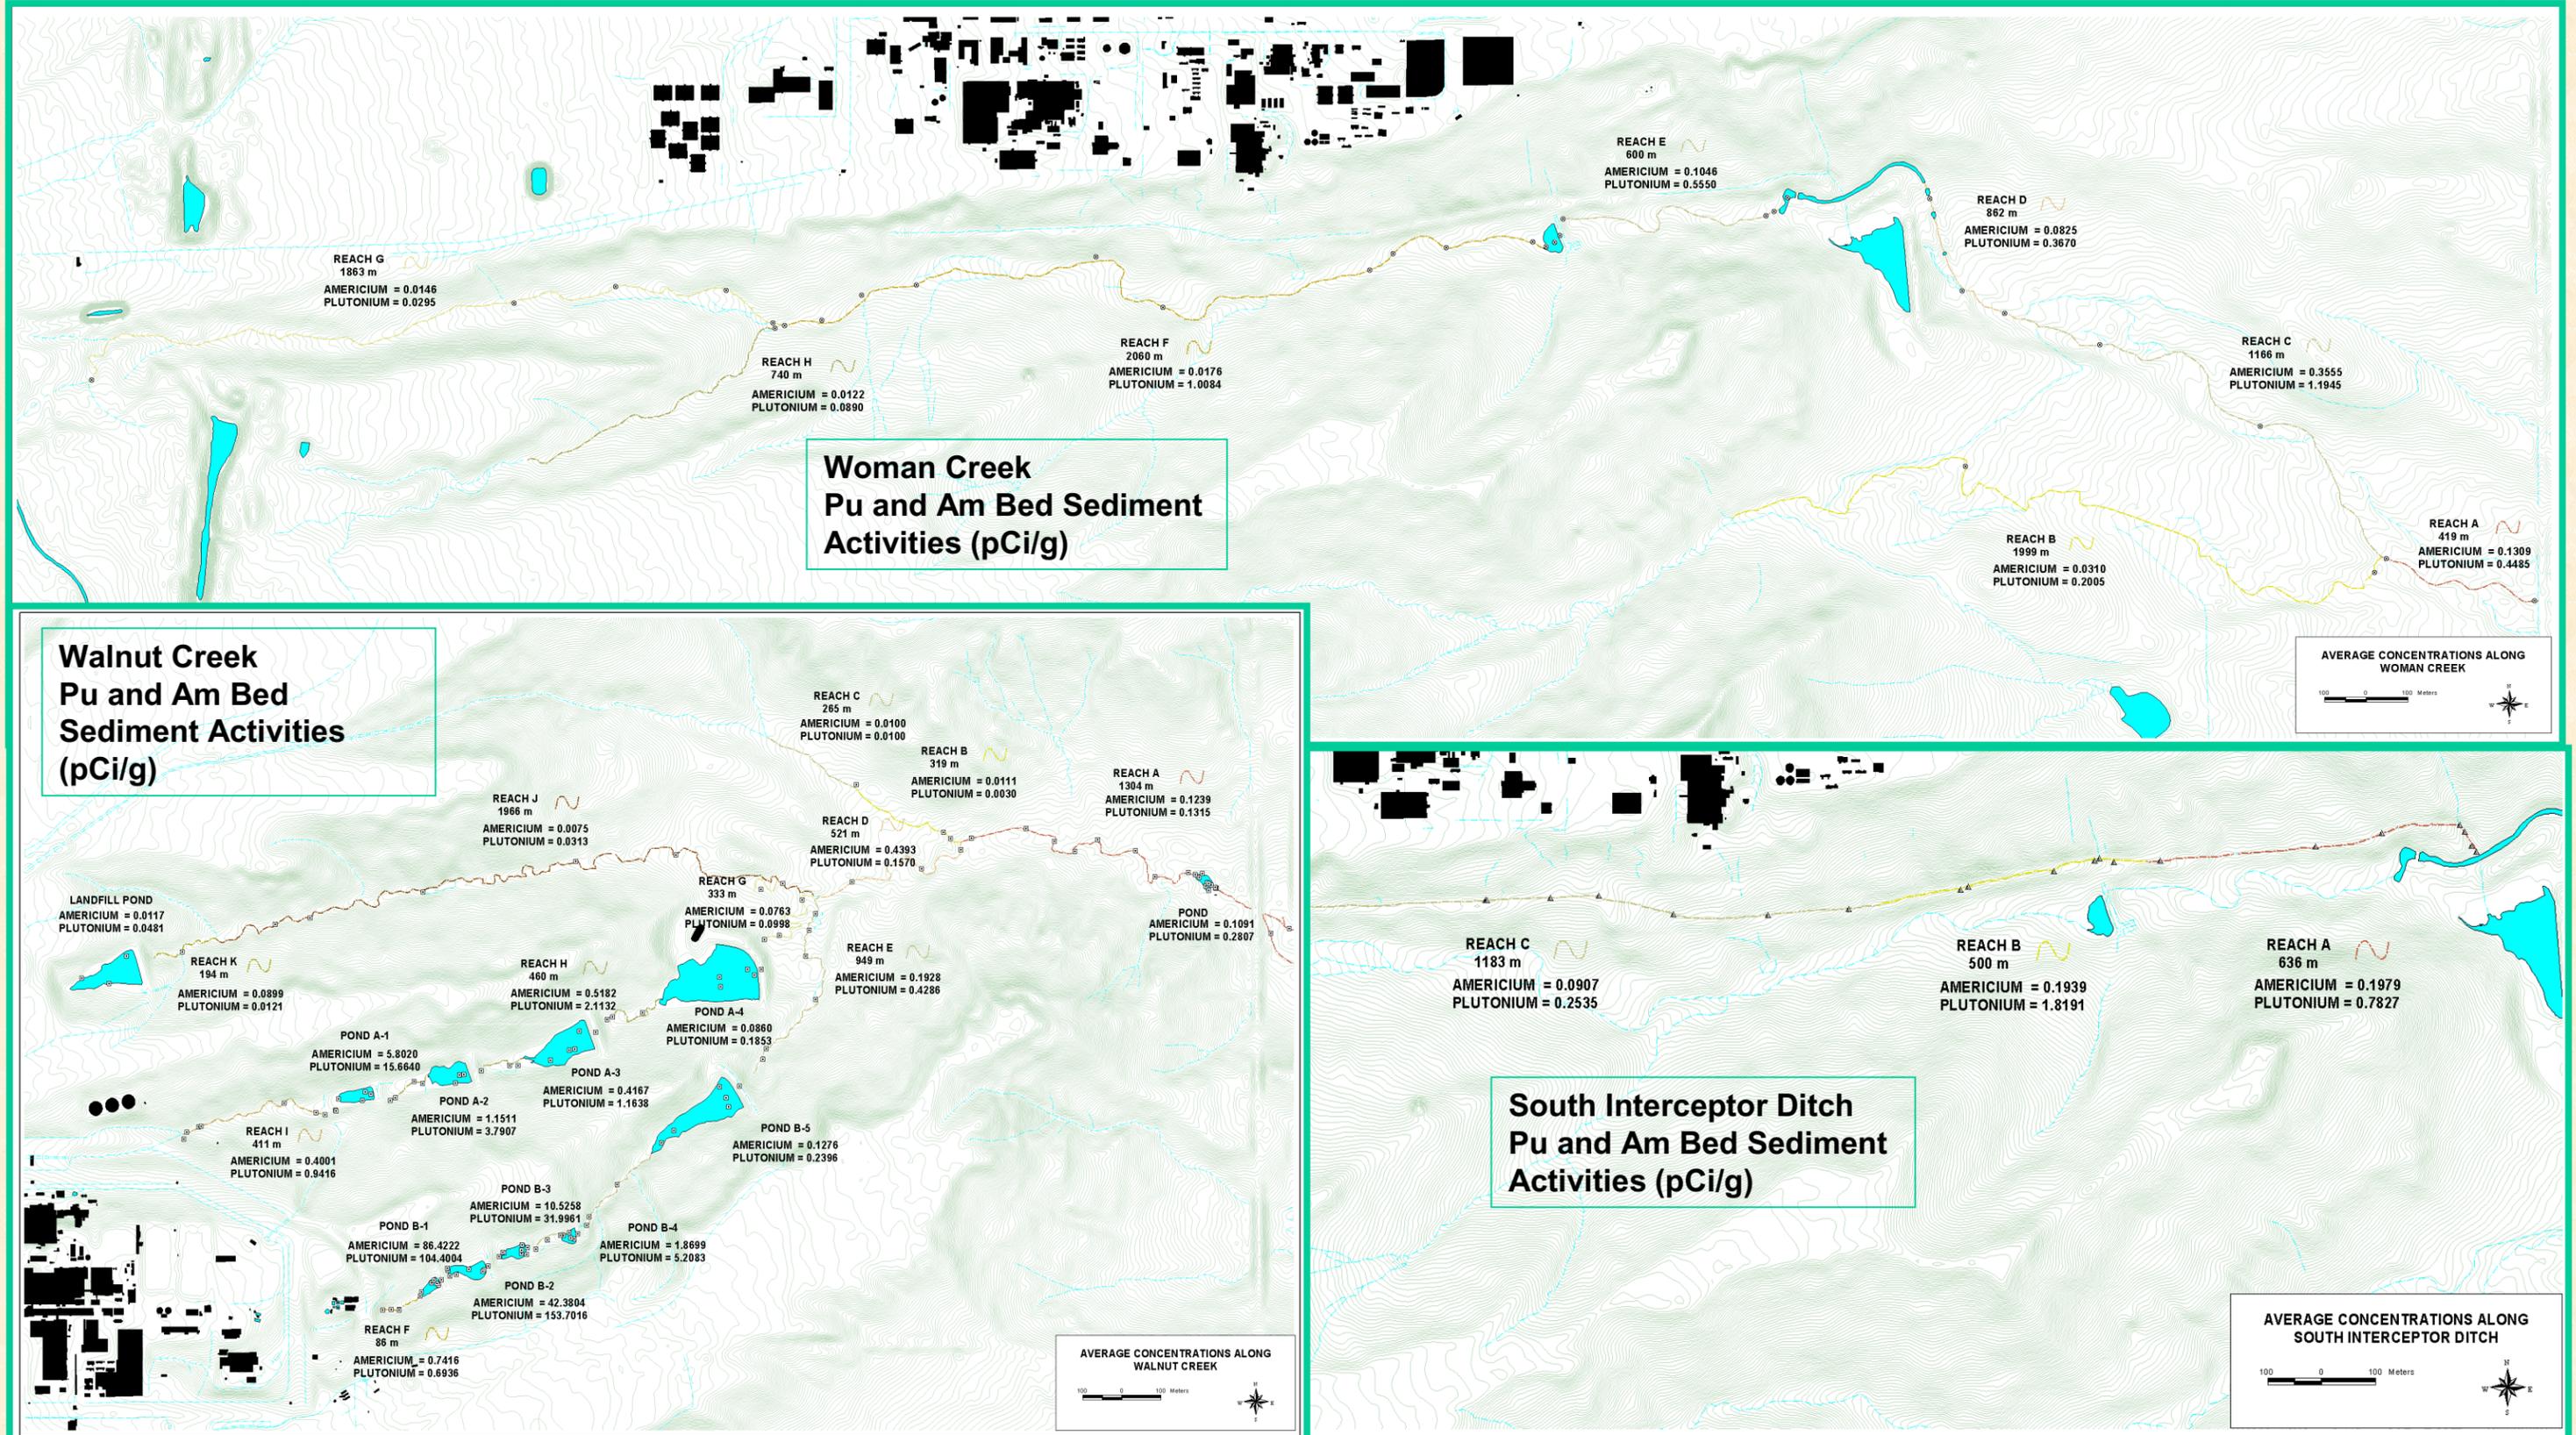
Figure 8. Pu and Am Activity in Bed Sediments for Walnut Creek, the South Interceptor Ditch and Woman Creek

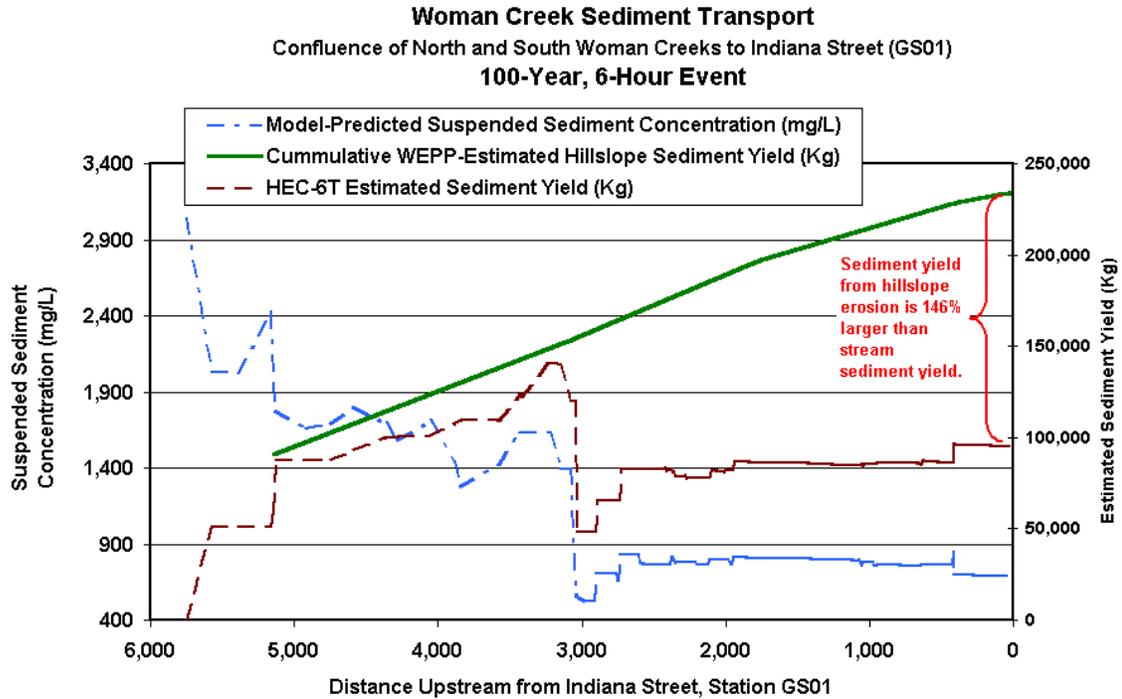
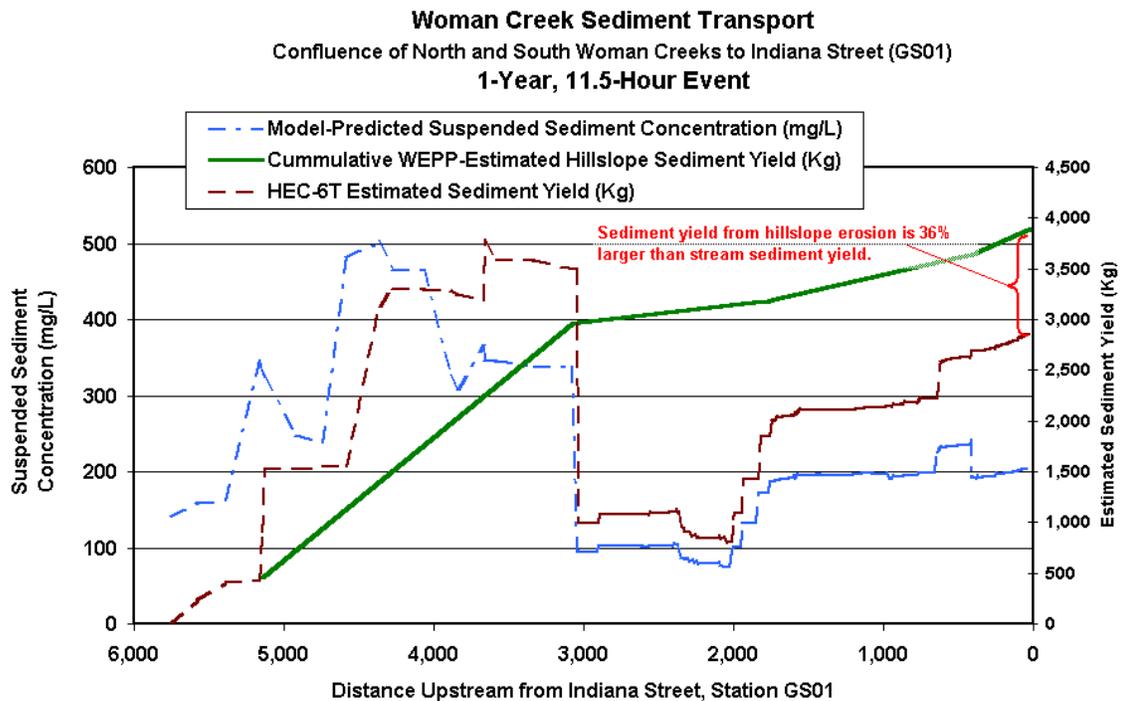
Figure 9. Comparison of Hillslope and Channel Erosion Sediment Yields in Woman Creek.

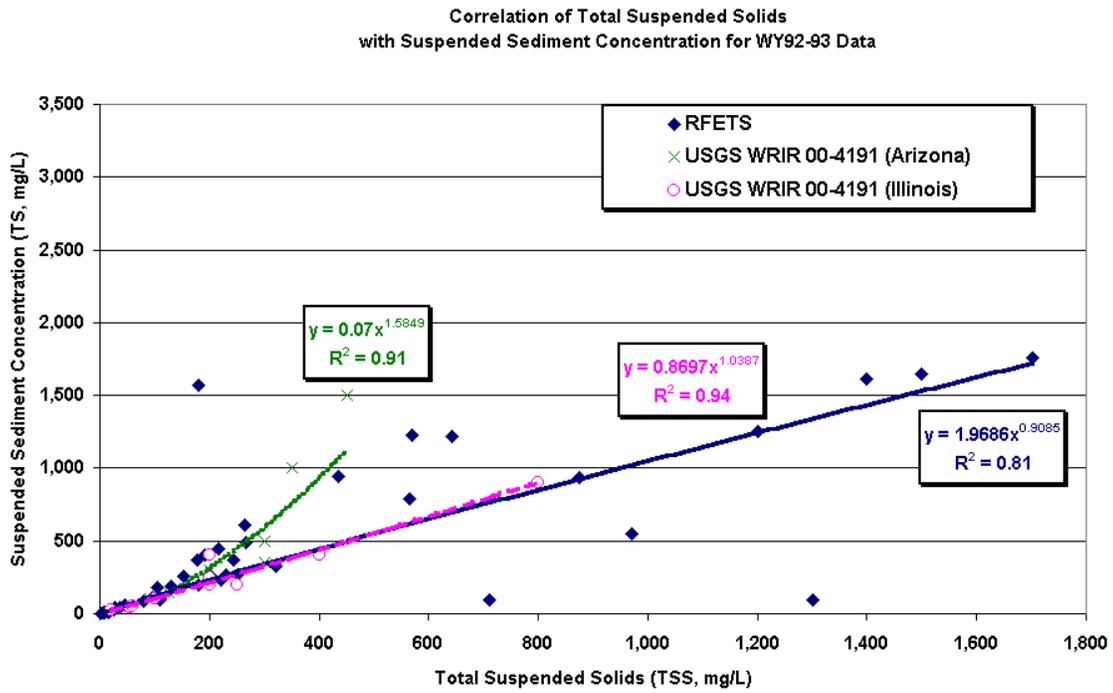
Figure 10. Correlation of Total Suspended Solids and Suspended Sediment Concentrations for Historical Surface Water Monitoring Data

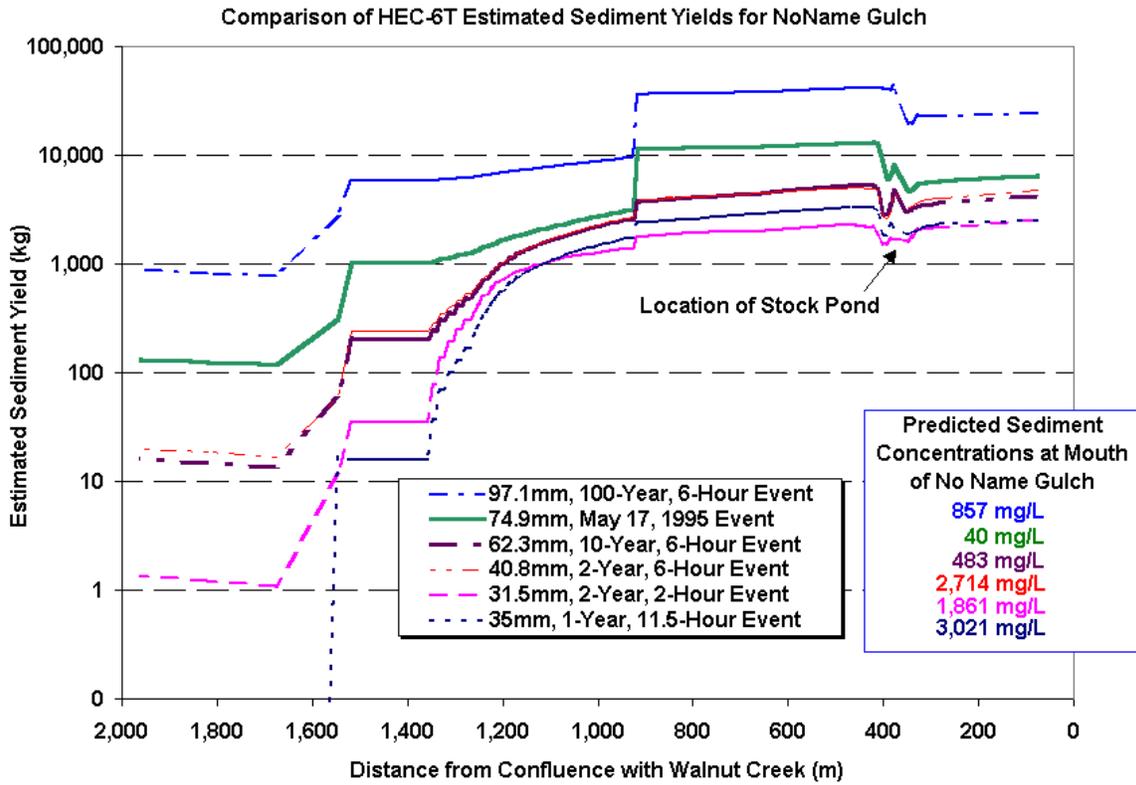
Figure 11. Comparison of HEC-6T Estimated Sediment Yields for Updated No Name Gulch Model
