FIGURES

U.S. Department of Energy
 Rocky Flats Environmental Technology Site

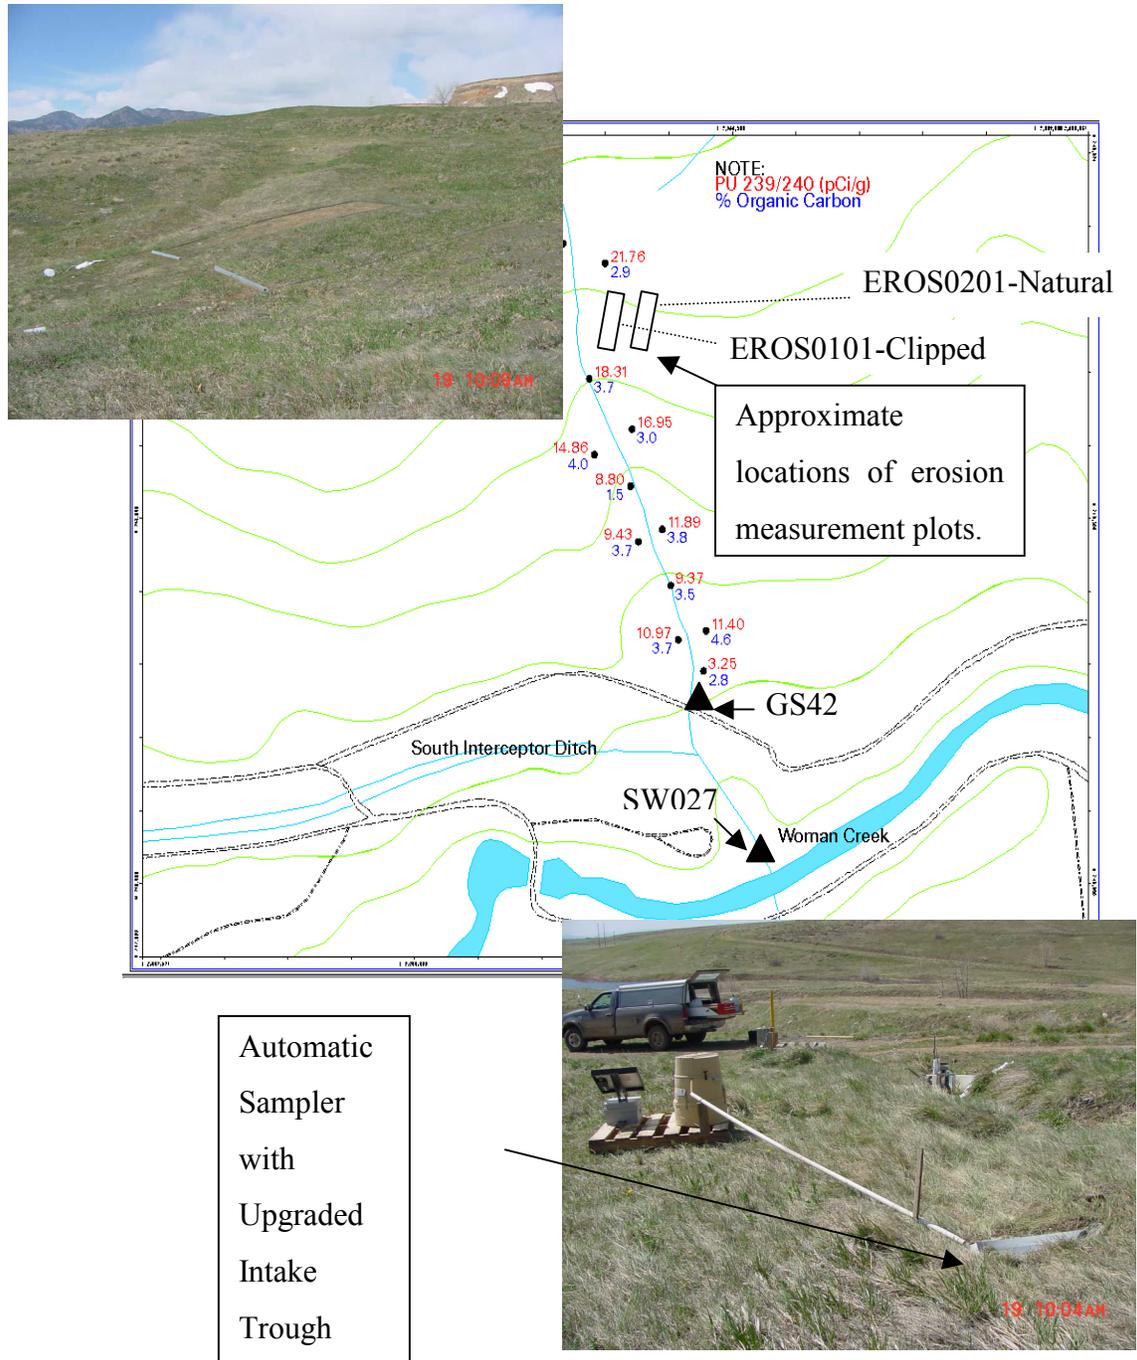
Figure 12. Location and Photographs of Erosion Plots and GS42 Monitoring Station

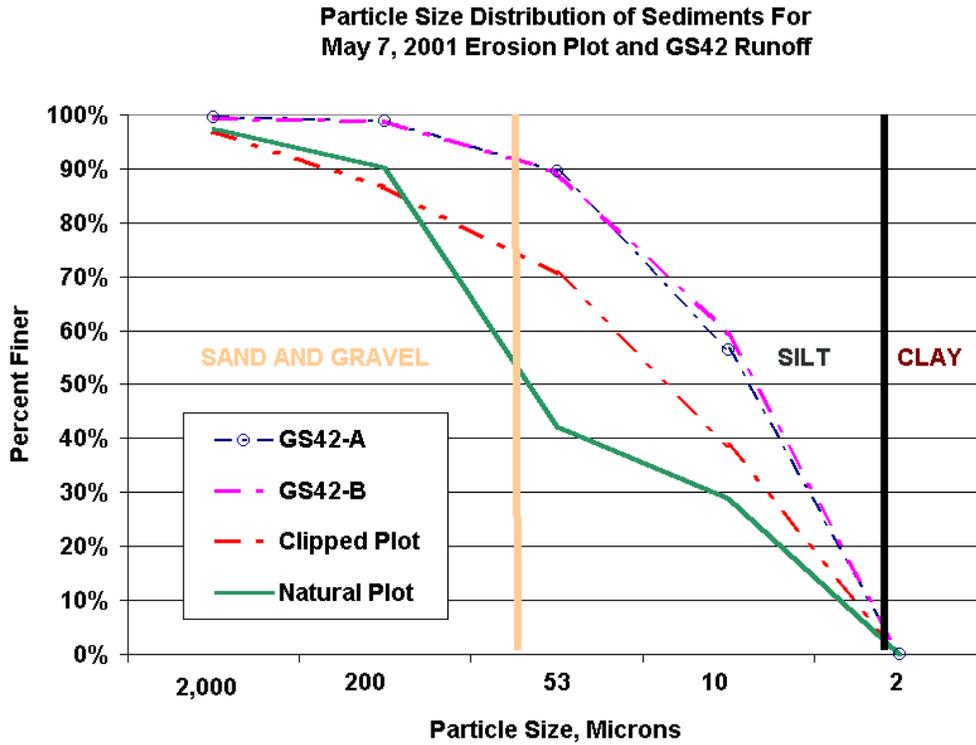
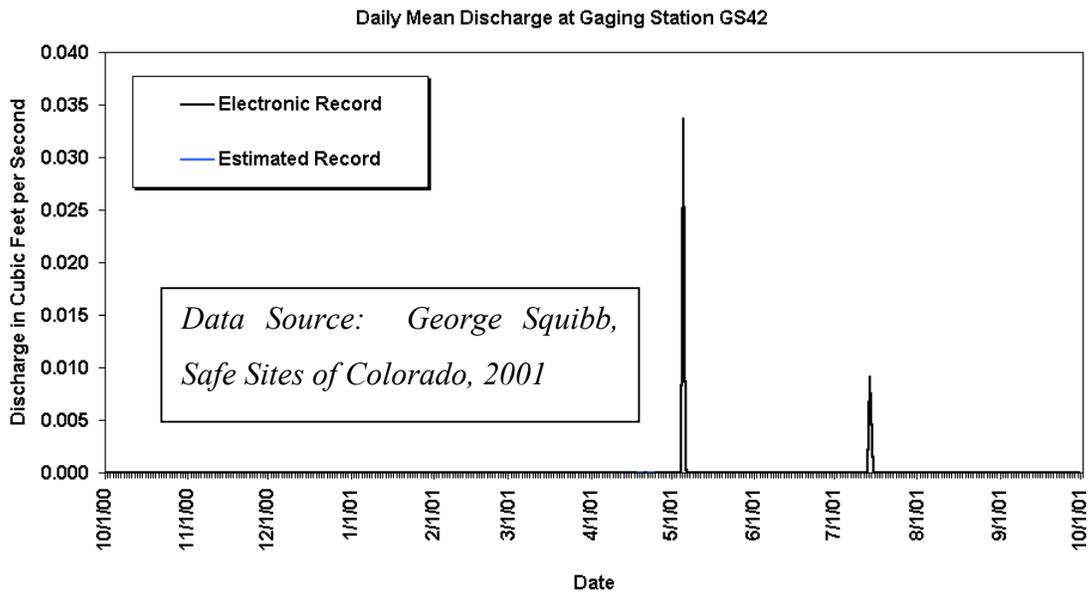
Figure 13. Comparison of Particle Size Distributions for May 7, 2001 Runoff From Erosion Plots and the GS42 Drainage Basin and Water Year 2001 Daily Mean Discharge Hydrograph for GS42

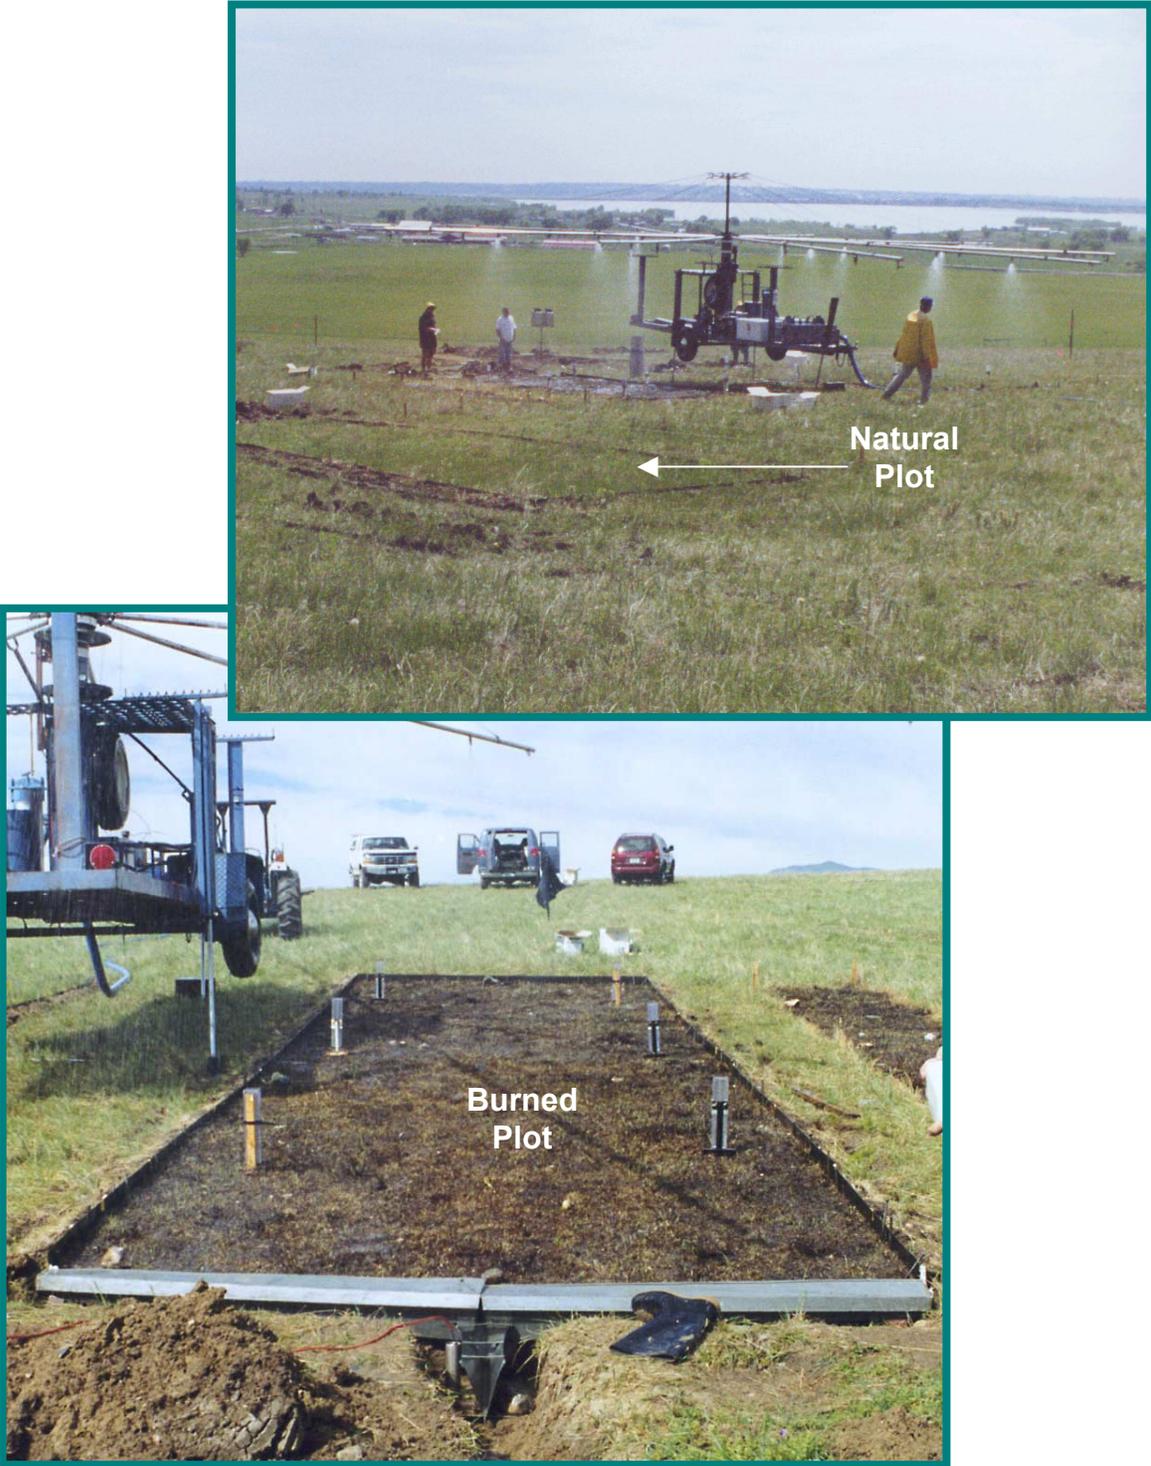
Figure 14. Colorado State University Erosion Plots at the Hope Ranch Adjacent to the Site

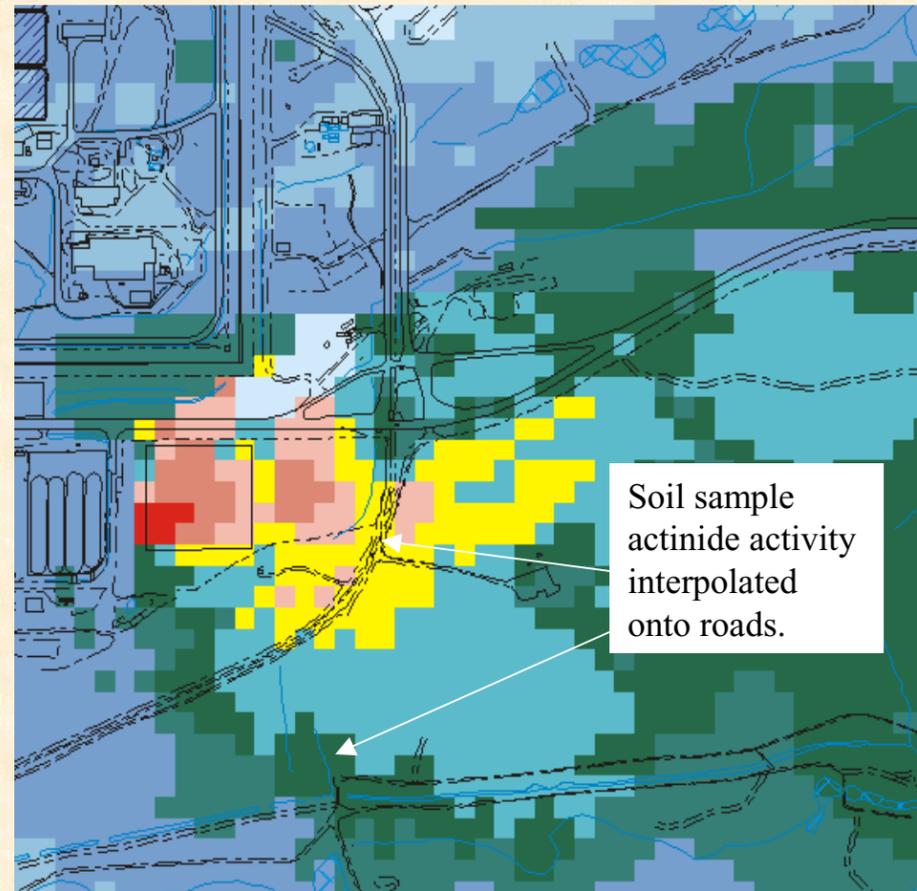
Figure 16.
Pu-239,240 in Surface Soil -
Variations of Kriged Isoplot
Grids Near 903 Pad

Original surface soil Pu kriging analysis presented in the 2000 Erosion Report.

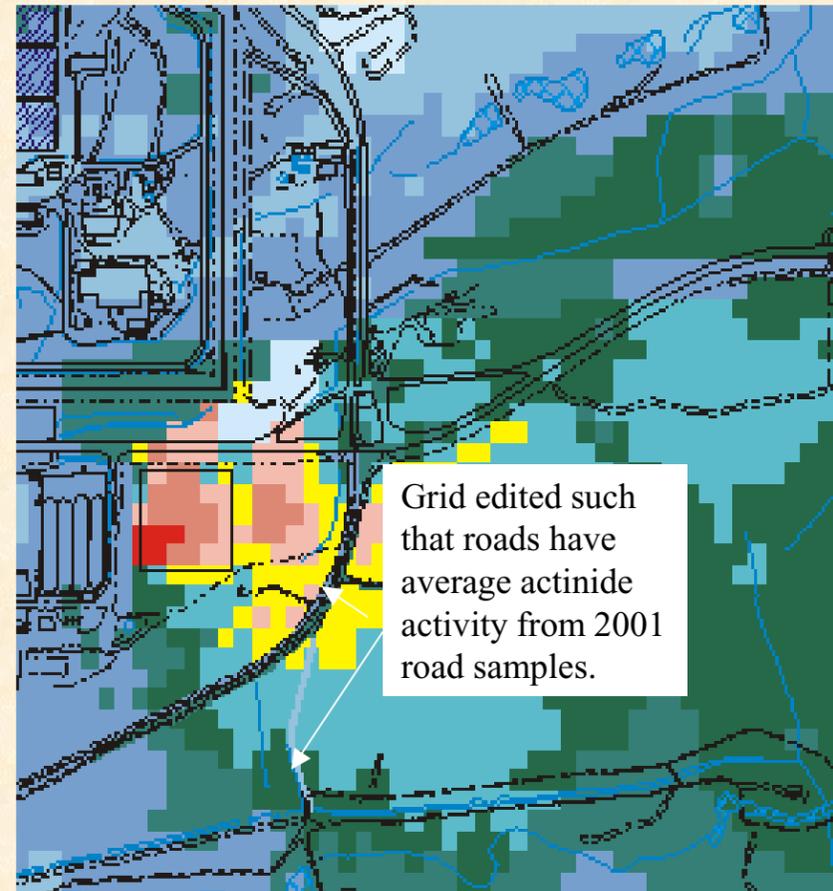
Original surface soil Pu kriging analysis modified with dirt road sample data collected on 5/17/01.

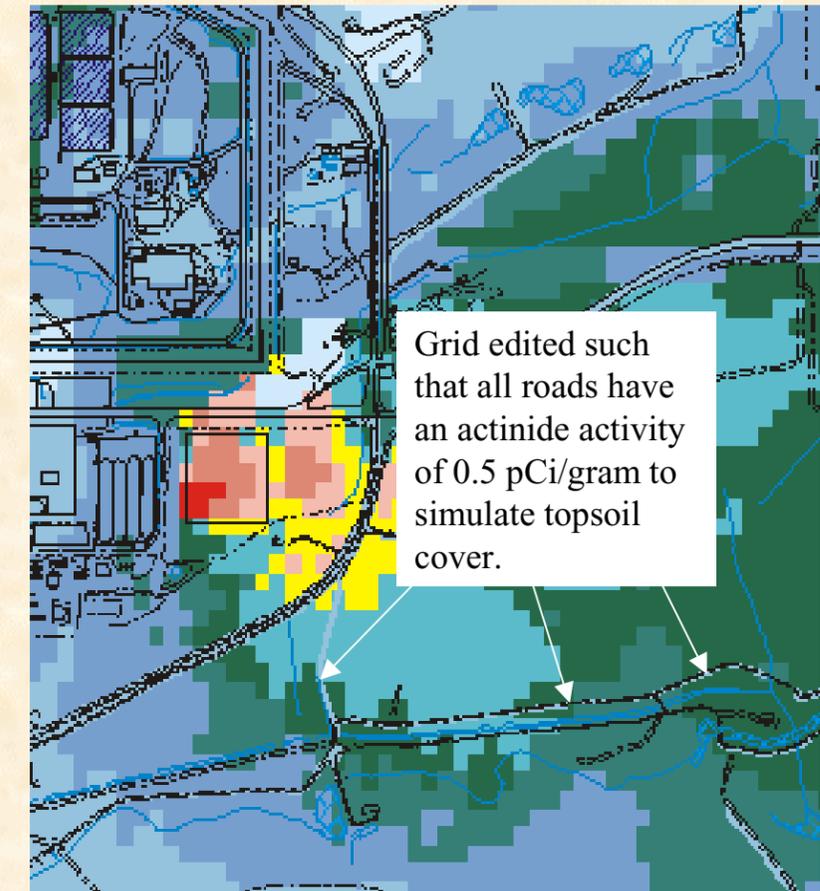
Original surface soil Pu kriging analysis edited with simulated road re-grading and re-vegetation.

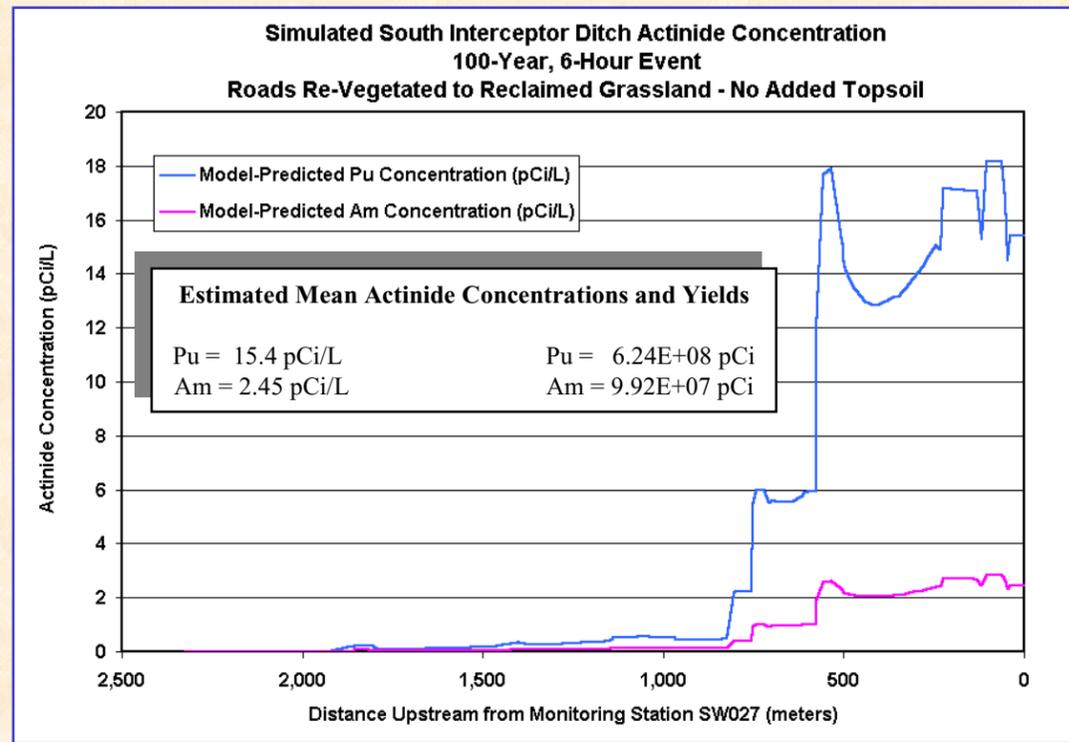
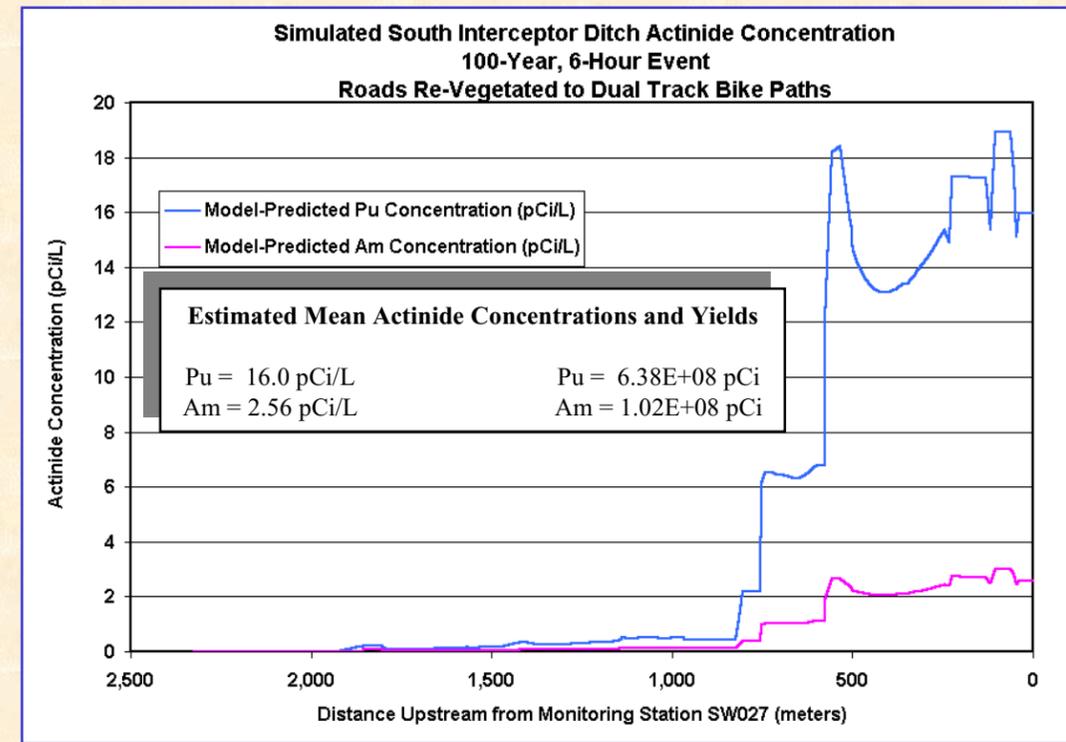
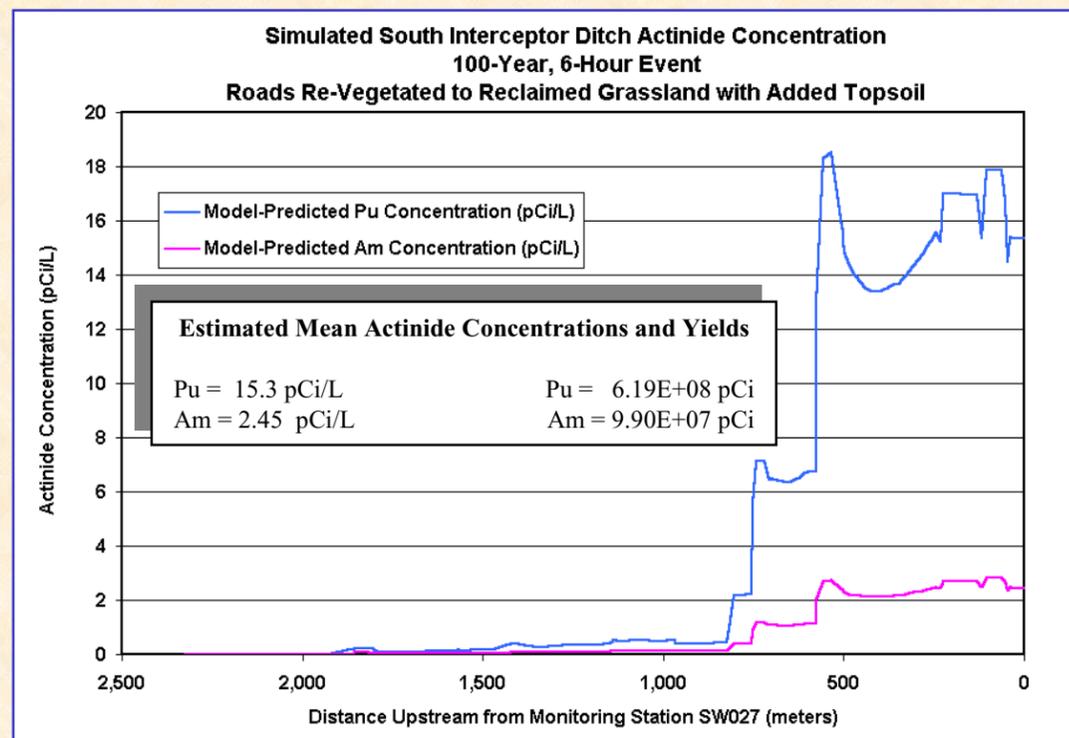
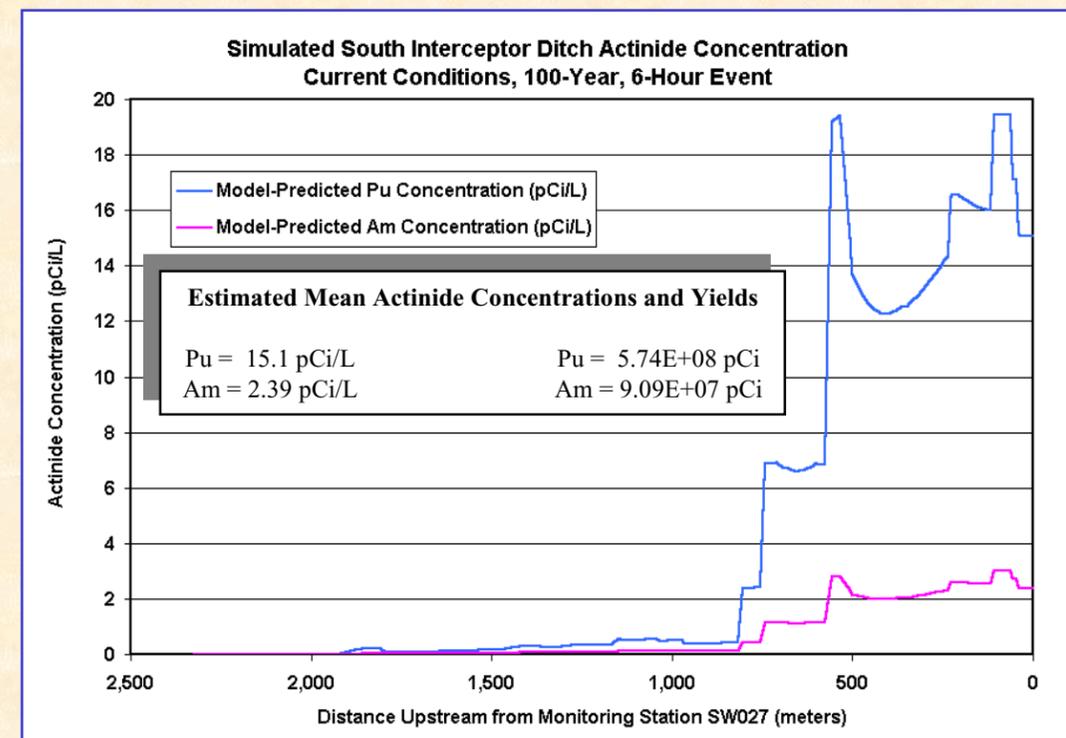
Figure 17. Comparison of Road Re-vegetation Scenarios for the SID

Complete Road Re-vegetation - No Added Topsoil

Road Re-vegetation to Dual Track Bike Paths - No Added Topsoil

Complete Road Re-vegetation - Added Topsoil

Existing Conditions

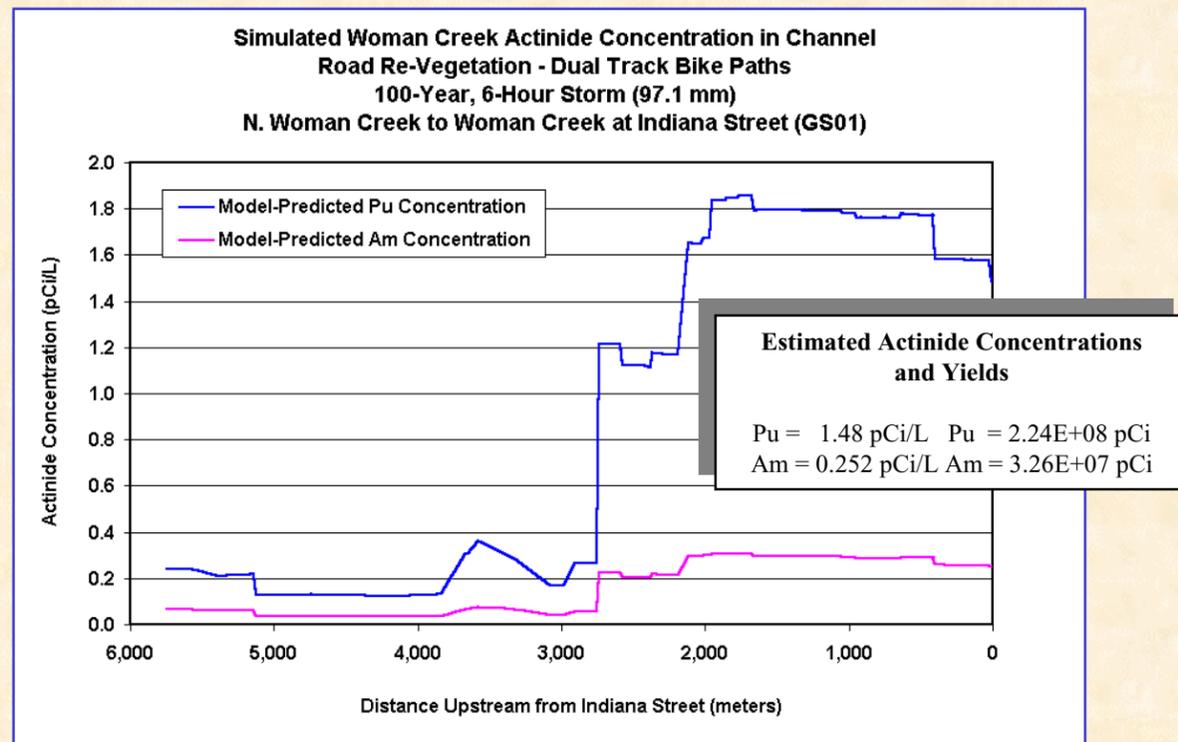
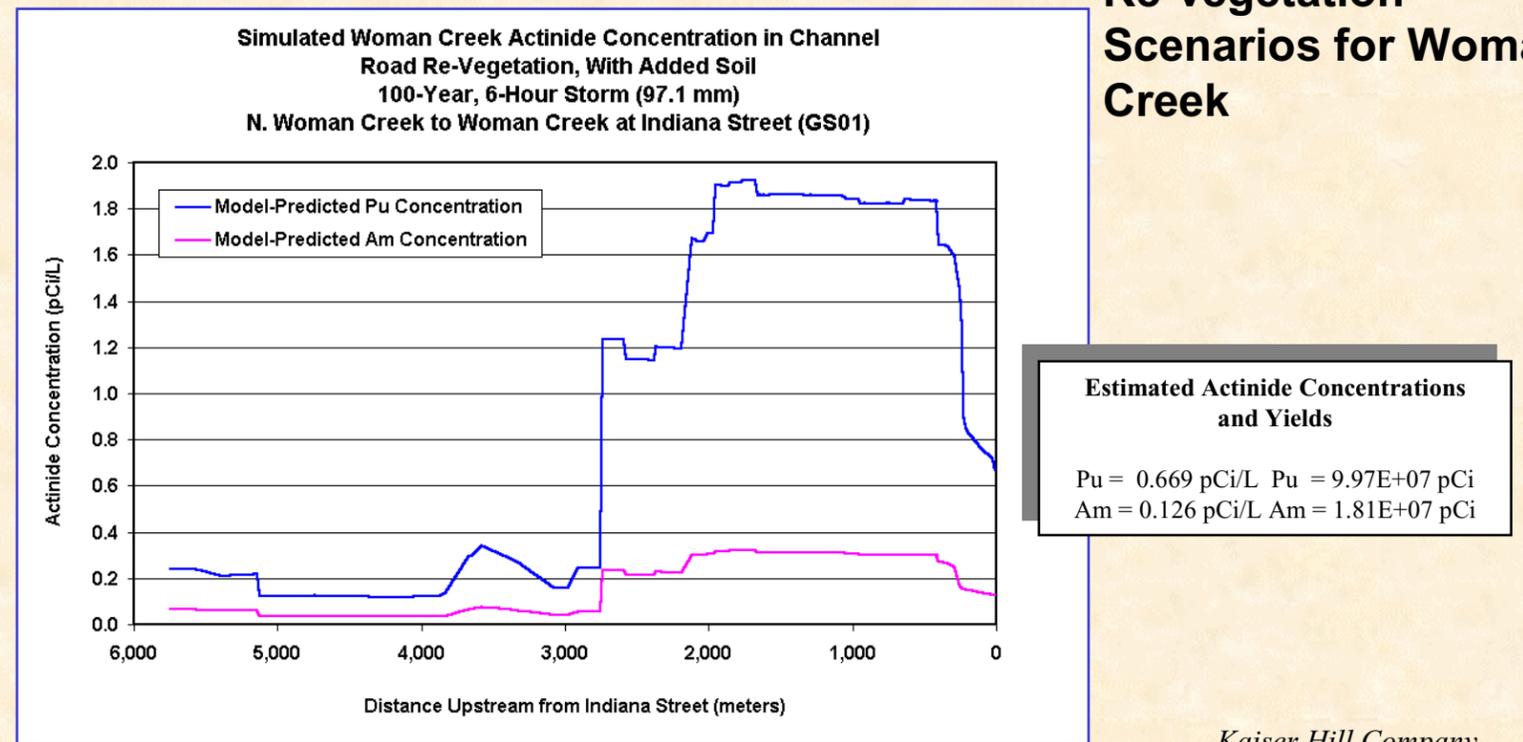
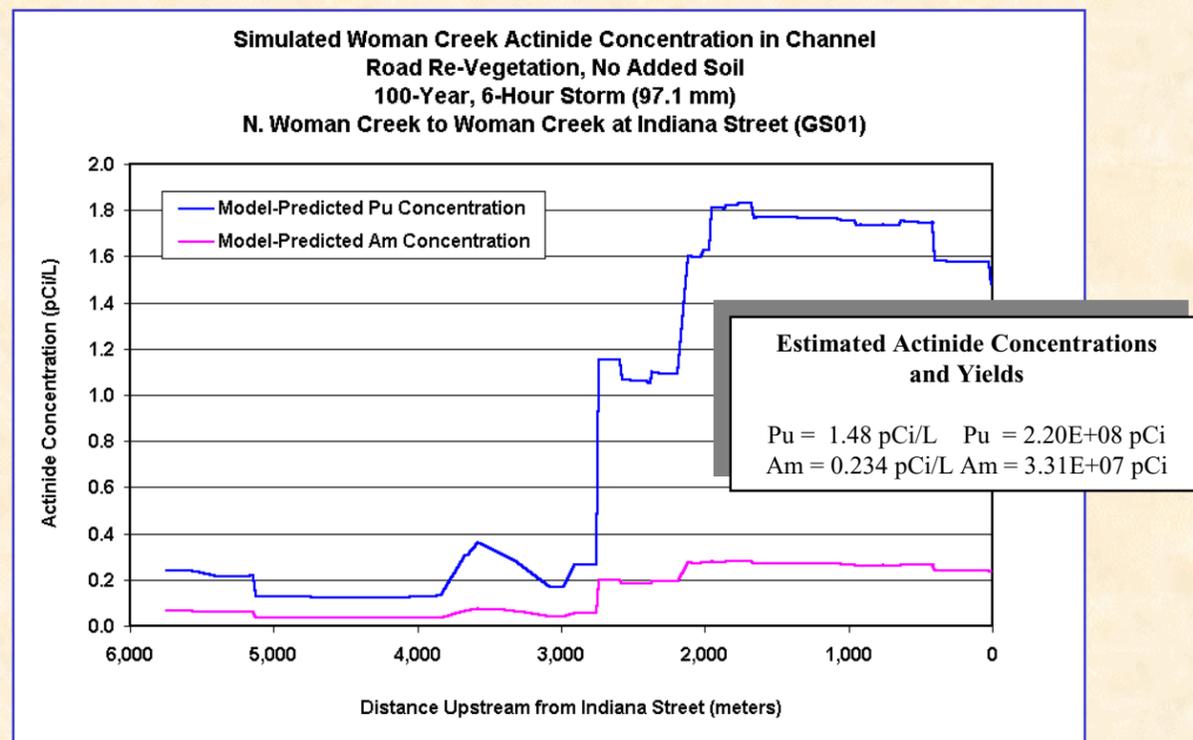
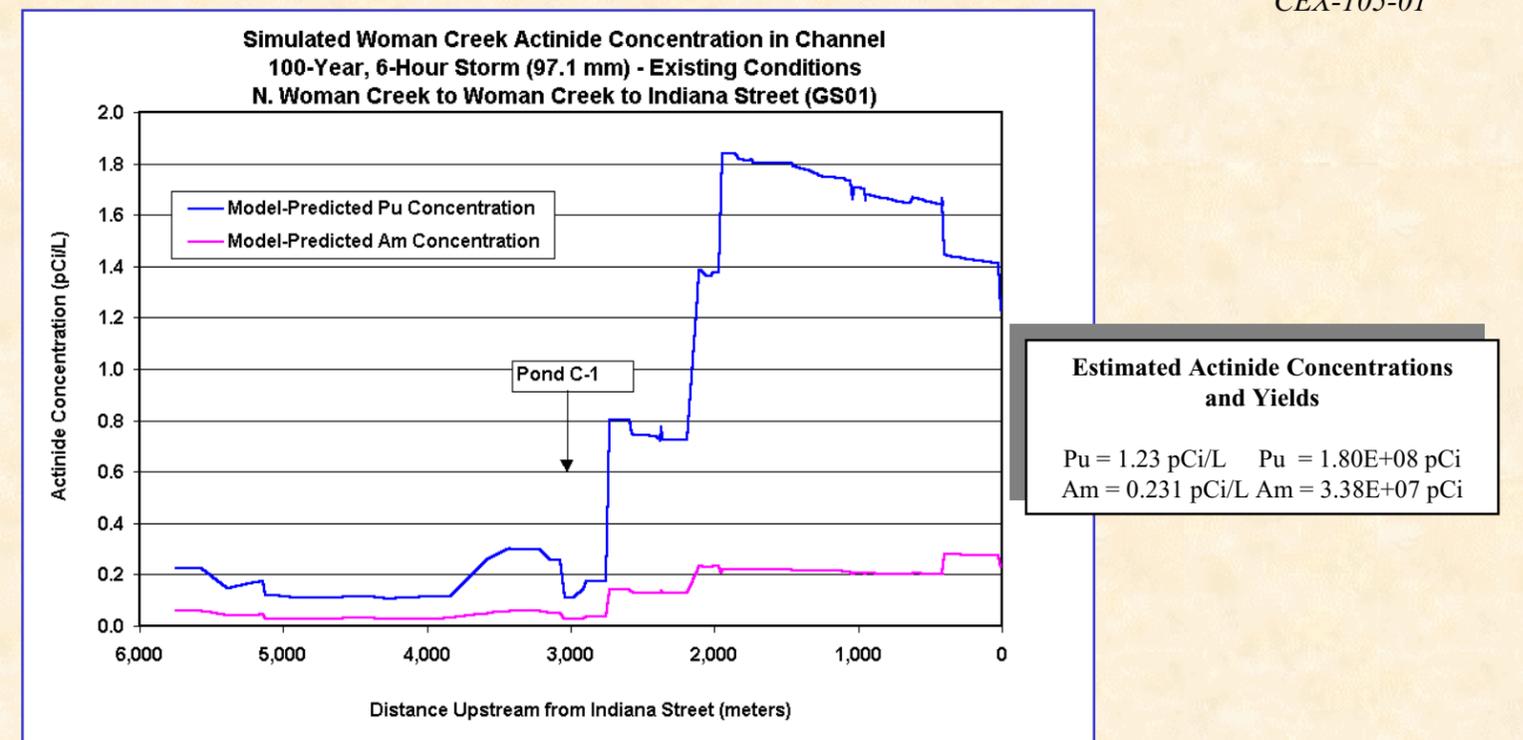
Figure 18.
Comparison of Road
Re-vegetation
Scenarios for Woman
Creek

Road Re-vegetation to Dual Track Bike Paths - No Added Topsoil

Complete Road Re-vegetation - Added Topsoil

Complete Road Re-vegetation - No Added Topsoil

Existing Conditions

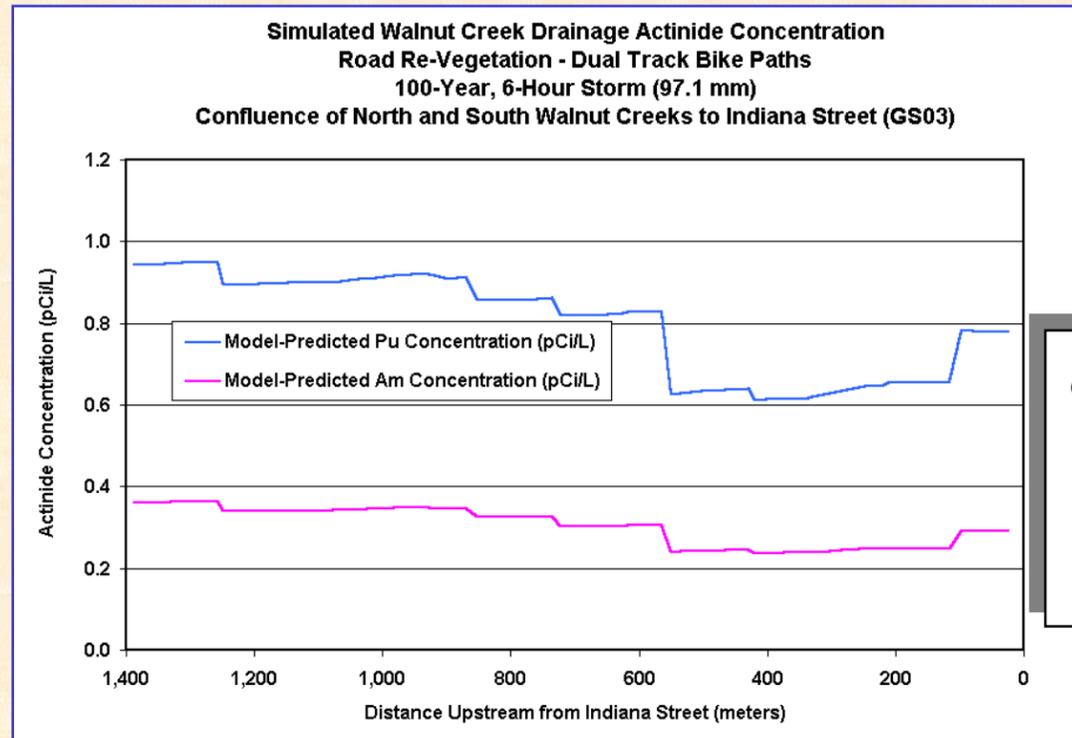
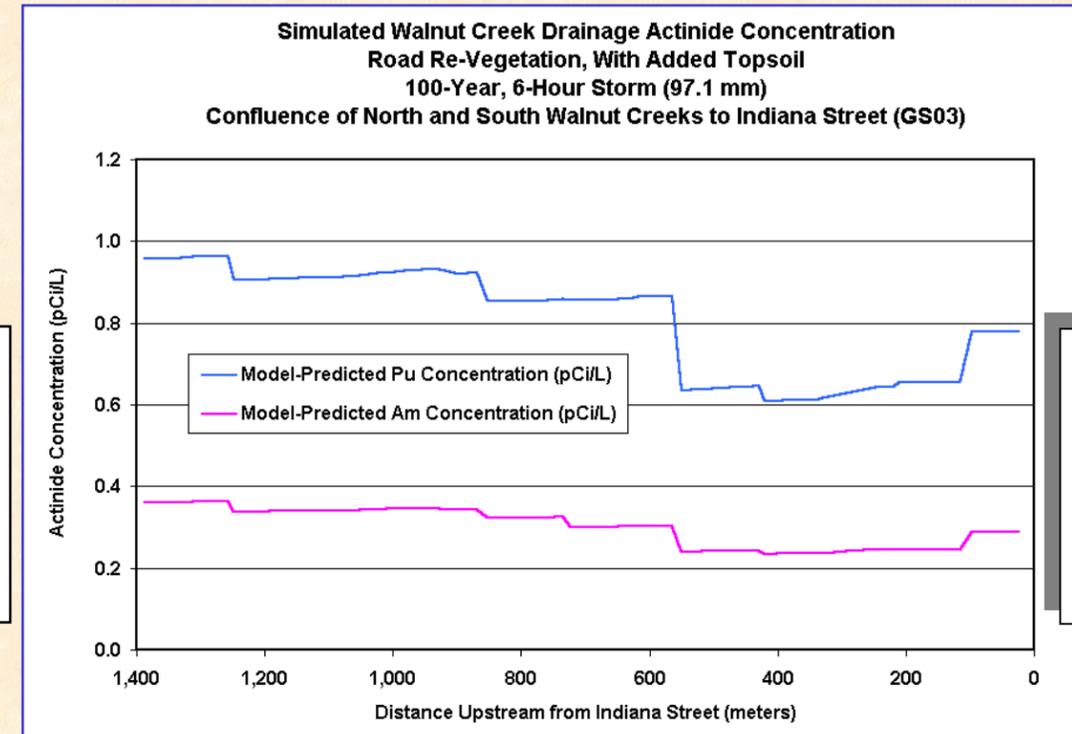
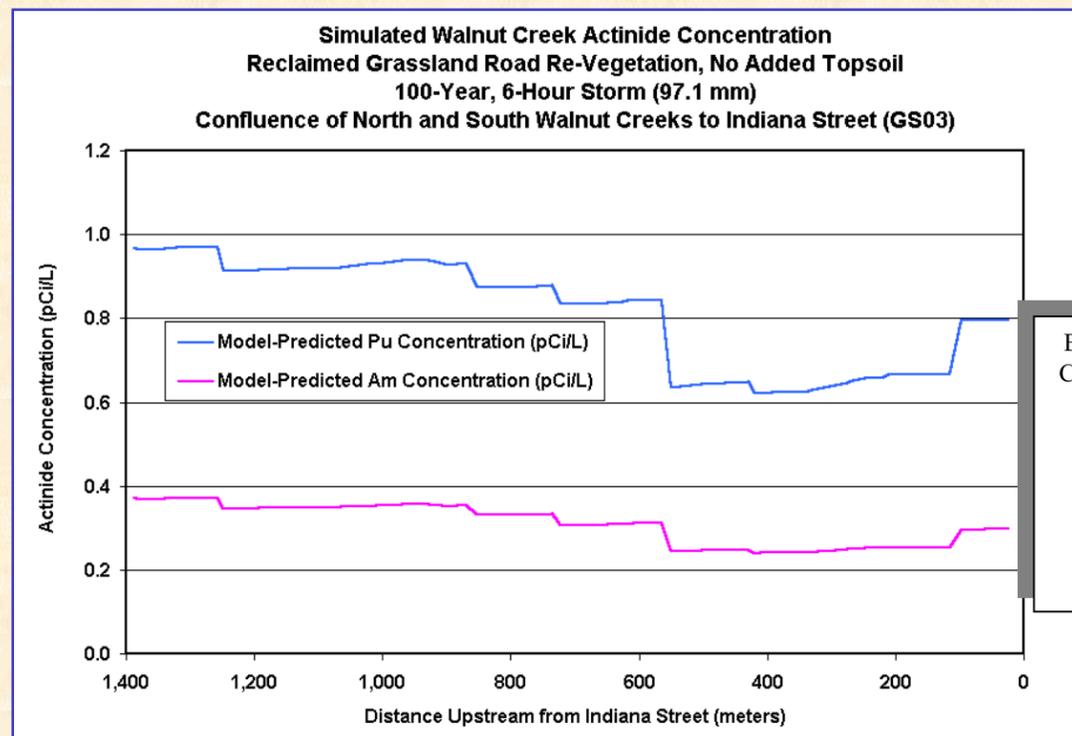
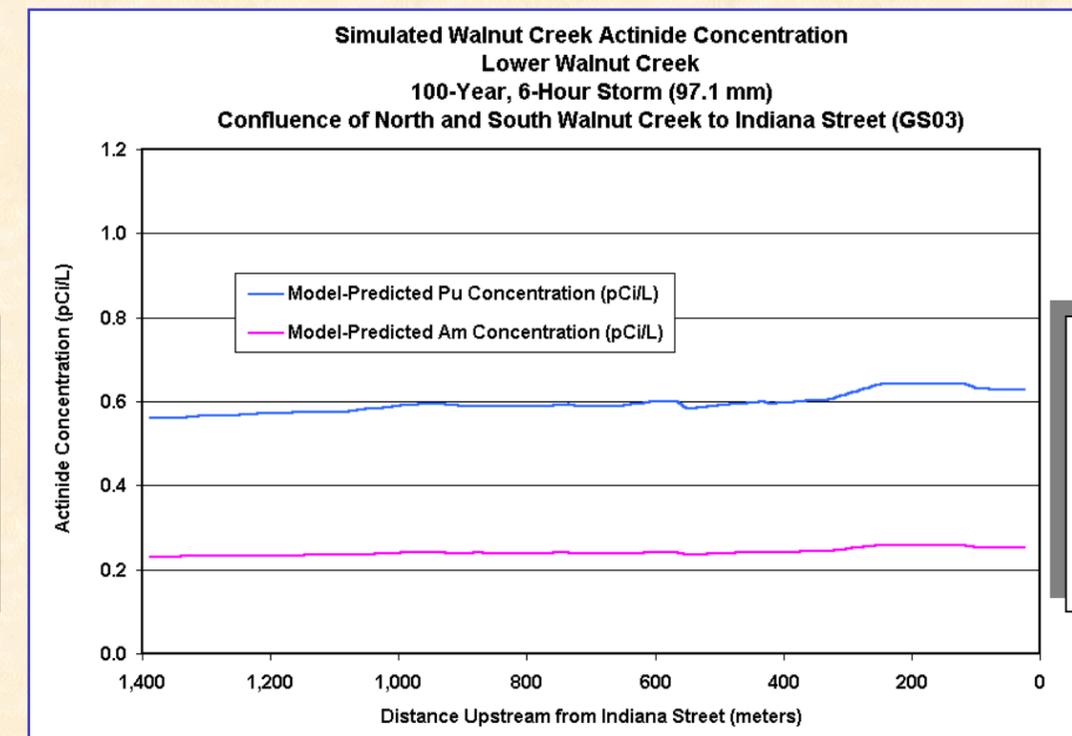
Figure 19.
Comparison of Road
Re-vegetation
Scenarios for Walnut
Creek

Road Re-vegetation to Dual Track Bike Paths - No Added Topsoil

Complete Road Re-vegetation - Added Topsoil

Complete Road Re-vegetation - No Added Topsoil

Existing Conditions

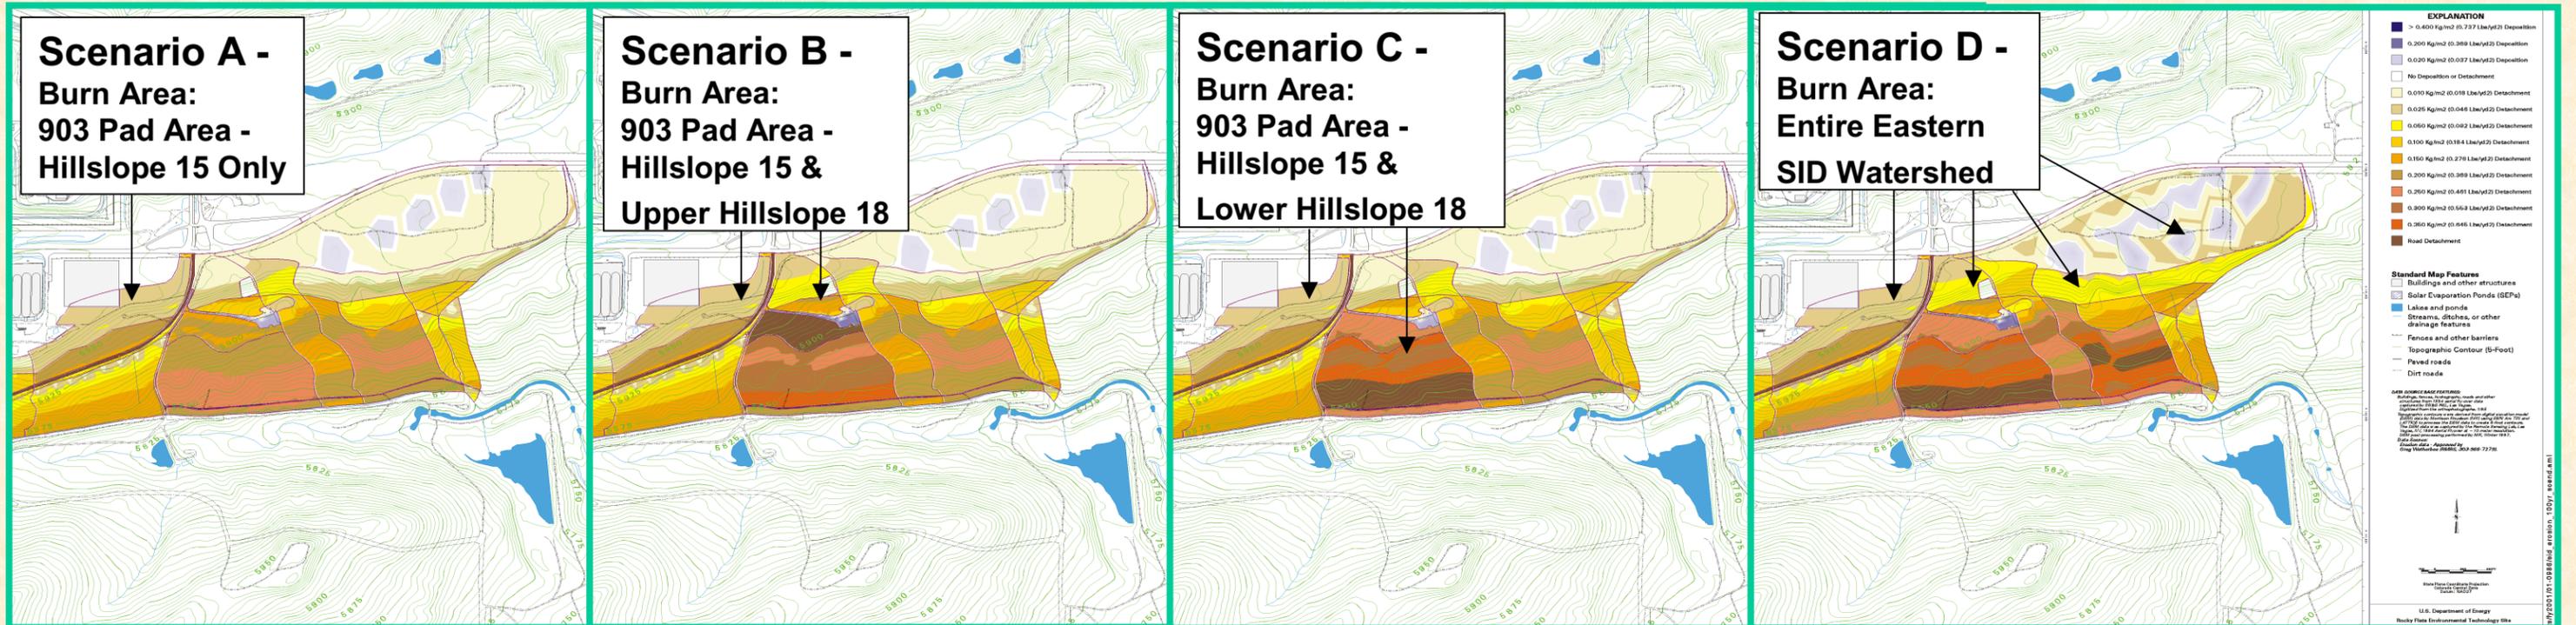
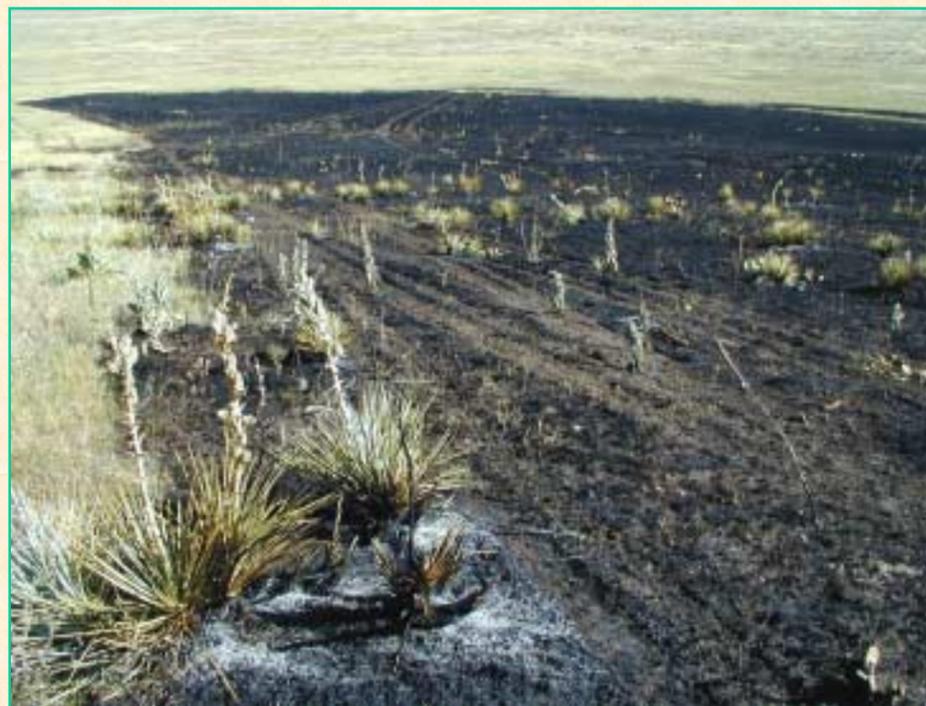
Figure 20. SID Range Fire Erosion Maps for the 100-Year, 6-Hour Storm (97.1-mm)

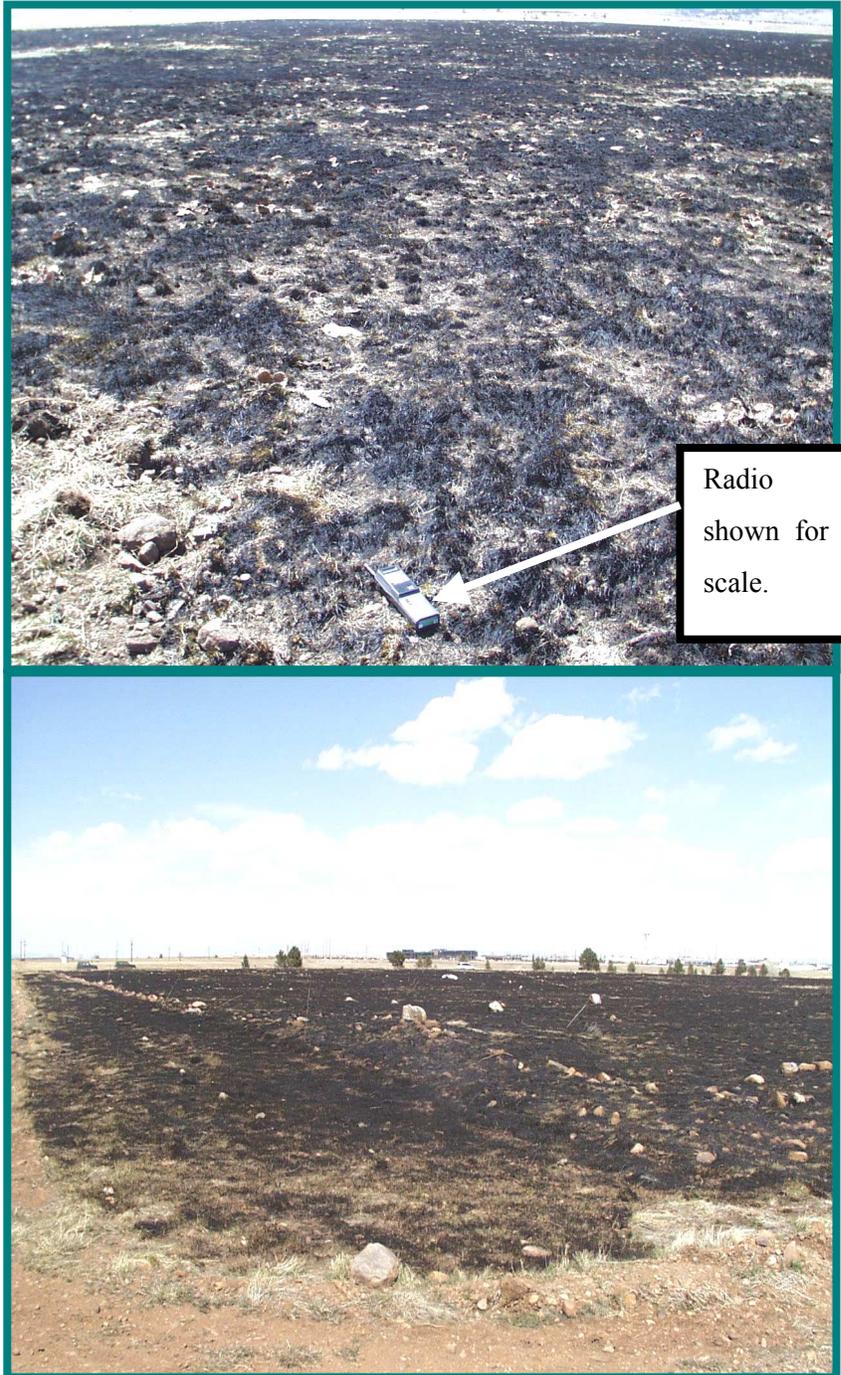
Figure 21. Examples of Prescribed Burn Vegetation Cover
