FIGURES

U.S. Department of Energy
 Rocky Flats Environmental Technology Site

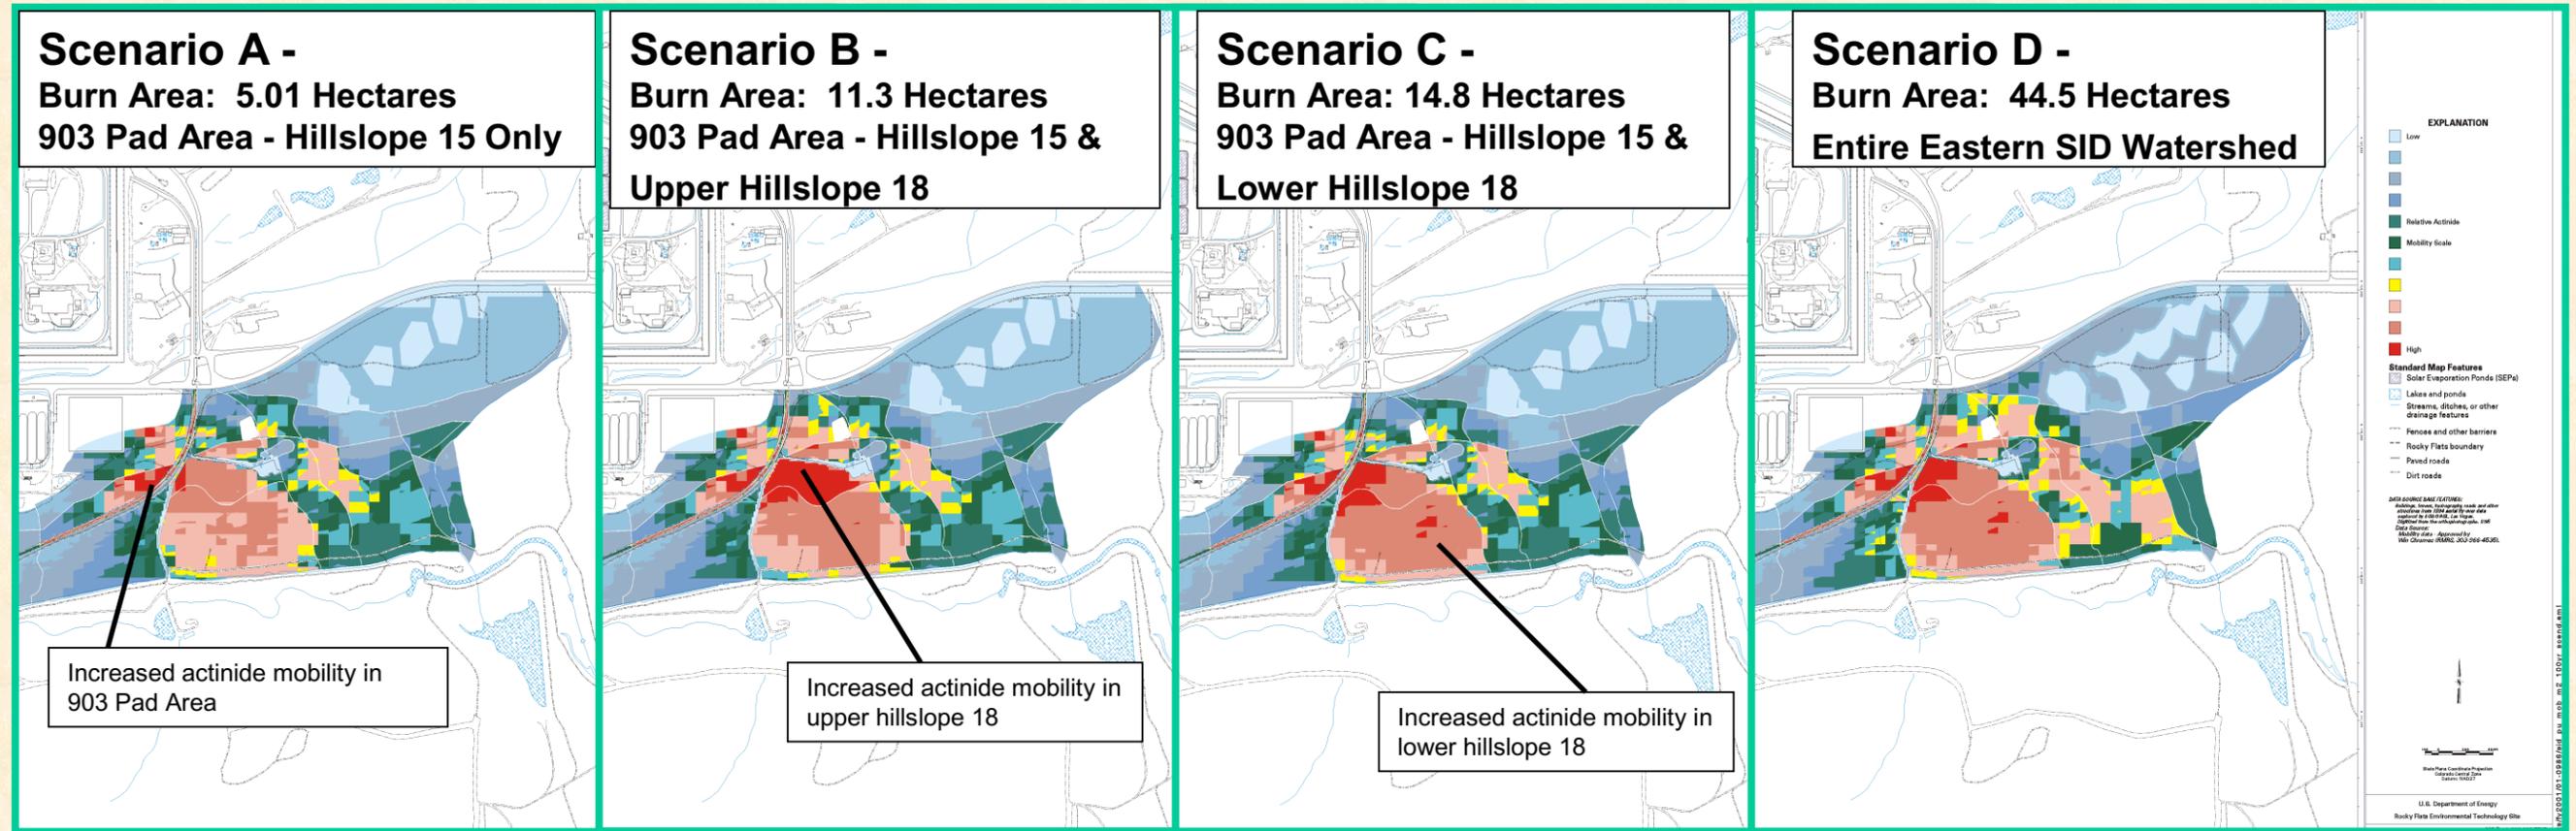
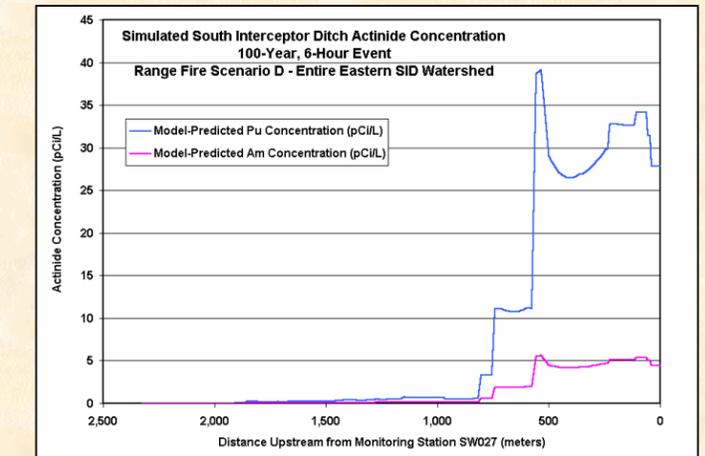
Figure 22. Range Fire Analysis - Impact on Pu and Am Mobility in South Interceptor Ditch Watershed, 100 Year, 6-Hour Storm (97.1-mm)

Pu and Am Mobility Caused by Soil Erosion

Corresponding Surface Water Pu and Am Concentrations and Yields

SID Scenarios	Estimated Runoff Yield (m ³)	Estimated Pu Yield (pCi)	Estimated Am Yield (pCi)
Unburned	38,086	5.74E+08	9.09E+07
A	38,401	8.53E+08	1.38E+08
B	39,126	1.31E+09	2.09E+08
C	39,812	1.05E+09	1.67E+08
D	44,310	1.25E+09	1.99E+08

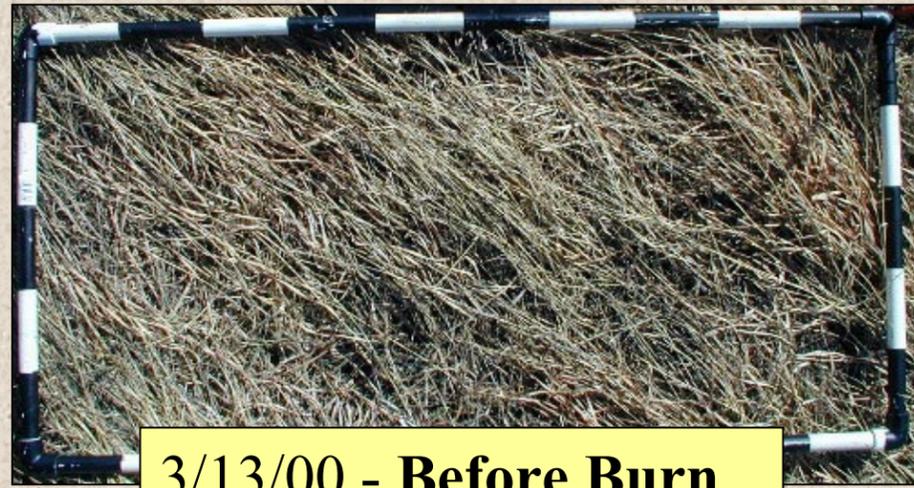
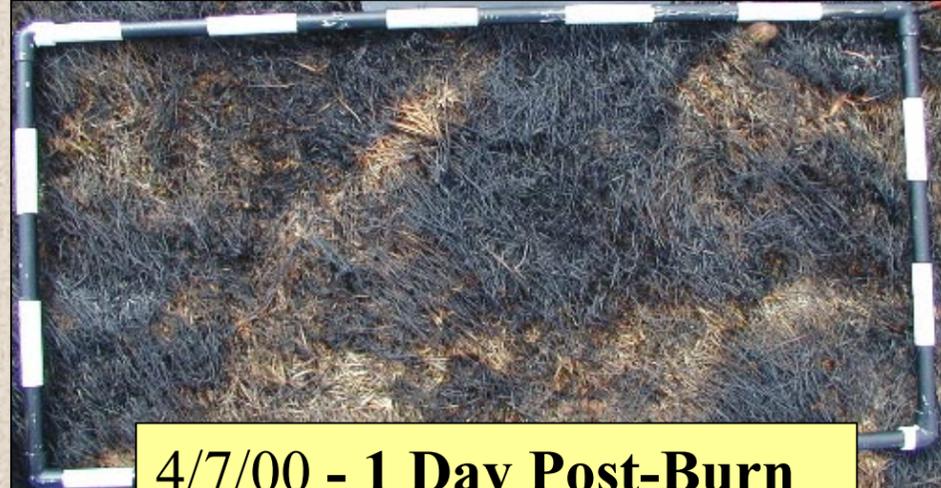
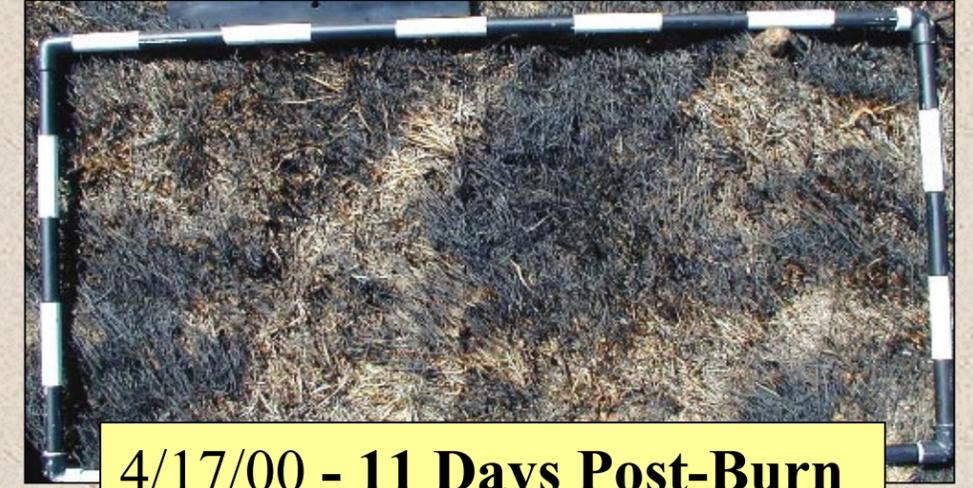
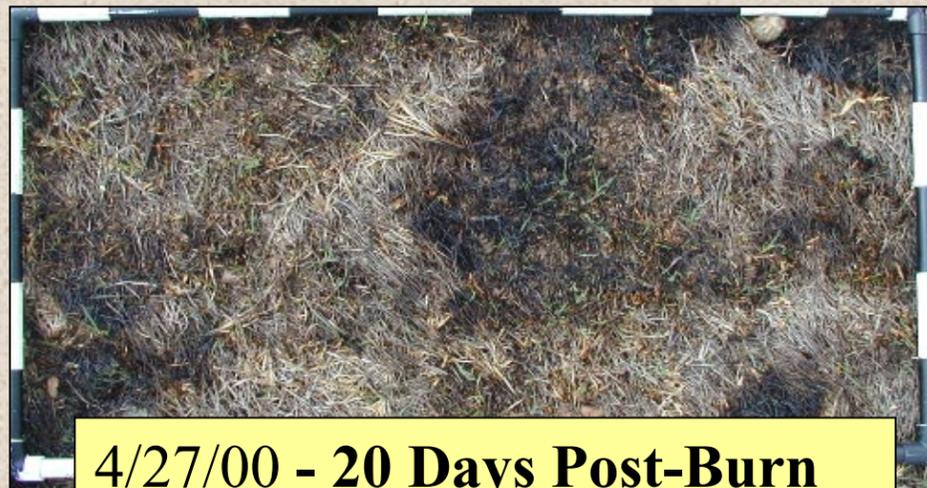
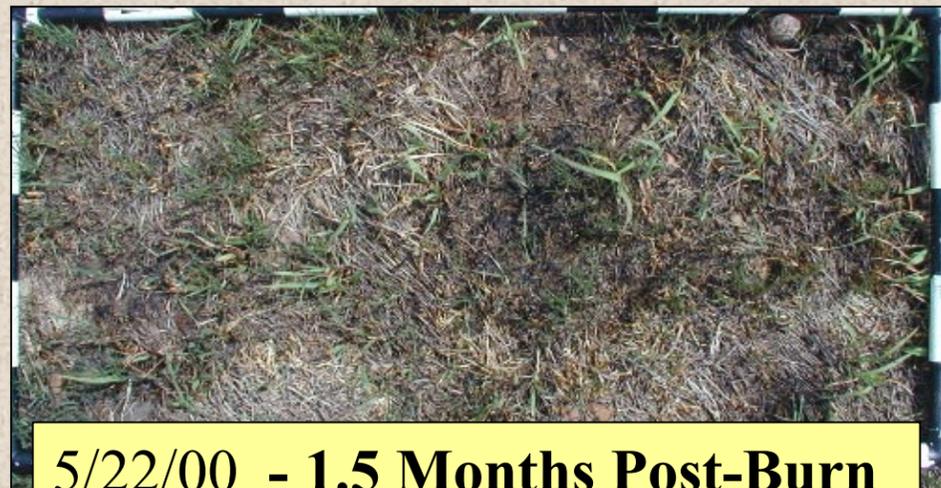
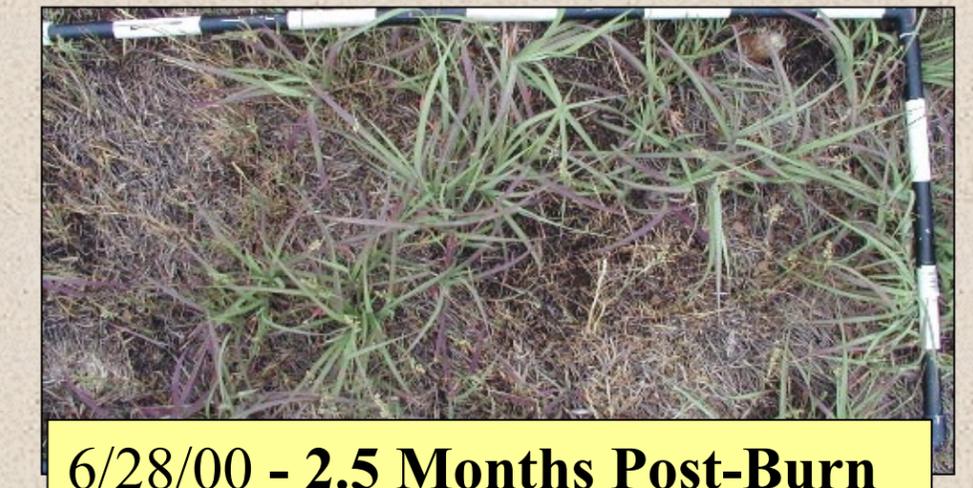
**Figure 23. Time Series of
Ground Surface in 2000
Prescribed Burn Area at the Site**

3/13/00 - Before Burn

4/7/00 - 1 Day Post-Burn

4/17/00 - 11 Days Post-Burn

4/27/00 - 20 Days Post-Burn

5/22/00 - 1.5 Months Post-Burn

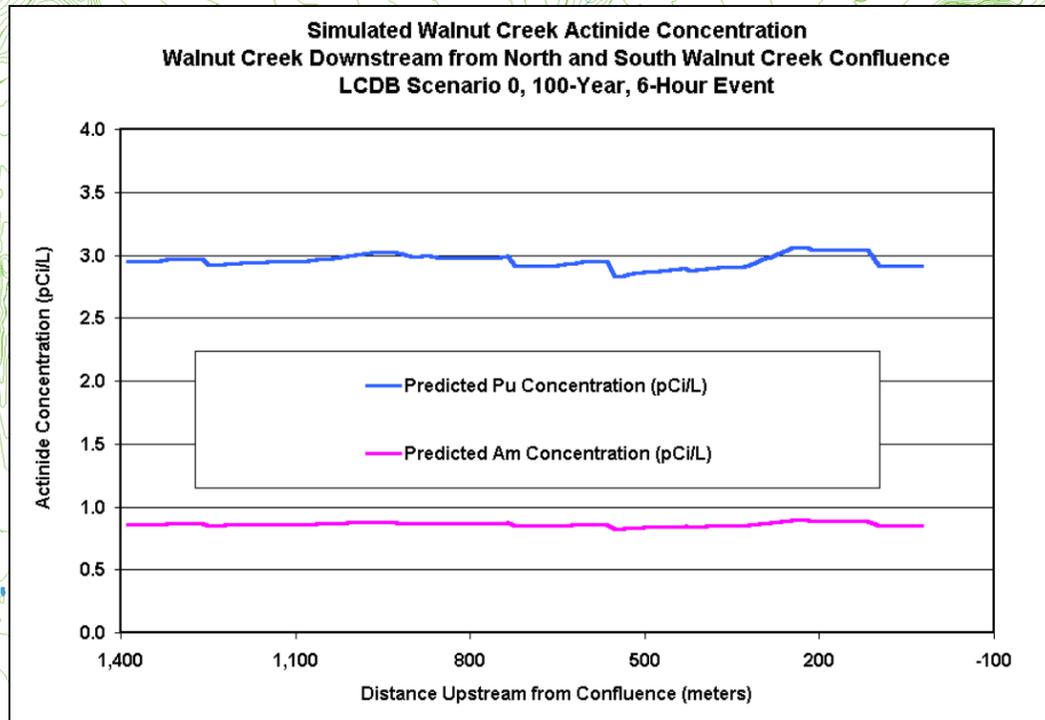
Figure 24. Preliminary, Hypothetical Site Erosion Map and Predicted Walnut Creek Actinide Concentrations for the 100-Year Event (Land Configuration Design Basis Project Scenario 0)

Estimated Mean Actinide Concentrations and Yields at Indiana Street (GS03)
 Pu = 2.915 pCi/L
 Am = 0.853 pCi/L
 Pu = 4.74E+08 pCi
 Am = 1.39E+08 pCi

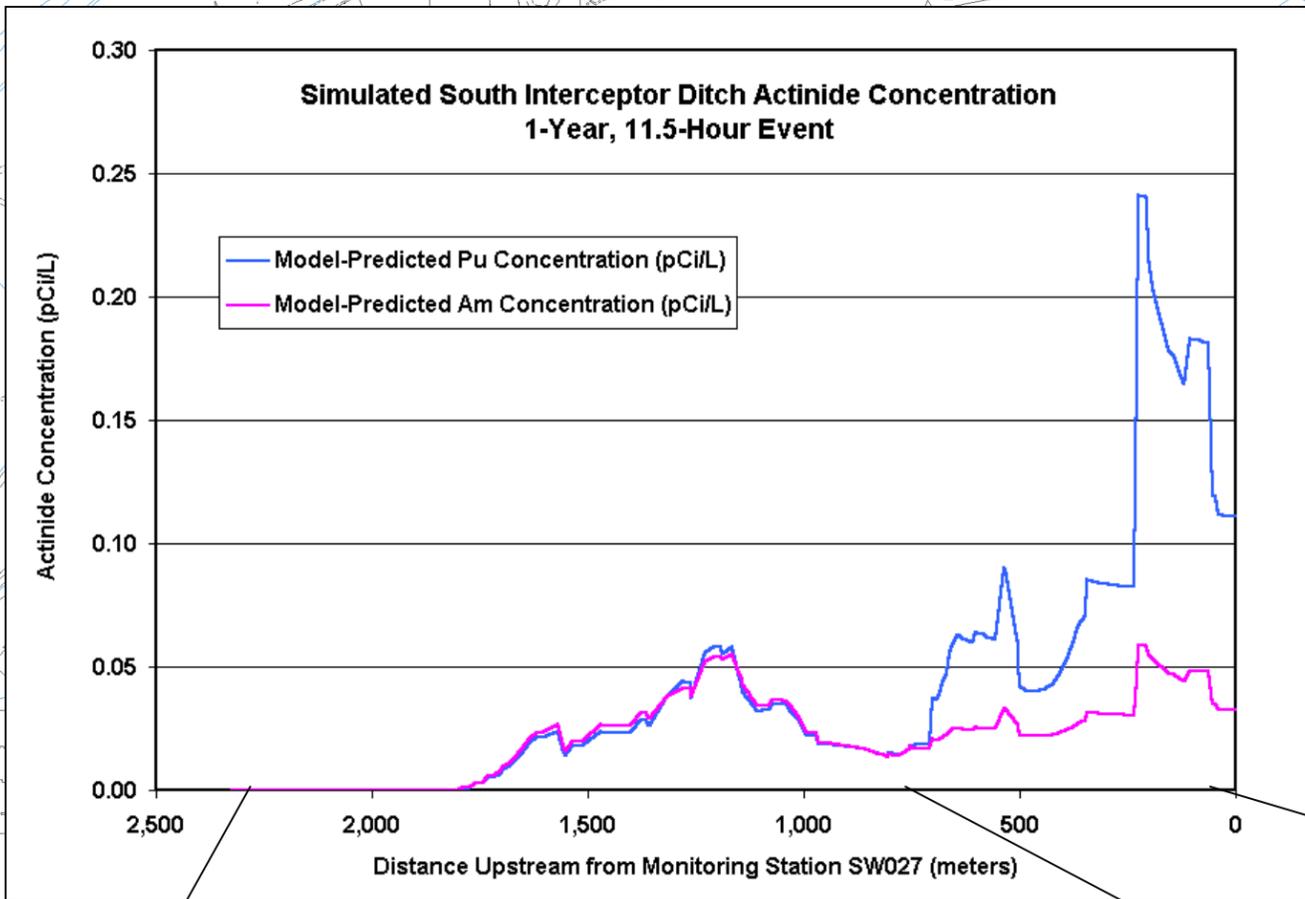
Figure 25
1-Year, 11.5-Hour, 35-mm Event

Pu-239,240 Mobility

Estimated Mean Actinide Concentrations and Yields At SW027

Pu = 0.011 pCi/L
 Am = 0.033 pCi/L

Pu = 4.36E+05 pCi
 Am = 1.28E+05 pCi

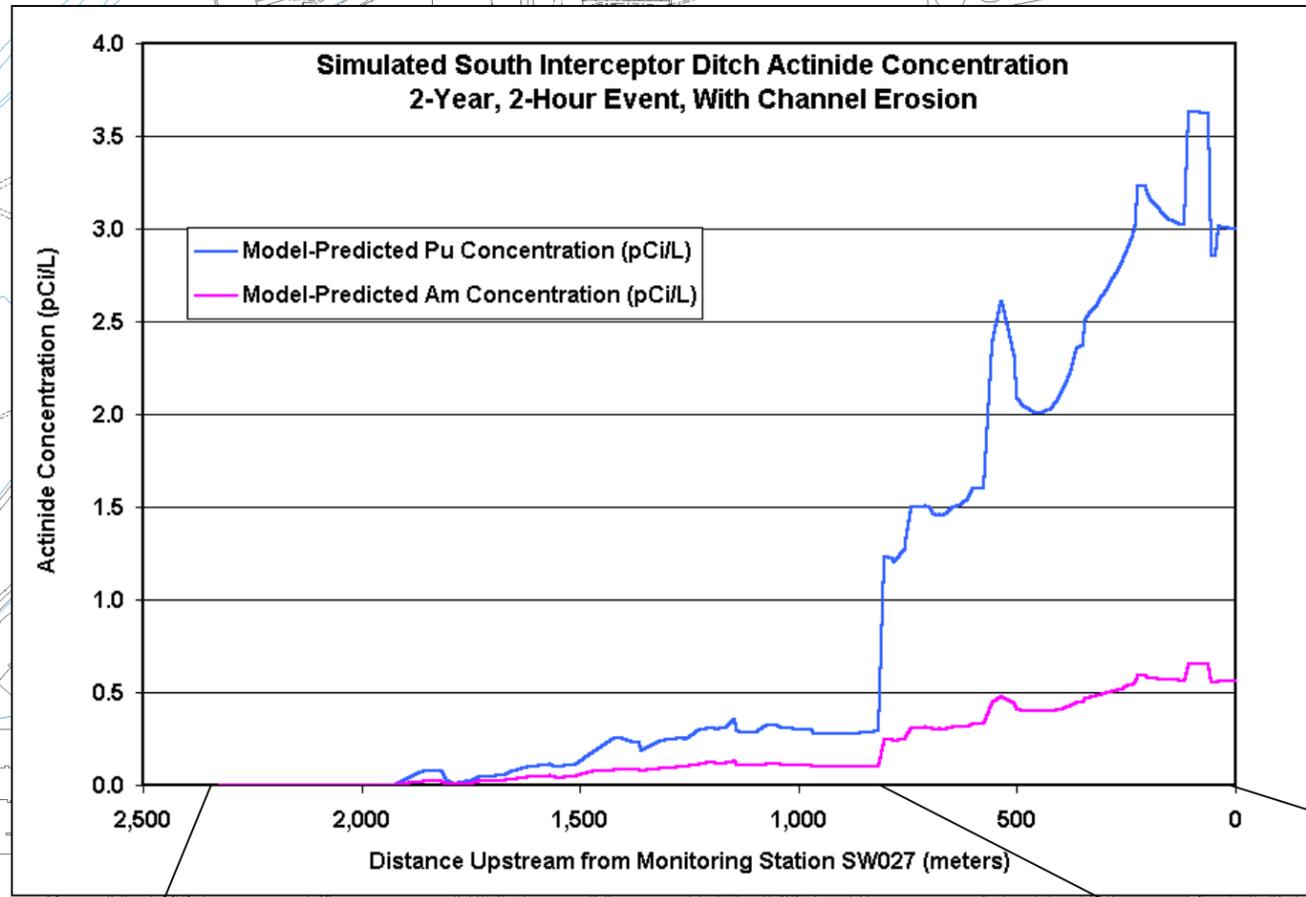
Figure 26
2-Year, 2-Hour, 31.5-mm Event

Estimated Mean Actinide Concentrations and Yields at SW027

Pu = 3.00 pCi/L
 Am = 0.558 pCi/L

Pu = 1.35E+07 pCi
 Am = 2.51E+06 pCi

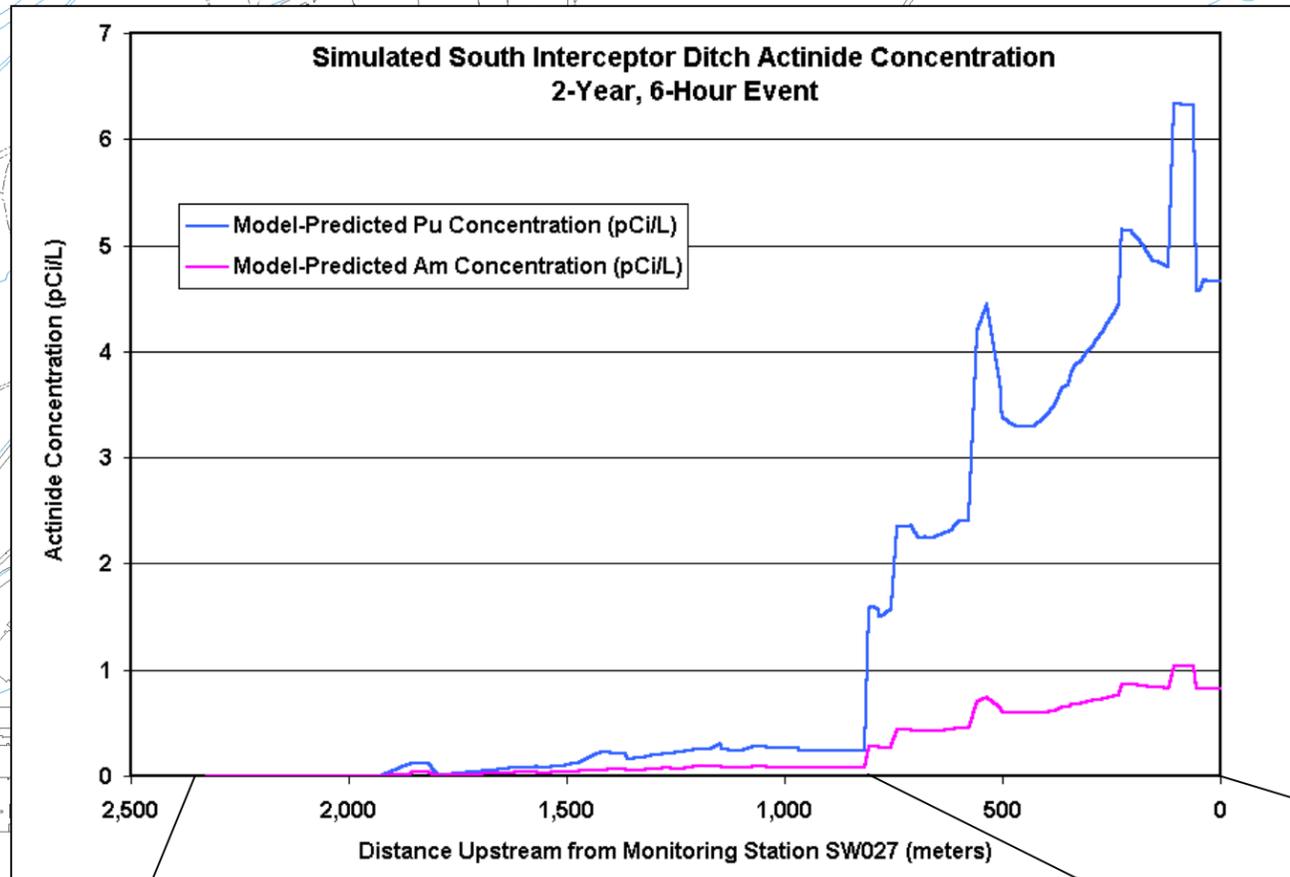
Figure 27
2-Year, 6-Hour, 40.8-mm Event

Estimated Actinide Concentrations and Yields at SW027

Pu = 4.66 pCi/L
 Am = 0.81 pCi/L

Pu = 3.66E+07 pCi
 Am = 6.43E+06 pCi

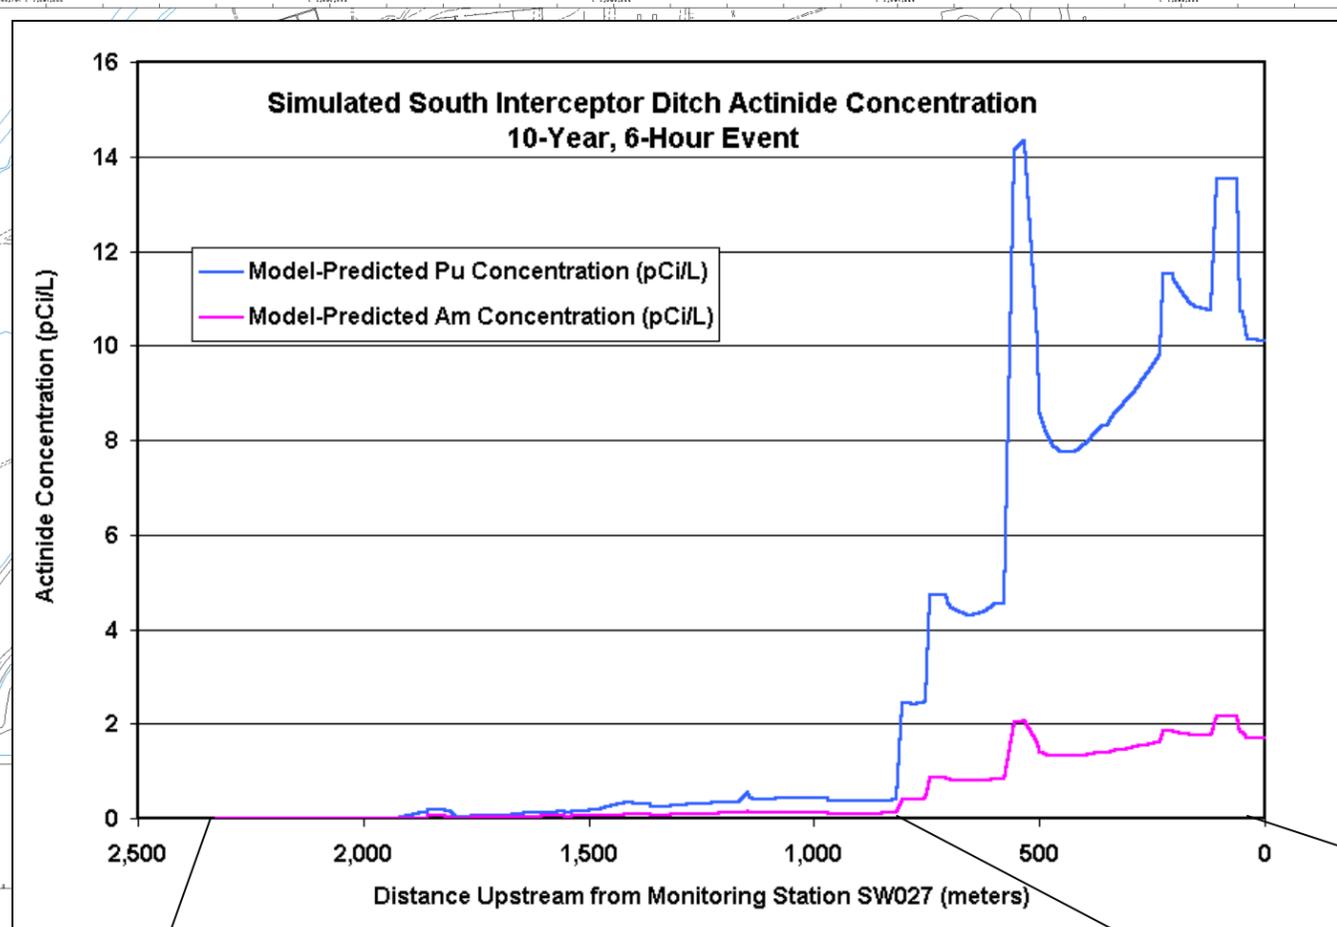
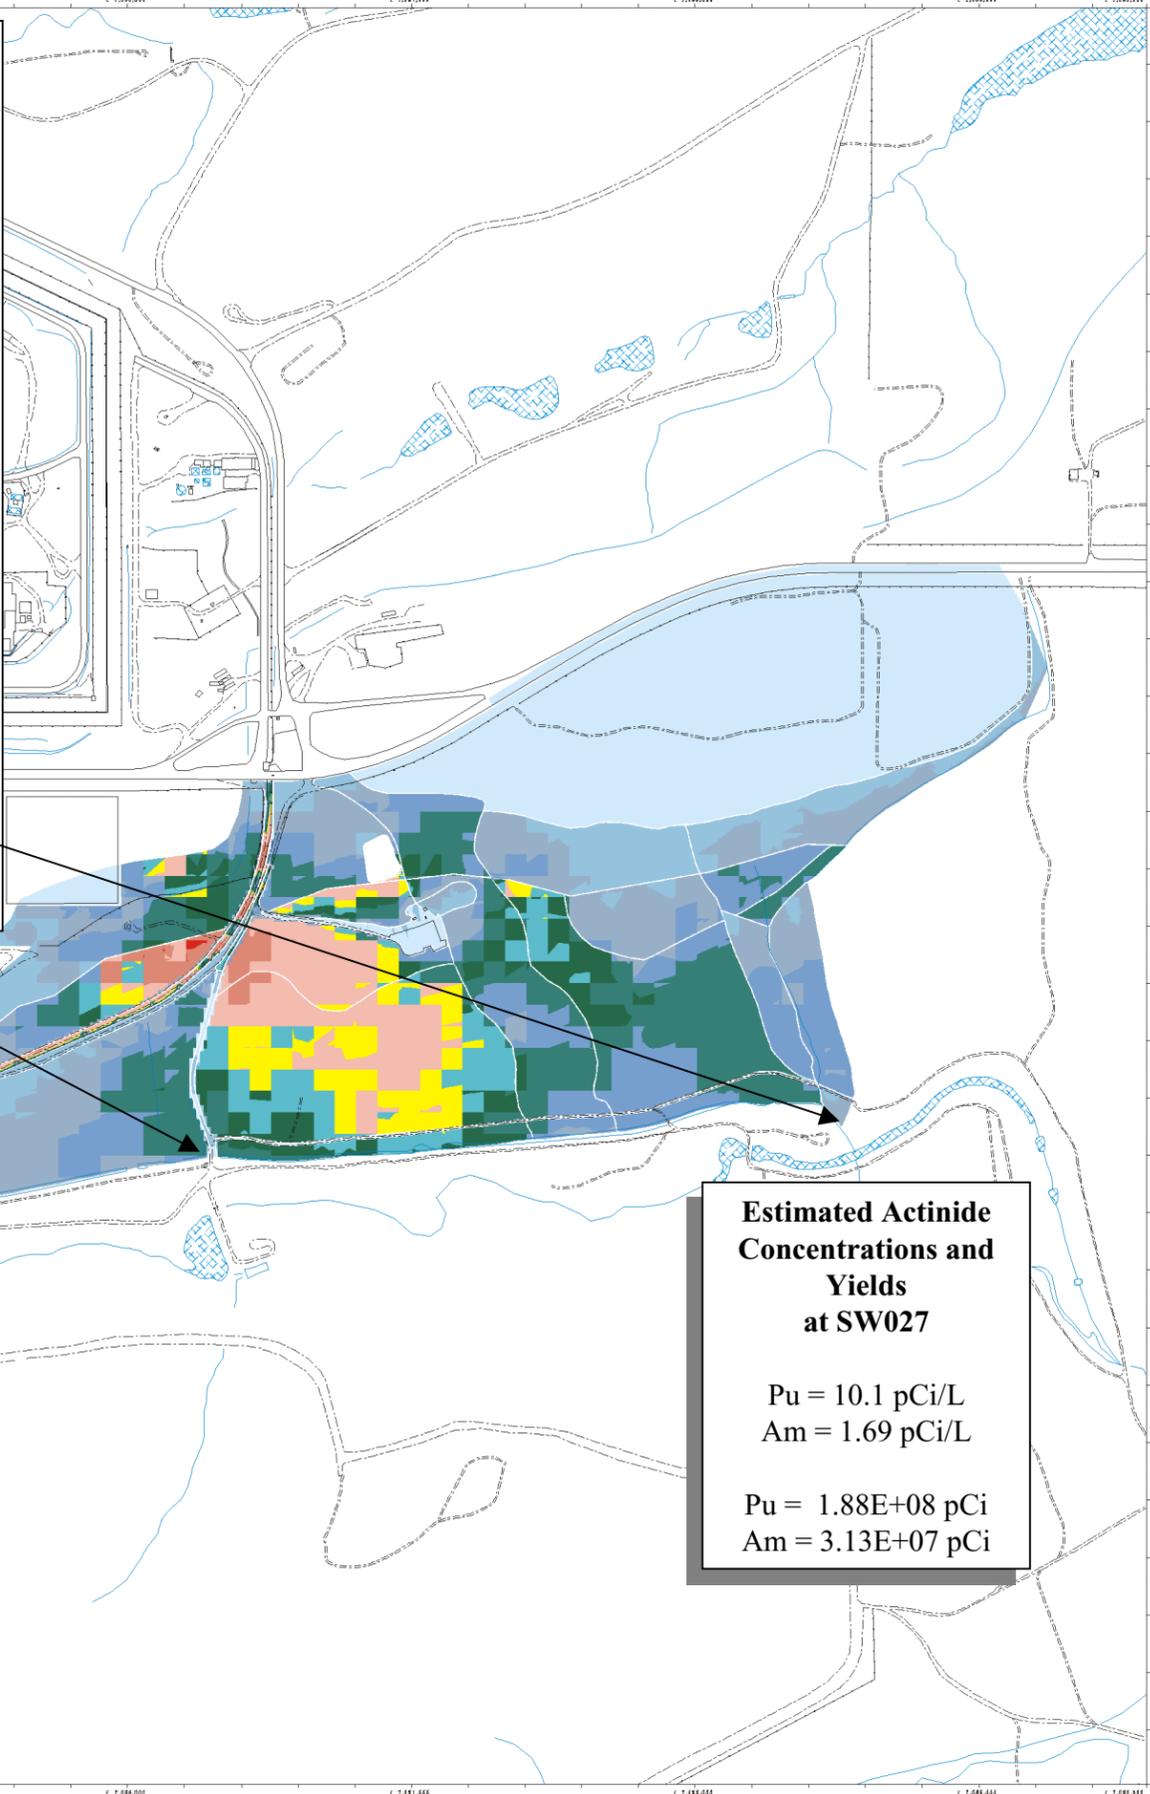
Figure 28

**10-Year, 6-Hour,
62.3-mm Event
Pu-239,240 Mobility**

**Estimated Actinide
Concentrations and
Yields
at SW027**

Pu = 10.1 pCi/L
Am = 1.69 pCi/L

Pu = 1.88E+08 pCi
Am = 3.13E+07 pCi

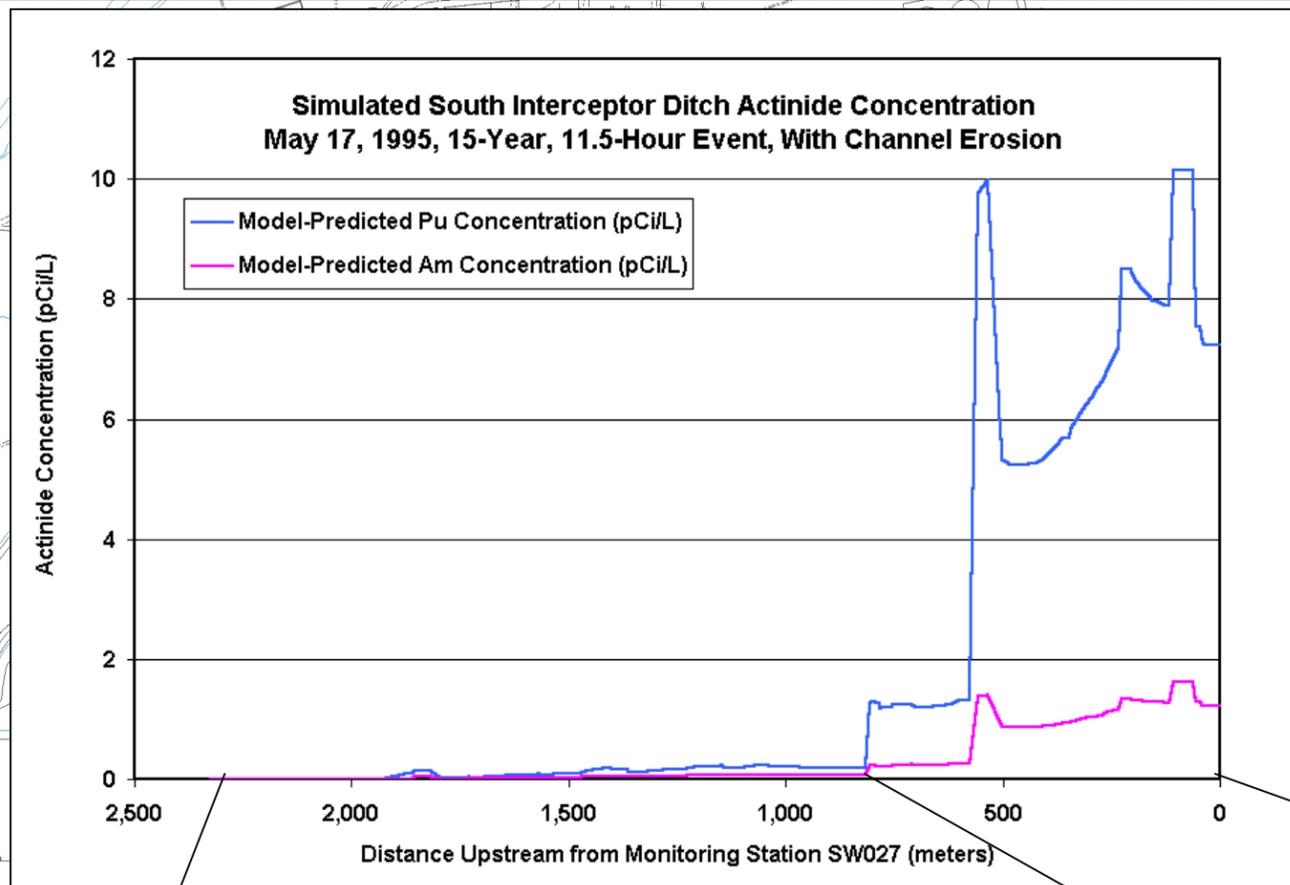
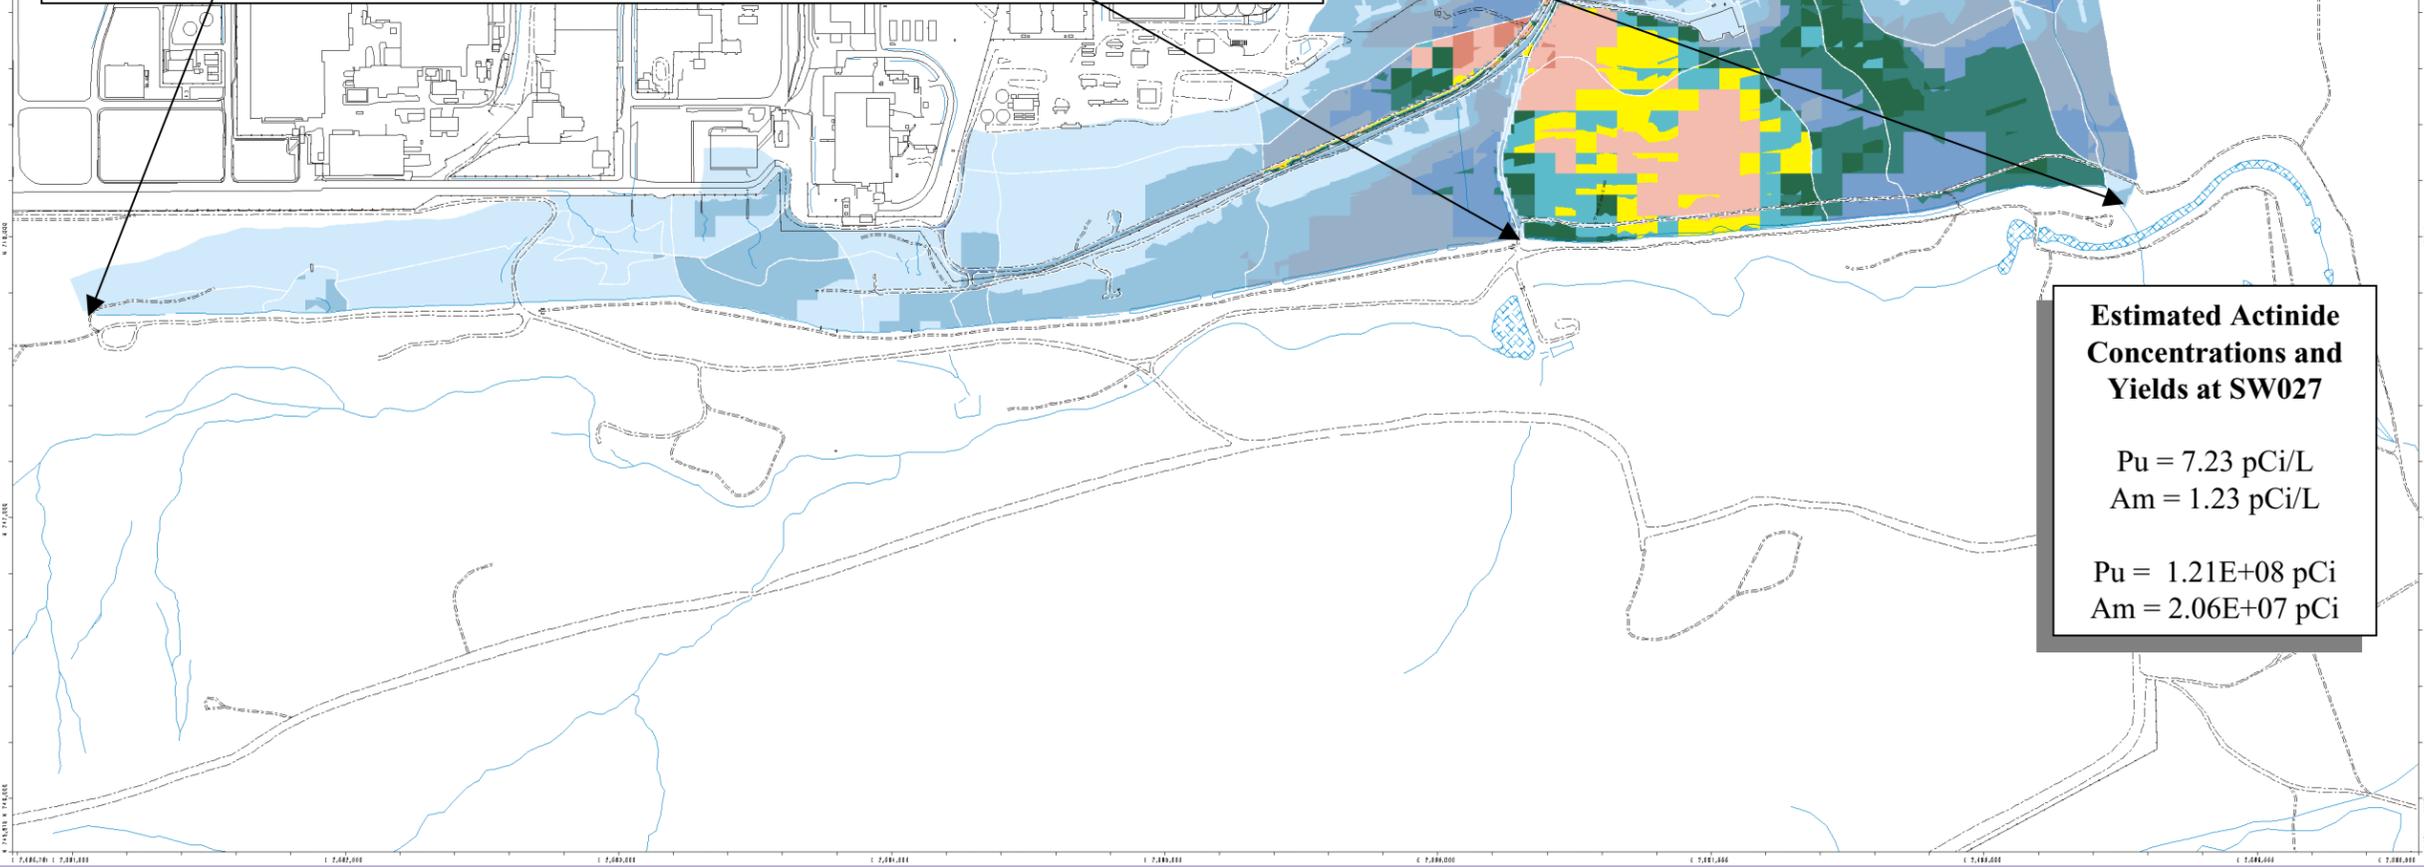
Figure 29
May 17, 1995 Event
Pu-239,240 Mobility
South Interceptor Ditch

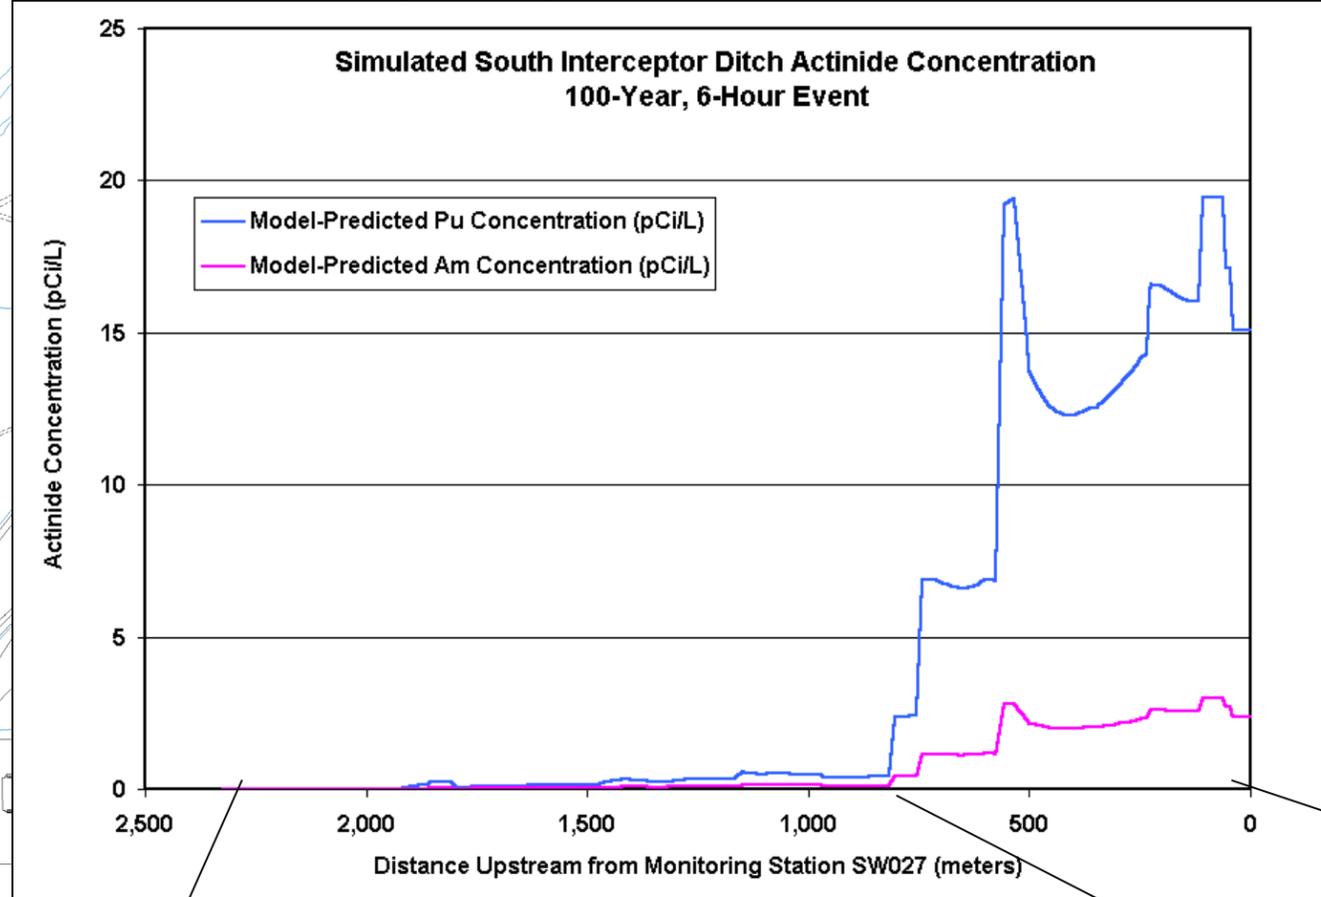
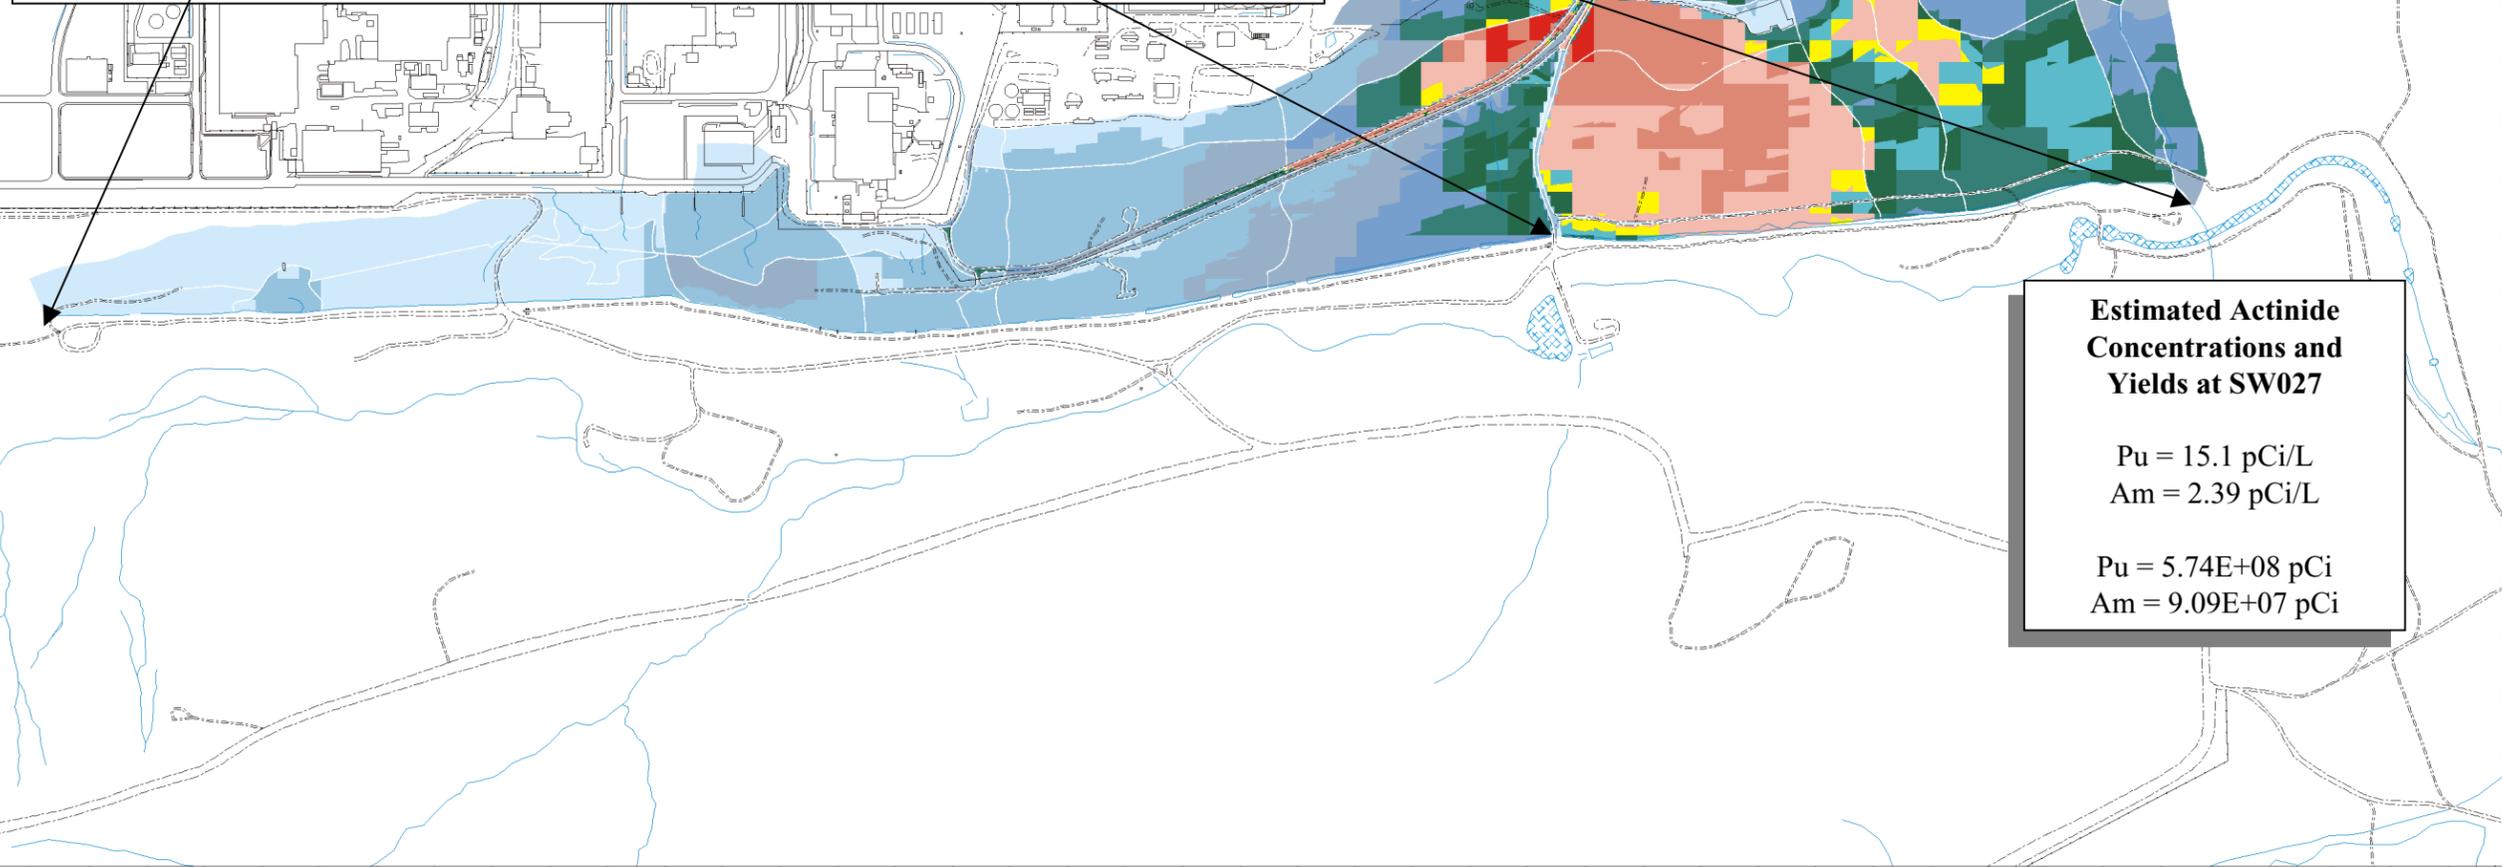
Figure 30

**100-Year, 6-Hour,
97.1-mm Event**

Pu-239,240 Mobility

**Estimated Actinide
Concentrations and
Yields at SW027**

Pu = 15.1 pCi/L
Am = 2.39 pCi/L

Pu = 5.74E+08 pCi
Am = 9.09E+07 pCi

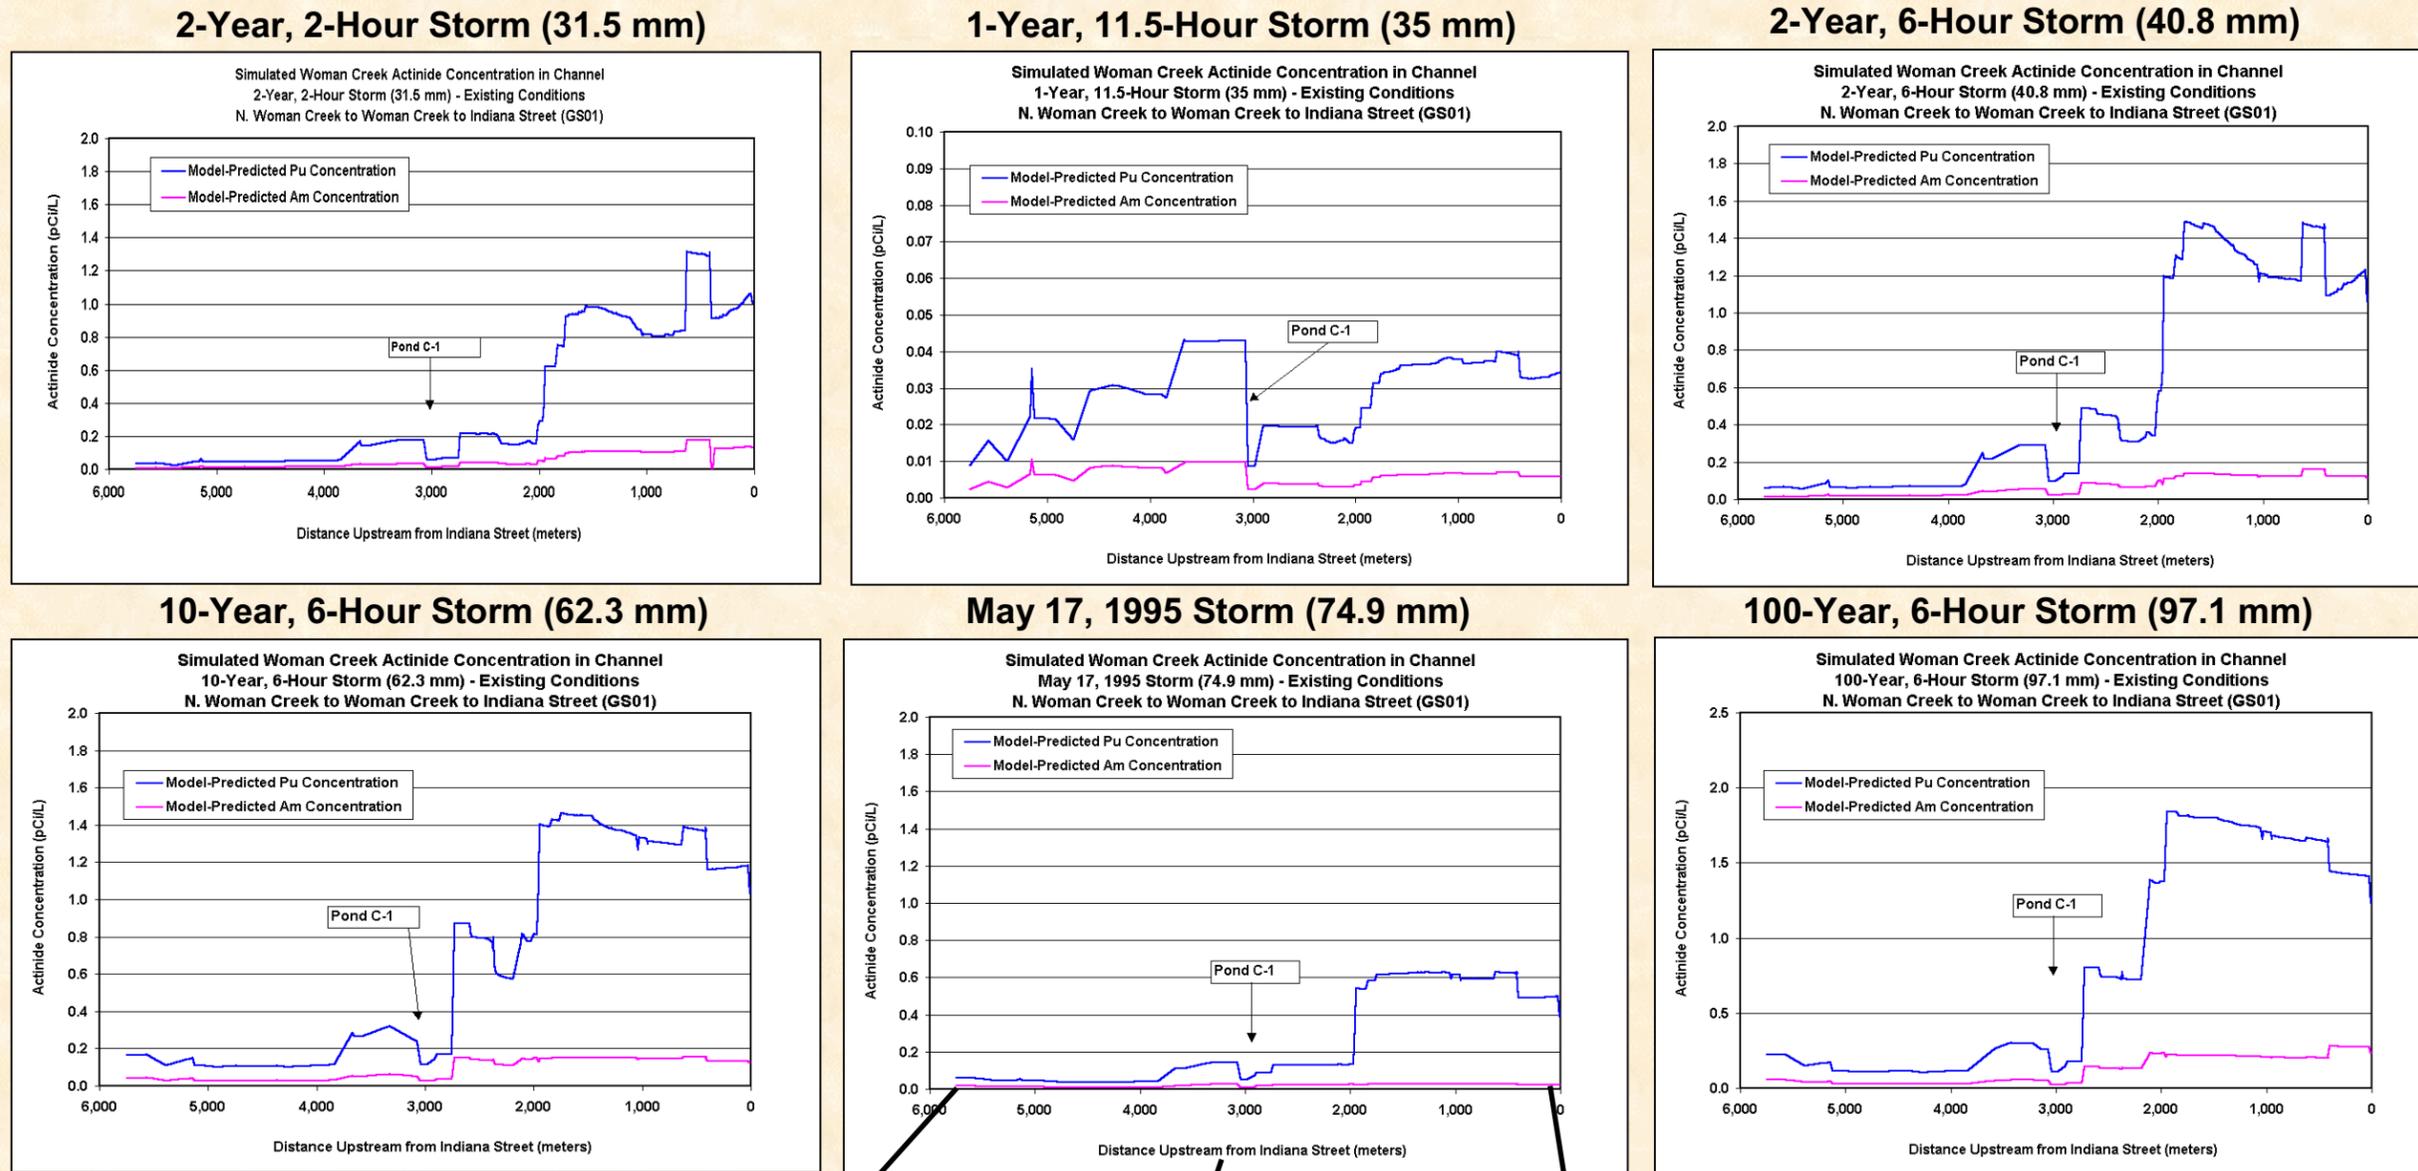
Figure 32. Woman Creek - Model-predicted Surface Water Pu and Am Concentrations for 6 Storm Events

Woman Creek Scenarios	Estimated Pu Yield (pCi)	Estimated Am Yield (pCi)
2-Year 2-Hour (31.5mm)	8.23E+06	1.09E+06
1-Year 11.5-Hour (35mm)	4.97E+05	8.46E+04
2-Year 6-Hour (40.8mm)	1.41E+07	1.53E+06
10-Year 6-Hour (62.3mm)	5.08E+07	6.04E+06
5/17/2001 (74.9mm)	2.87E+07	1.81E+06
100-Year 6-Hour (97.1mm)	1.80E+08	3.38E+07
