FIGURES

U.S. Department of Energy
 Rocky Flats Environmental Technology Site

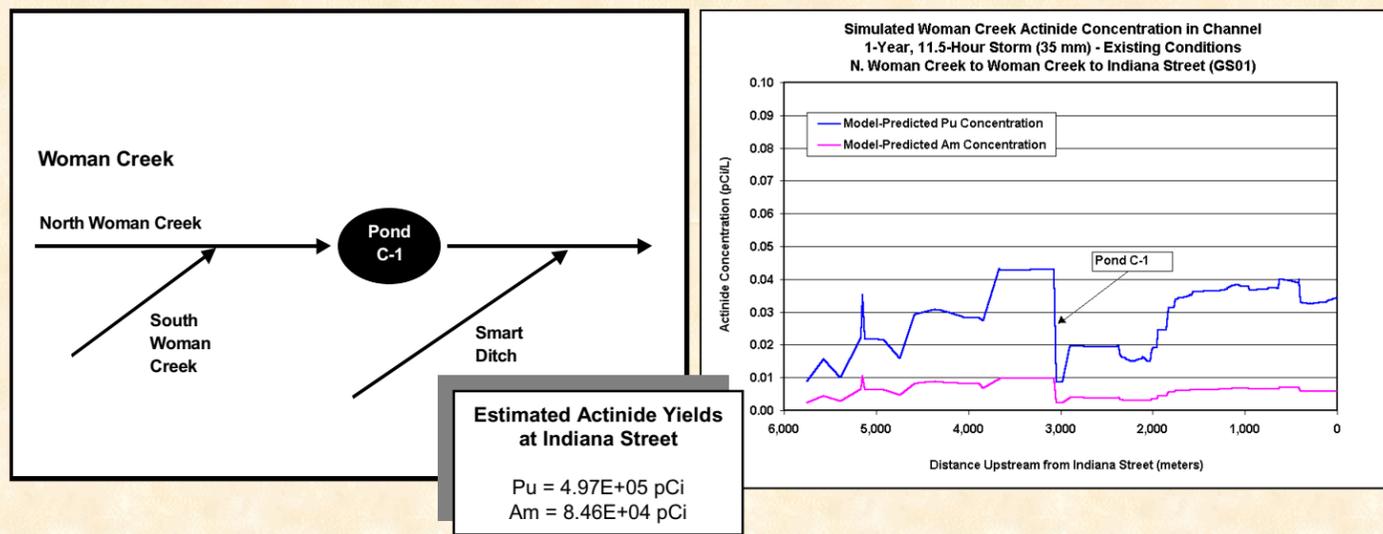
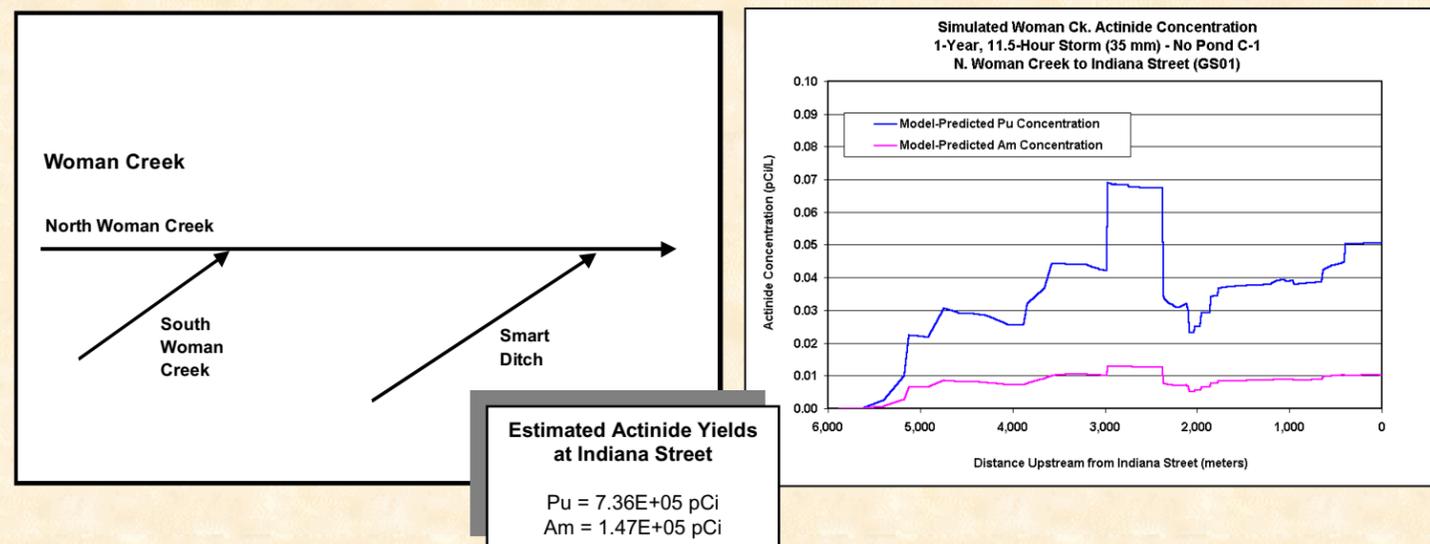
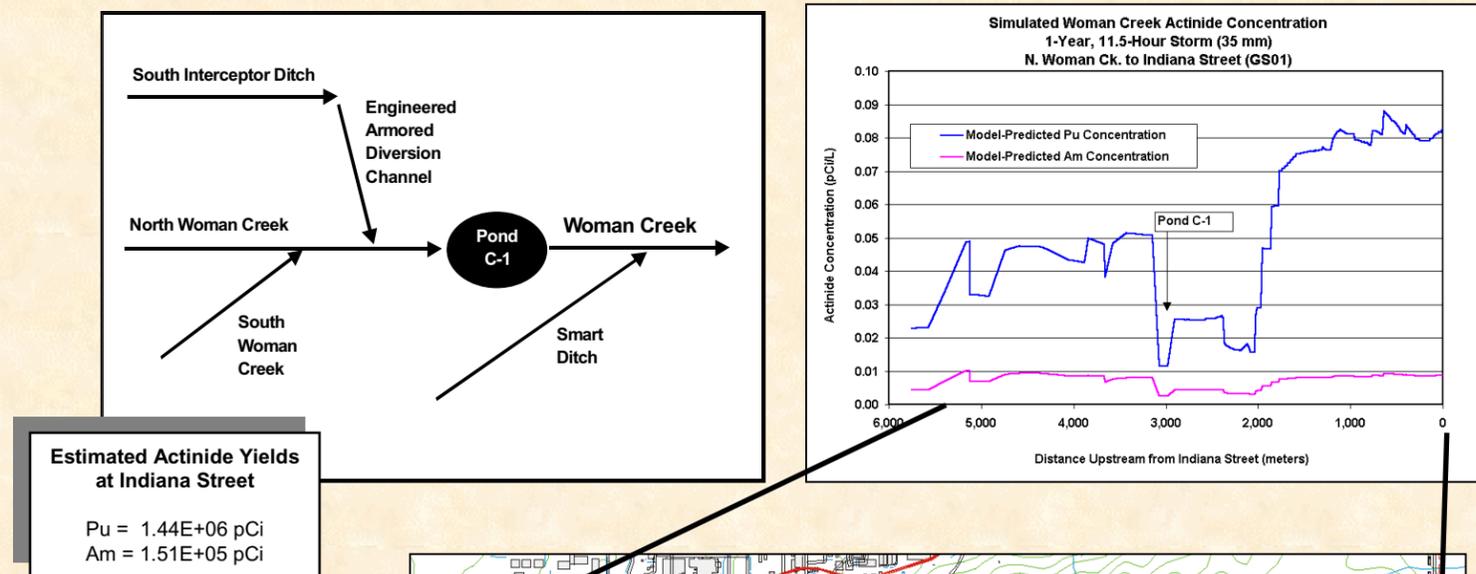
Figure 34. Woman Creek - 3 Configuration Alternatives Model-predicted Pu and Am Surface Water Concentrations in Woman Creek - 1-Year, 11.5 hour Storm (35-mm)

Woman Creek: Current Configuration

Woman Creek: Pond C-1 Removed

Woman Creek: South Interceptor Ditch Routed Into Woman Creek

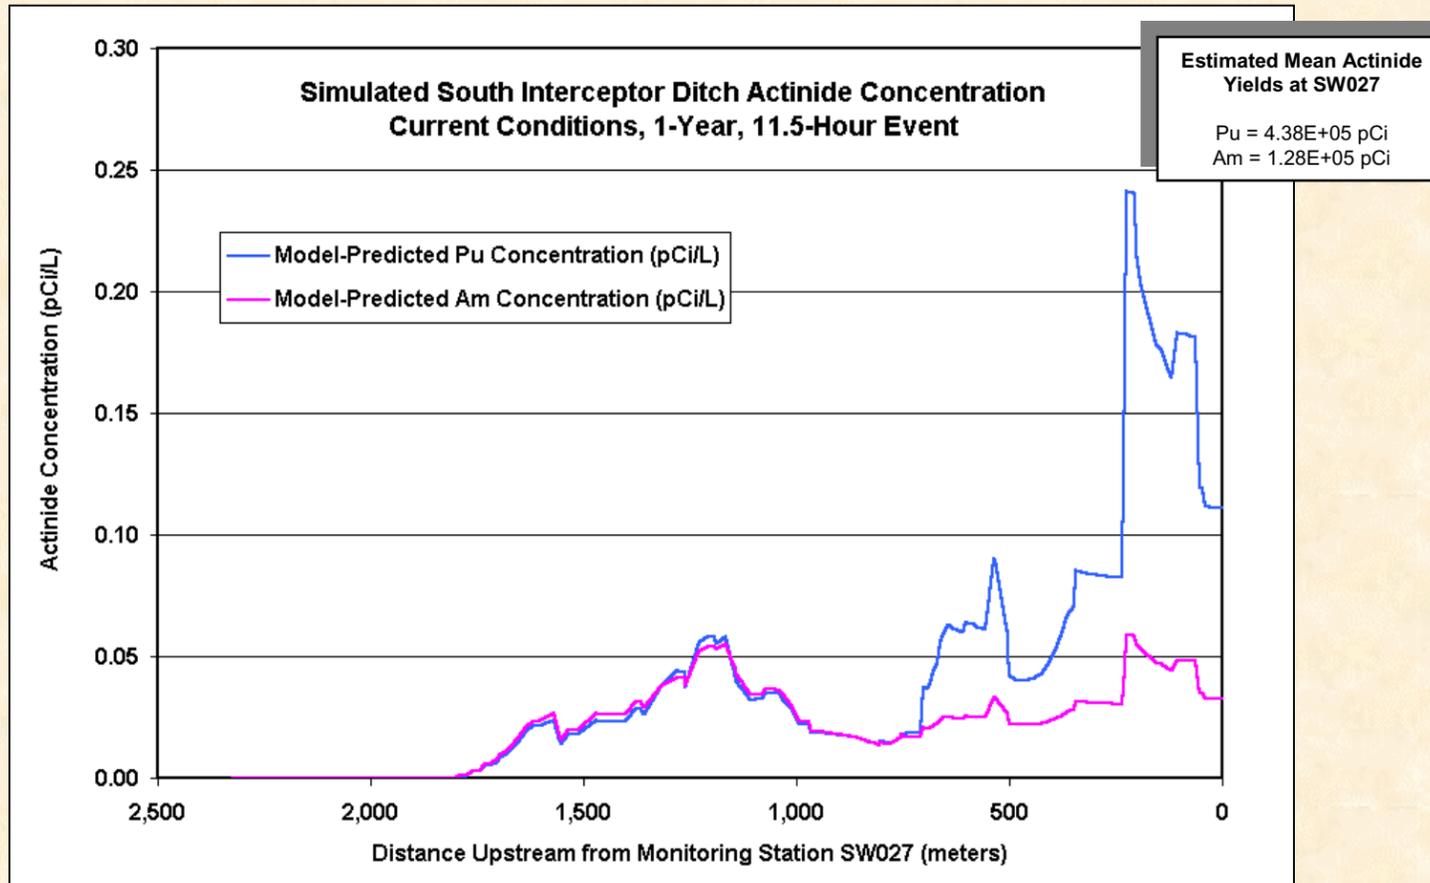
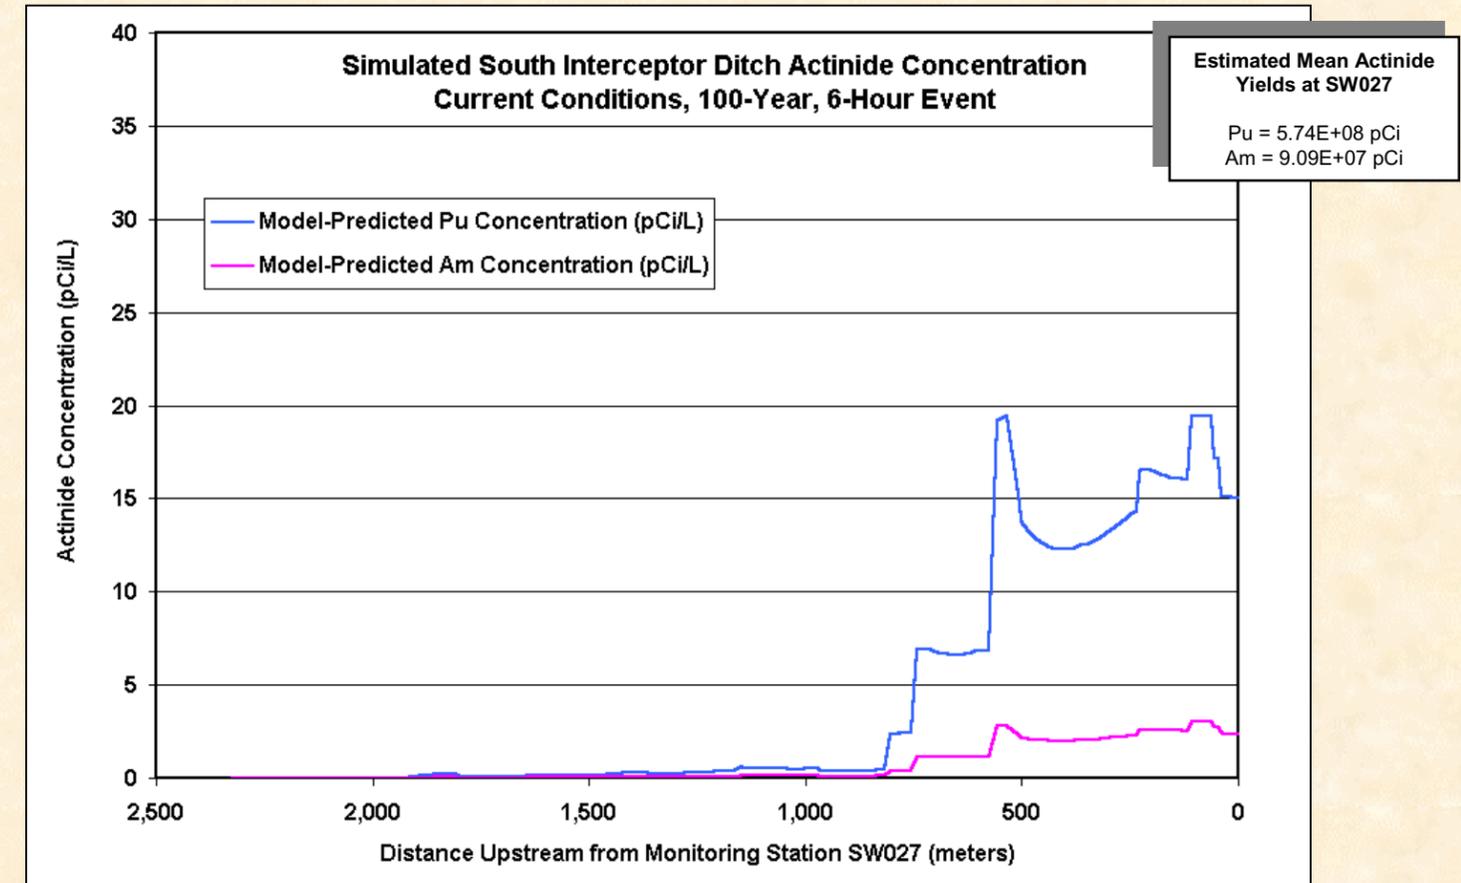
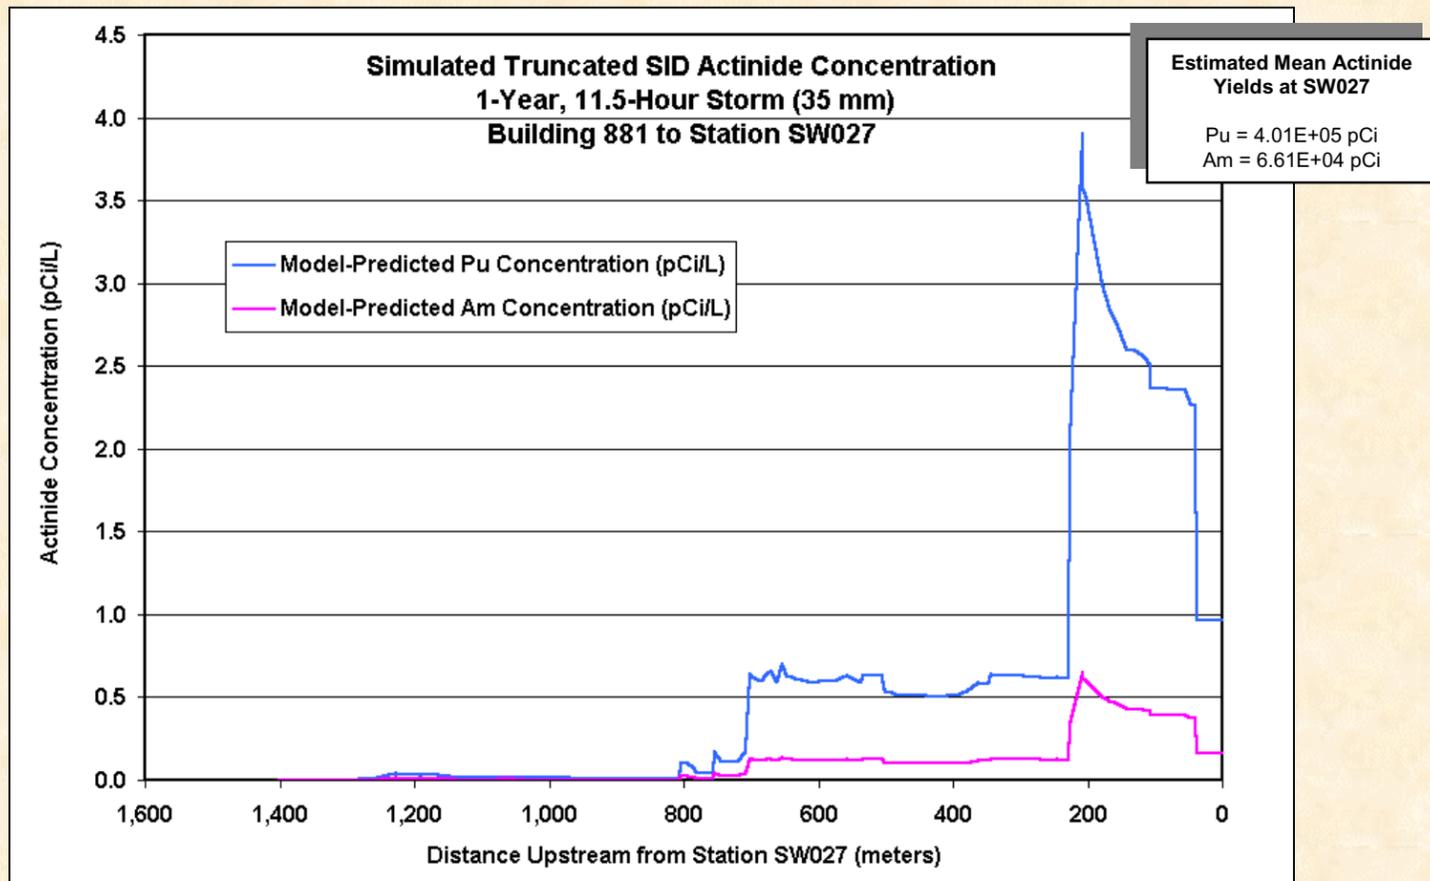
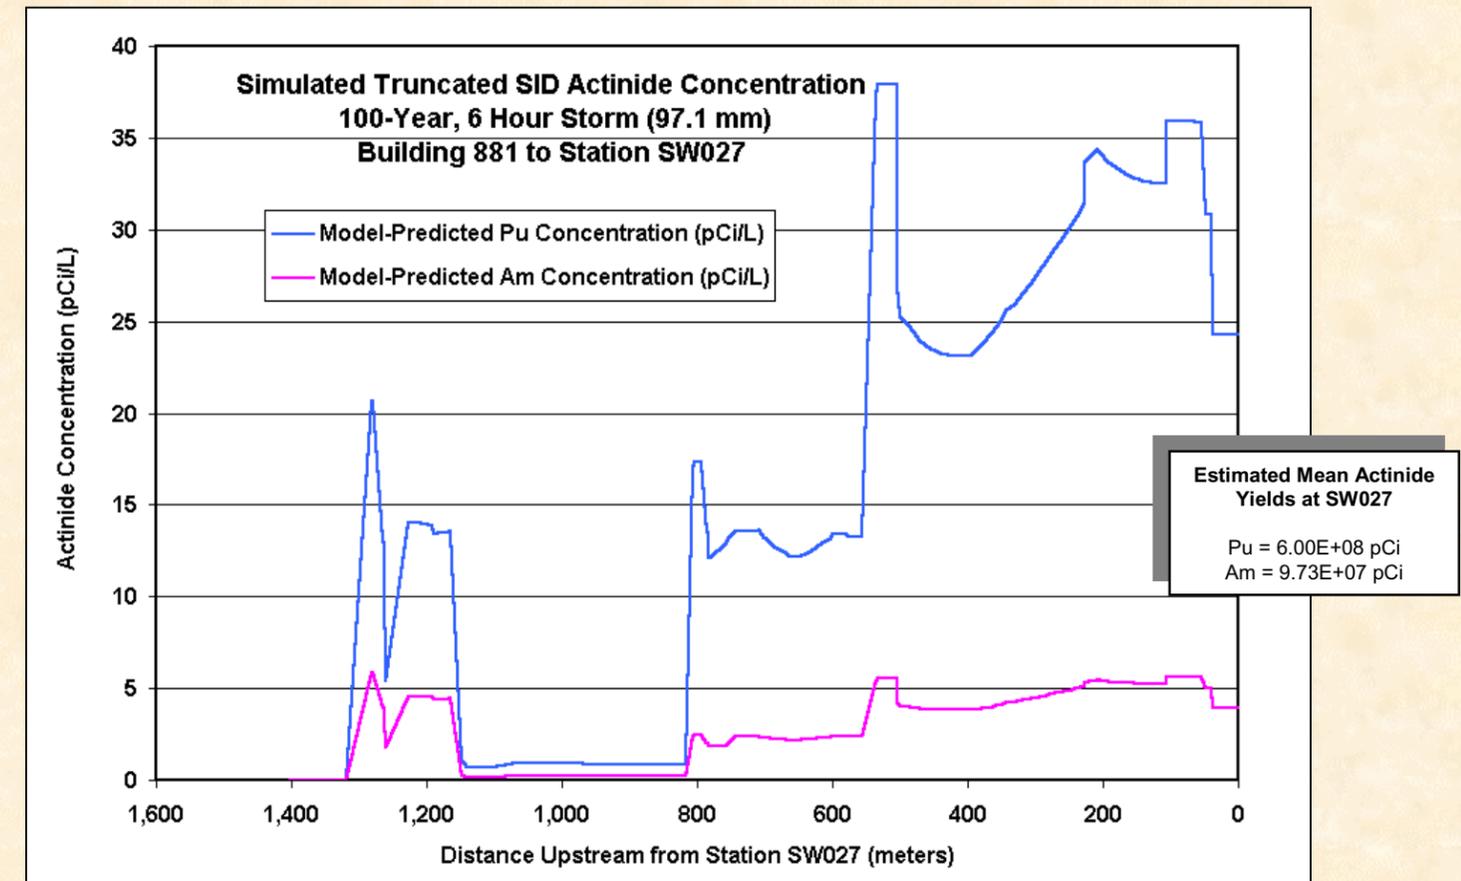
Figure 36. Comparison of Simulated Actinide Concentrations for Truncated SID

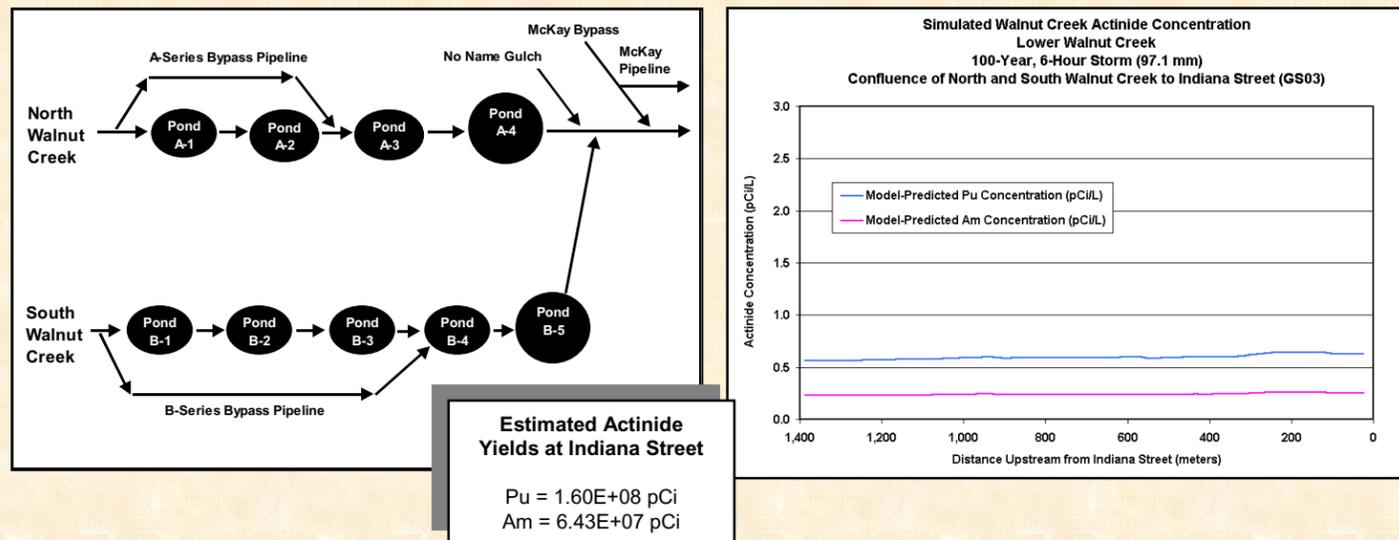
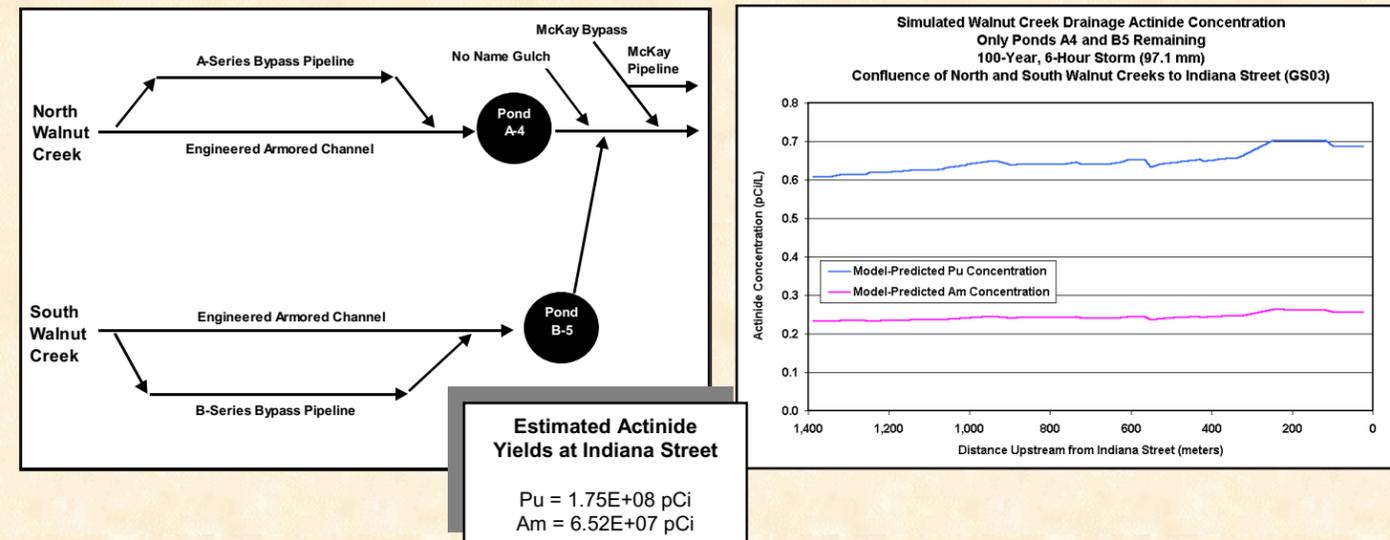
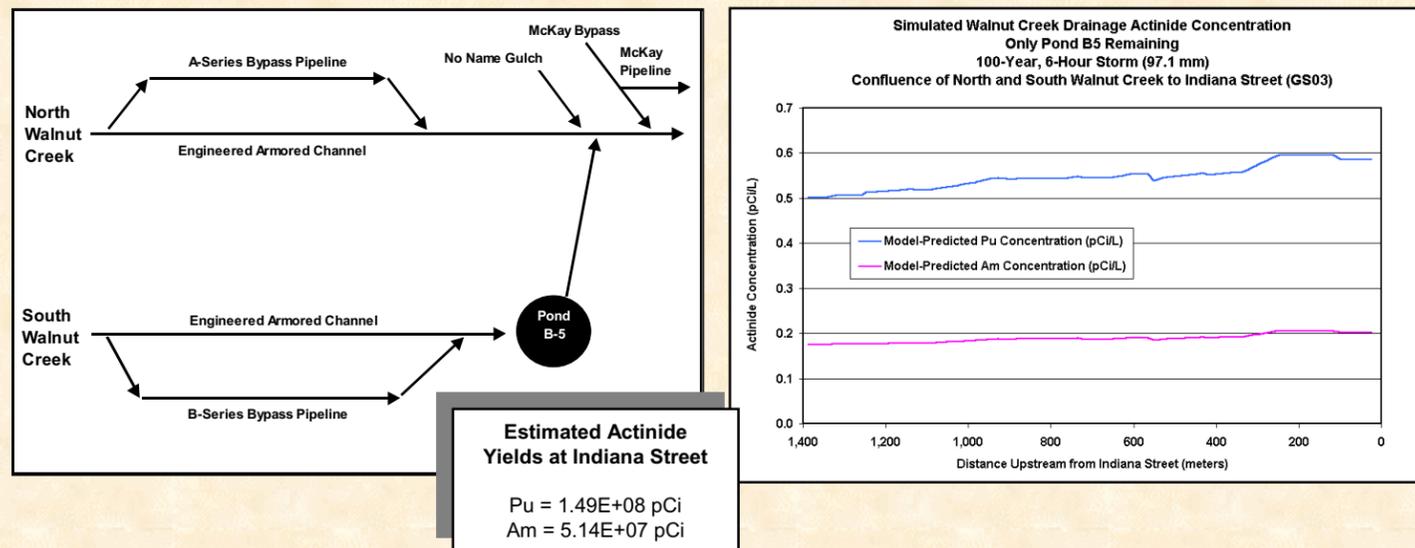
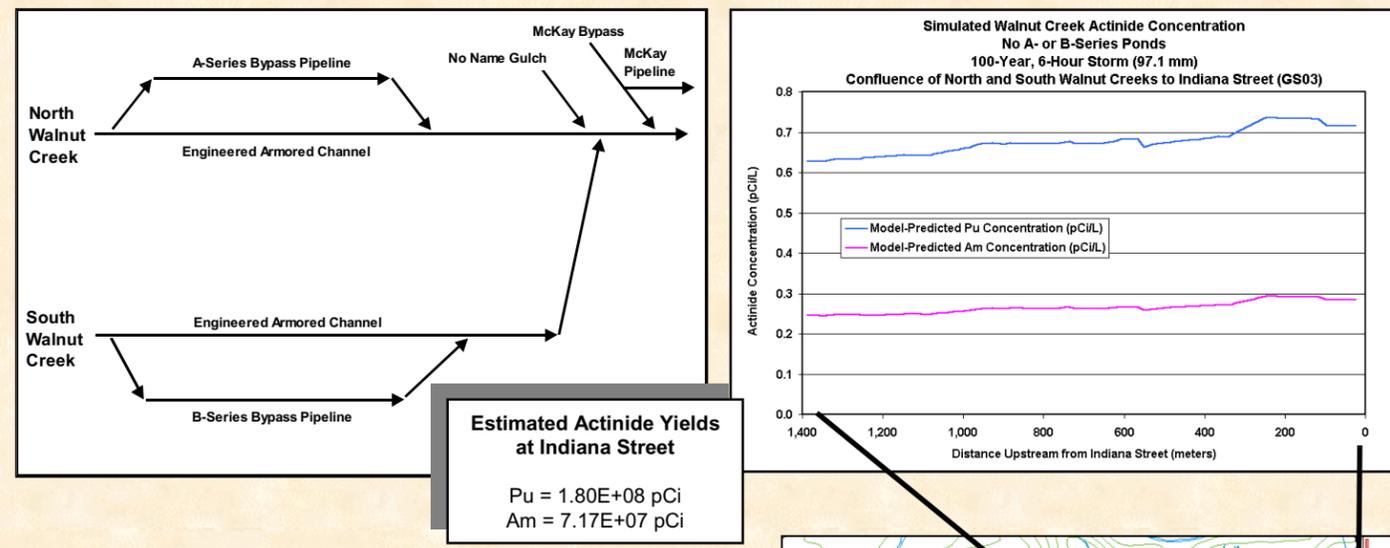
**Figure 38. Walnut Creek - 4 Pond Configuration Alternatives
Model-predicted Pu and Am
Surface Water Concentrations in
Lower Walnut Creek - 100-Year,
6-Hour Storm (97.1-mm)**

Walnut Creek: Current Pond Configuration

Walnut Creek: Only Pond A-4 and B-5 Remain

Walnut Creek: Only Pond B-5 Remains

Walnut Creek: No Ponds Remain
