**DRAFT ENVIRONMENTAL RESTORATION
RFCA STANDARD OPERATING PROTOCOL
FOR ROUTINE SOIL REMEDIATION
FY03 NOTIFICATION #03-09
IHSS 133.5 - INCINERATOR**

June 2003

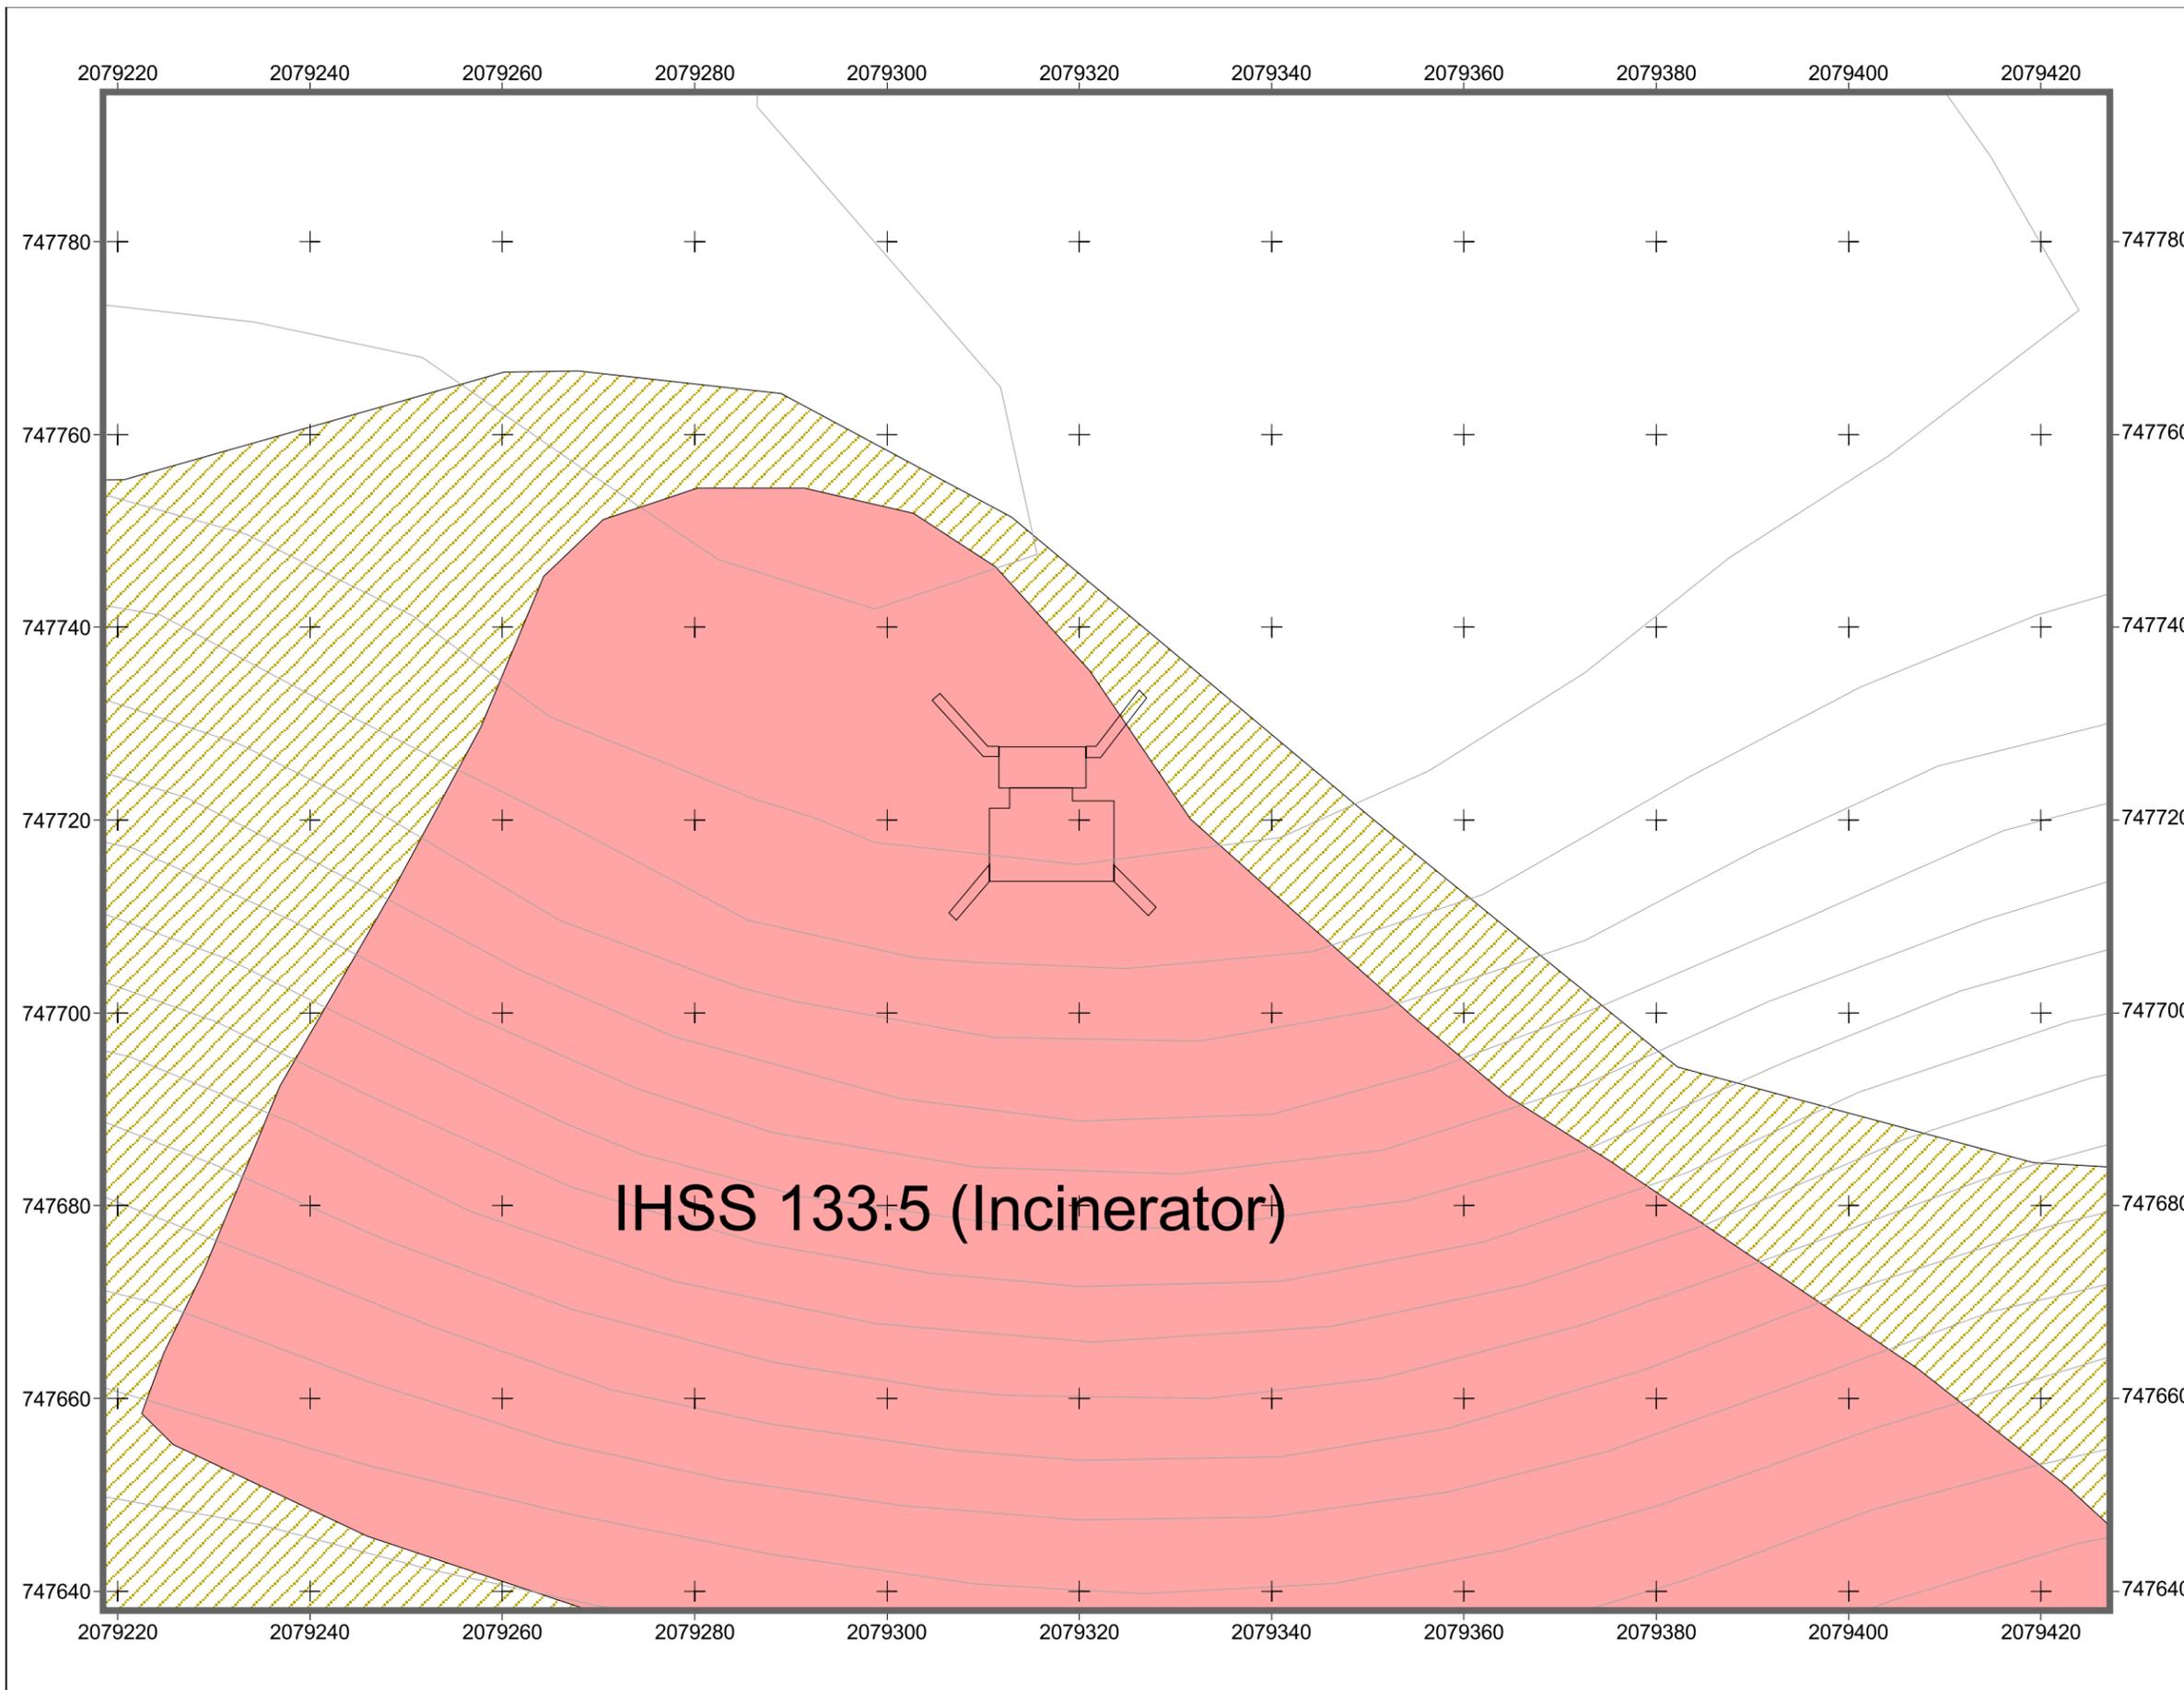
Figure 2
IHSS 133.5 - Incinerator
Building Configuration

The Incinerator was operated from 1952 to 1968. General combustible wastes and an unknown quantity of depleted uranium contaminated materials were burned. The waste was estimated to contain at least 100 grams of depleted uranium. Based on the review of historical aerial photographs, the incinerator was buried between August 7, 1969 and August 6, 1971 (DOE 1992). The Incinerator building configuration is shown on Figure 2.

- The Incinerator exists with a footprint of approximately 12 feet by 16 feet (192 square feet);
- The Incinerator is approximately 24 feet tall and constructed of concrete walls (with rebar) on a concrete slab;
- The Incinerator is flanked with concrete wing walls;
- The Incinerator is located on the side of a hill that slopes to the south towards Woman Creek; and
- Miscellaneous concrete estimated at 40 cubic yards is located approximately 200 feet south of the Incinerator.

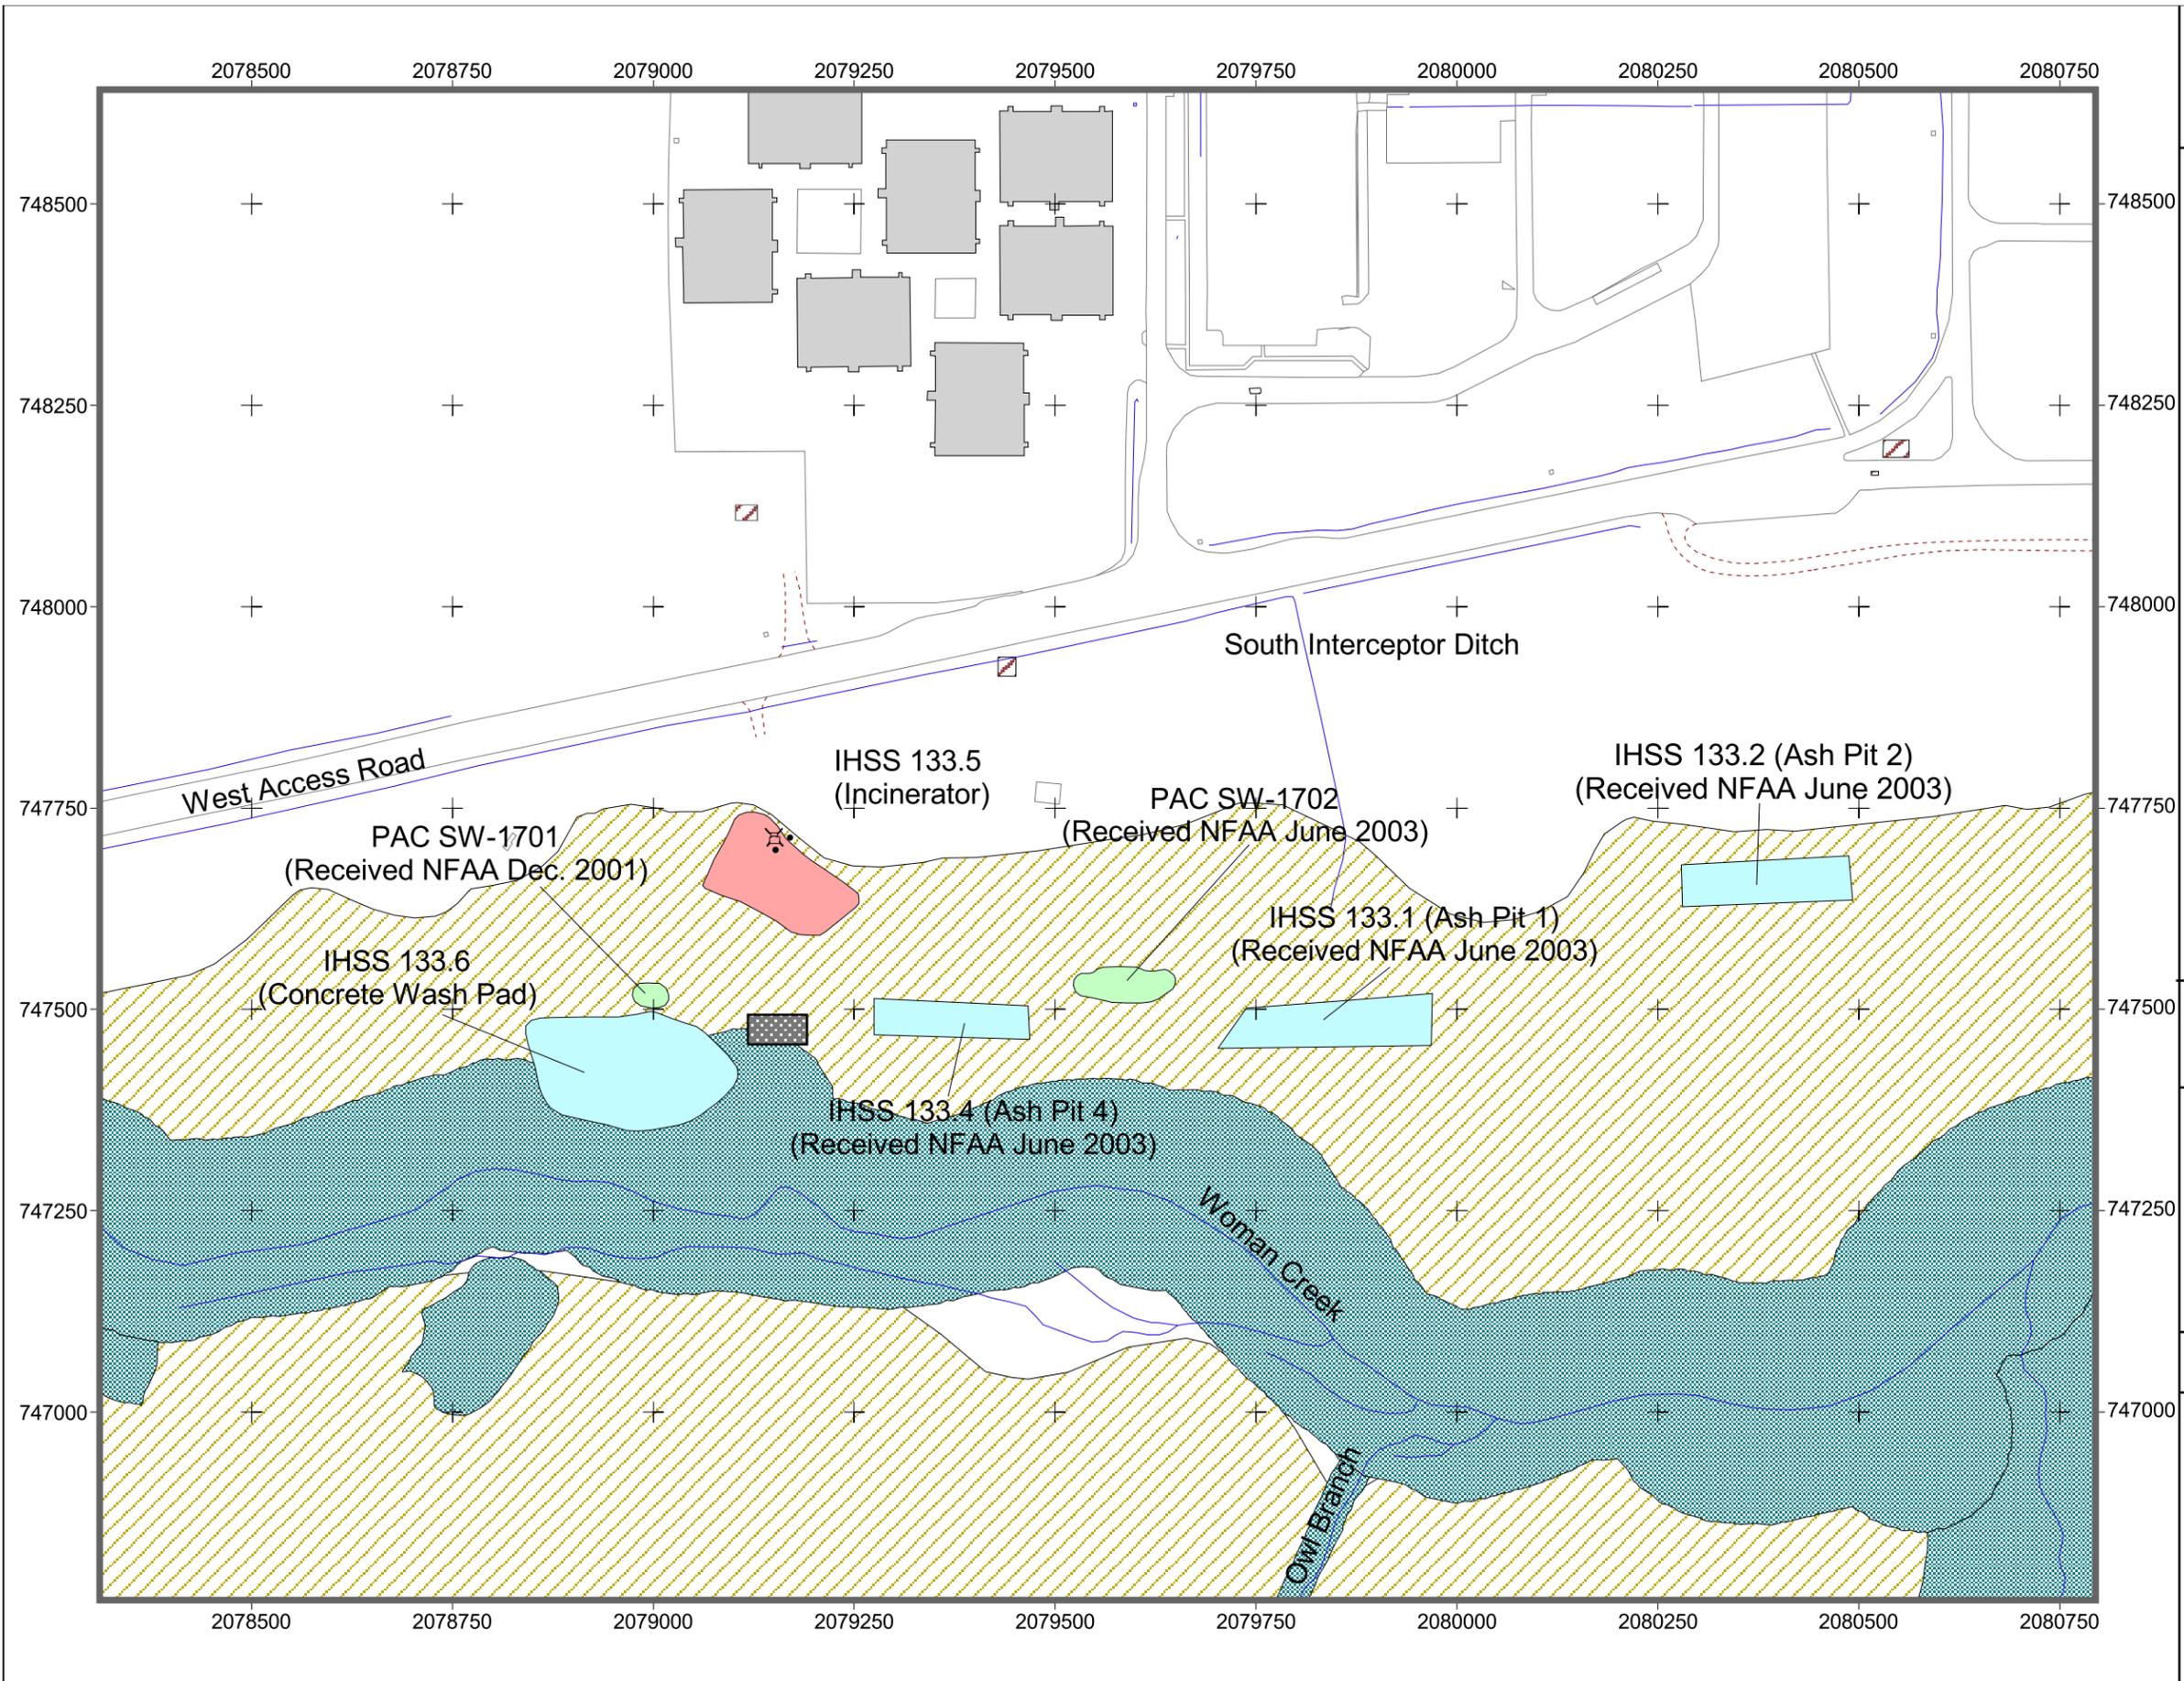
Figure 3
IHSS 133.5 - Incinerator
Potential Remediation Area

It is anticipated that after remediation there may be areas with concentrations of radionuclides, metals, VOCs and dioxins/furans greater than background or method detection limit, but less than RFCA ALs. The potential remediation area is shown on Figure 3. Special care will be taken not to disturb critical Prebbles Jumping Mouse habitat, which is located approximately 150 feet south of the remediation area.

Based on the PCOCs (Table 1 and Section 2.1) and the ER RSOP (DOE 2002a), it is anticipated that contamination above the RFCA WRW ALs or as indicated through the SSRS will be remediated. Figure 3 shows the potential remediation area. Additional remediation to below RFCA WRW ALs or as indicated through the SSRS is not required by RFCA, but will be evaluated using the consultative process during project execution.

IHSS 133.5 is located in the RFETS Southwest BZ. The nearest IHSS or PAC is IHSS 133.4, Ash Pit 4 located approximately 200 feet to the southeast and PAC SW-1701, Recently Identified Ash Pit located approximately 200 feet to the southwest. IHSSs 133.1, 133.2 and 133.4 and PACs SW-1701 and SW-1702 received NFAA and are located downgradient, and as such, these sites do not have the potential to adversely impact IHSS 133.5. See Figure 3 for the locations of these IHSSs and PAC.

High-volume air samplers may be used at the remediation area consistent with work controls to determine airborne radioactivity concentrations. Potential air sampling locations are shown on Figure 3.

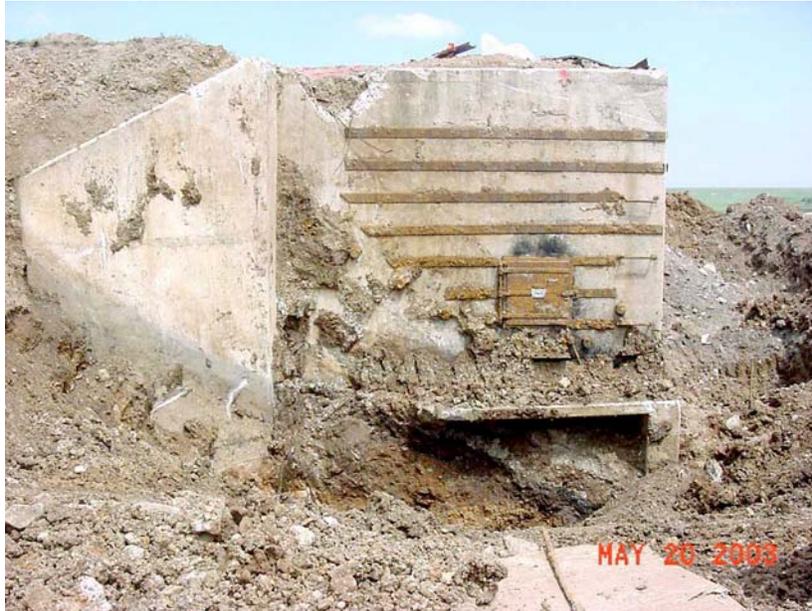
Incinerator view towards the east.

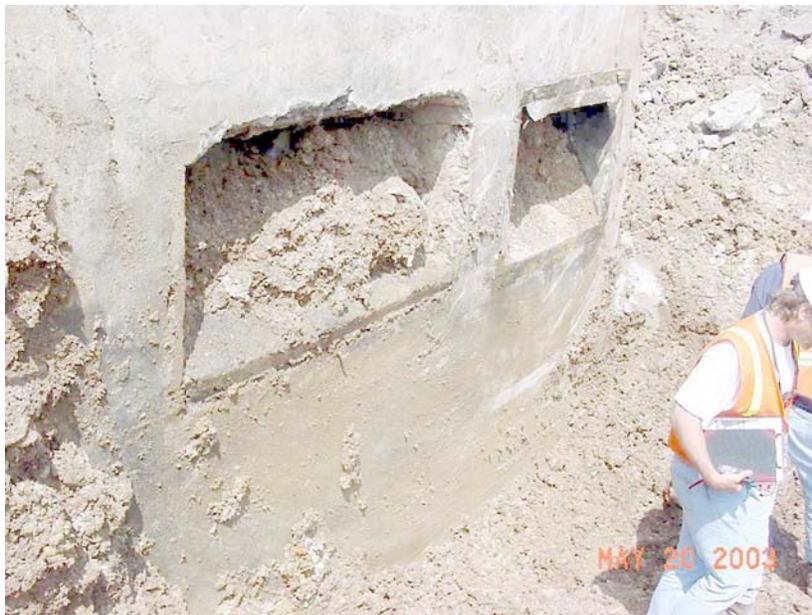
Incinerator chutes.

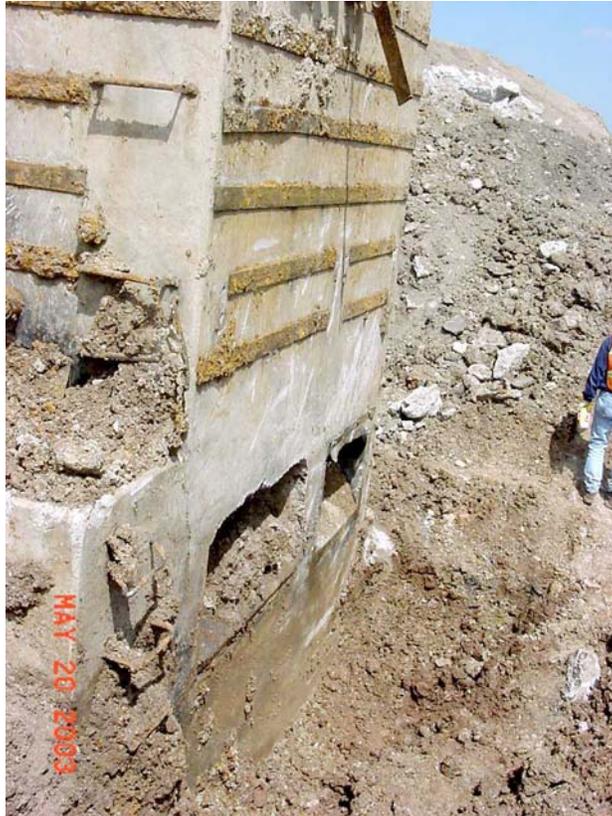
Incinerator chutes view looking towards the north.

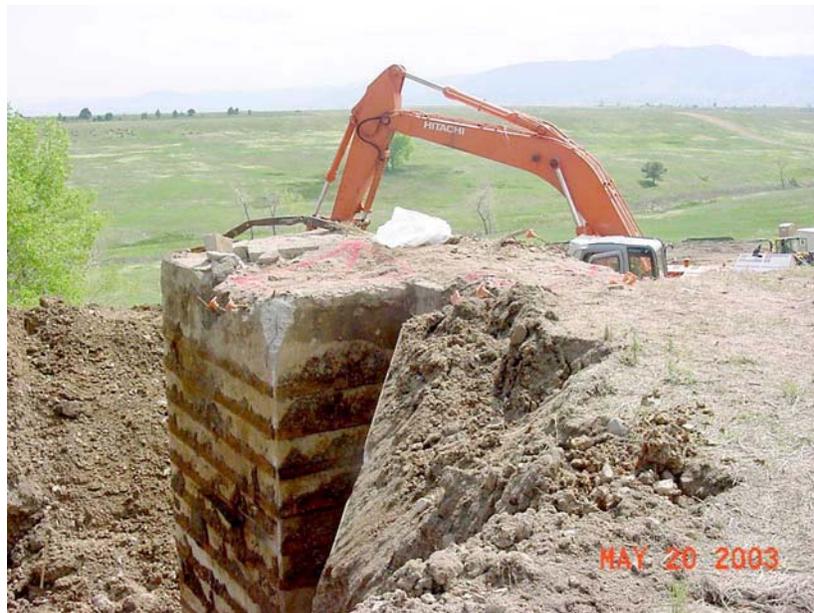
Incinerator view looking towards the south.

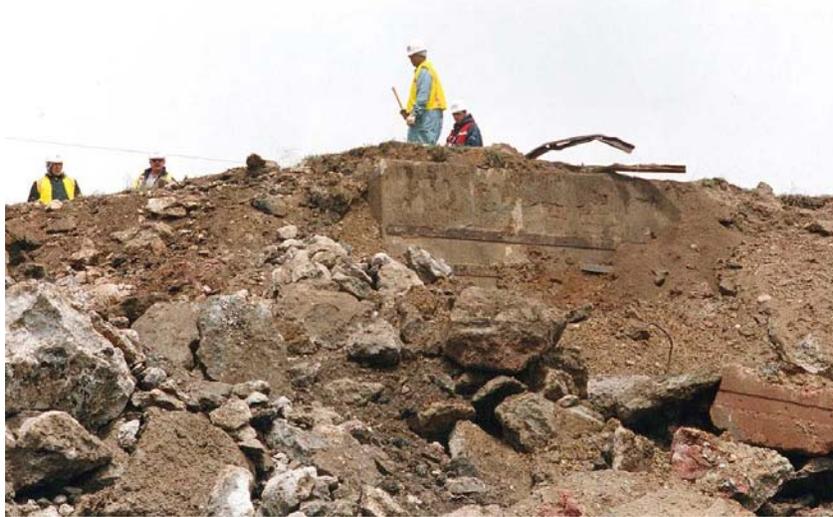
Excavation activities at the Incinerator.

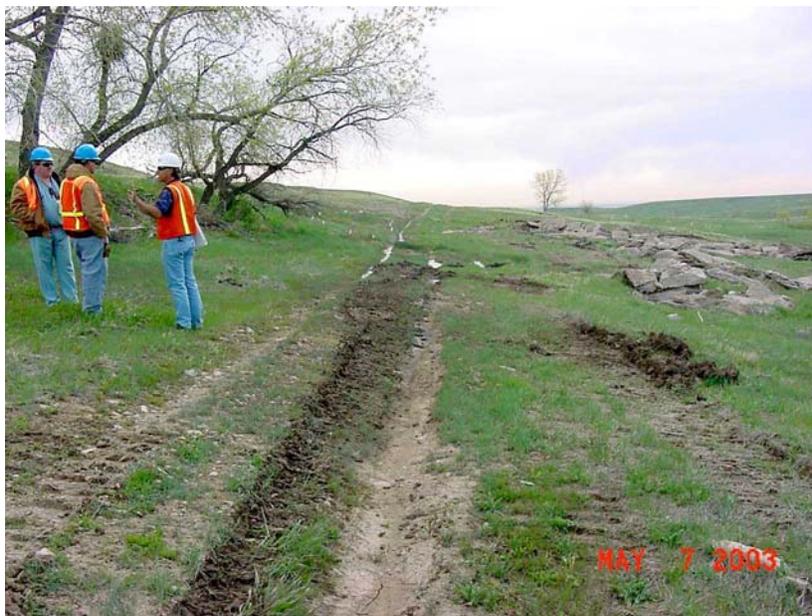
Concrete debris view looking towards the east.

- Remove miscellaneous concrete estimated at 40 cubic yards located approximately 200 feet south of the Incinerator. This concrete has been surveyed and is considered to be low-level waste.
